Artikel: Reconstruction of a railway station in Budapest

Reconstruction of a Railway Station in Budapest

TIBOR SIGRAI

UVATERV

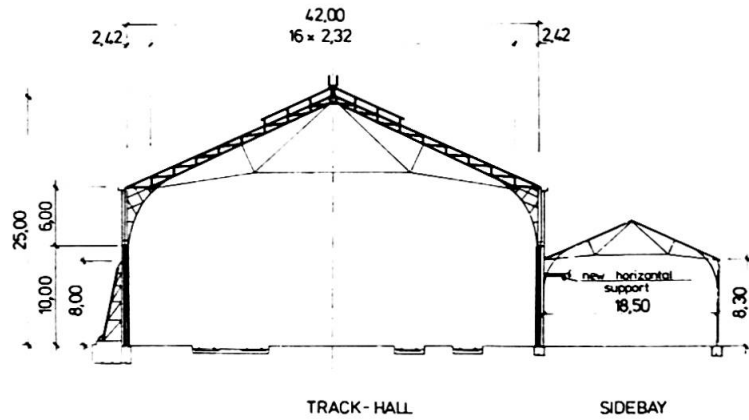
7. The remaining and the new parts of the frame structure

During the strengthening of the columns only those parts of the original columns were demolished which reached into the track-hall. The new and partly double-walled column section encases the remaining part of the original column, securing this way the composite action. Thus the remaining frame corners are located between new frame-beams and new columns. The full set of the tension bars of the trussings remained in the original state. But all of the latticed purlins had to be replaced. Also completely new are the construction of the roof glazing, the side glass-screens and the wind-braces, where the longitudinal wind-brace appears as a new structural element. The curtain wall on the exit side was totally destroyed and had to be completely rebuilt.
