Zeitschrift: IABSE congress report = Rapport du congrès AIPC = IVBH
Kongressbericht

Artikel: Timber bridge replacement to resist deicing agents

Timber Bridge Replacement to Resist Deicing Agents

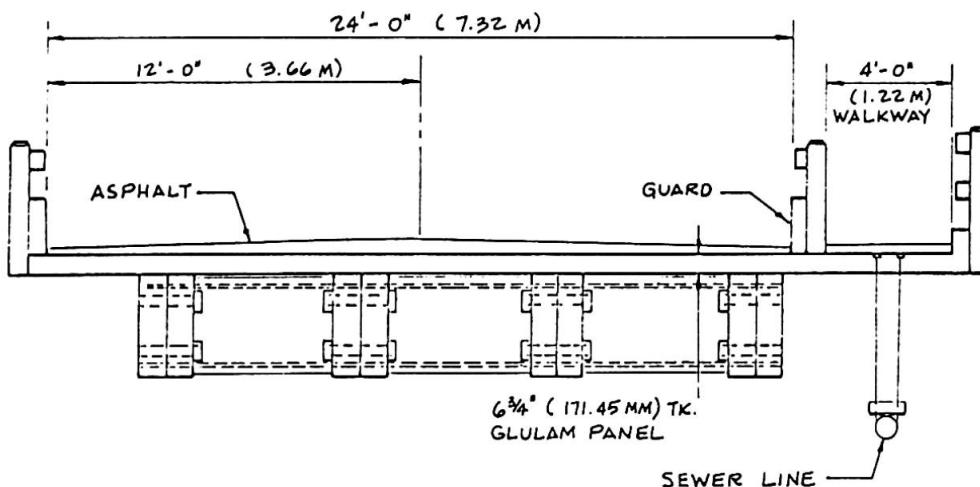
Figure 1: Case Study 2 - Cross section of glue-laminated timber replacement bridge.

The structure was widened from two 8-ft (2.4 m) lanes to two 12-ft (3.7 m) lanes and a four ft (1.2 m) sidewalk was added to the structure, as shown on Figure 1. The abutments, originally constructed from blocks of sandstone, which is also not affected by deicing agents, were in excellent condition and, therefore, reused.

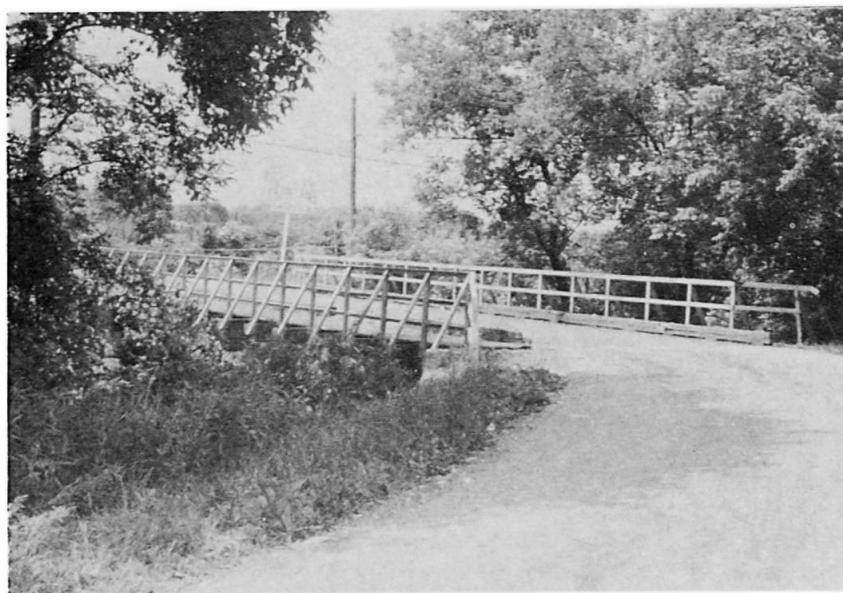
Two case studies are presented. The first deals with a deck replacement and the second with the replacement of the entire bridge structure. In 1947, a steel beam bridge structure with a mechanically laminated wood deck was constructed in Allegheny County, Pennsylvania, U.S.A. Thirty years later the deck had become weakened from use without a protective wearing surface. Where the wood had been worn from traffic and damaged with snow plows, decay by natural organisms had done the damage that water, temperature, and deicing agents had not been able to do, as shown on Photograph 1.

Photograph 1: Case Study 1 - Bridge prior to renovation.

The owner wished to consider several alternative materials, including reinforced concrete, steel grid, concrete filled steel grid, and glue-laminated timber. Timber was chosen because it had the lowest initial cost, the most pleasant appearance in the wooded surroundings and a greater service life than concrete and steel where deicing agents are heavily used. The relative costs per square foot (square meter) for the deck alternatives, excluding approach and stream work, were \$37 (\$400) for timber, \$70 (\$750) for reinforced concrete, \$77 (\$830) for open steel grid, and \$83 (\$890) for concrete filled steel grid. The lower cost for timber resulted, in part, from the ease with which the bridge could be widened and the sidewalk cantilevered.

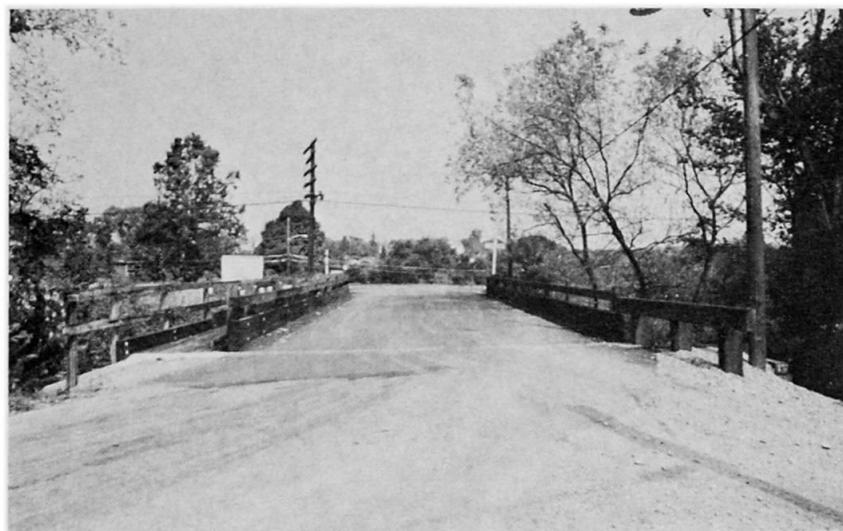
The 61 ft (18.6 m) span with two nine-ft (2.7 m) lanes and a four ft (1.2 m) sidewalk was designed to carry coal trucks weighing 60,000 lb (27,215 kg) to a mining site. The rehabilitated structure was to be able to carry 73,280 lb (33,239 kg) trucks in an AASHTO (American Association of State Highway and Transportation Officials) HS-20-44 configuration in two 11-ft (3.3 m) lanes while continuing to support the cantilevered sidewalk, as shown on Photograph 2.

Photograph 2: Case Study 2 - Bridge with glue-laminated timber deck.

The glue-laminated timber deck was assigned an expected life of 50 years while the other decks, comprised of deicing agent susceptible materials, were assigned an expected life of 15 years. The advantage of timber in cost of maintenance and second replacement was even more convincing than the lower first cost.

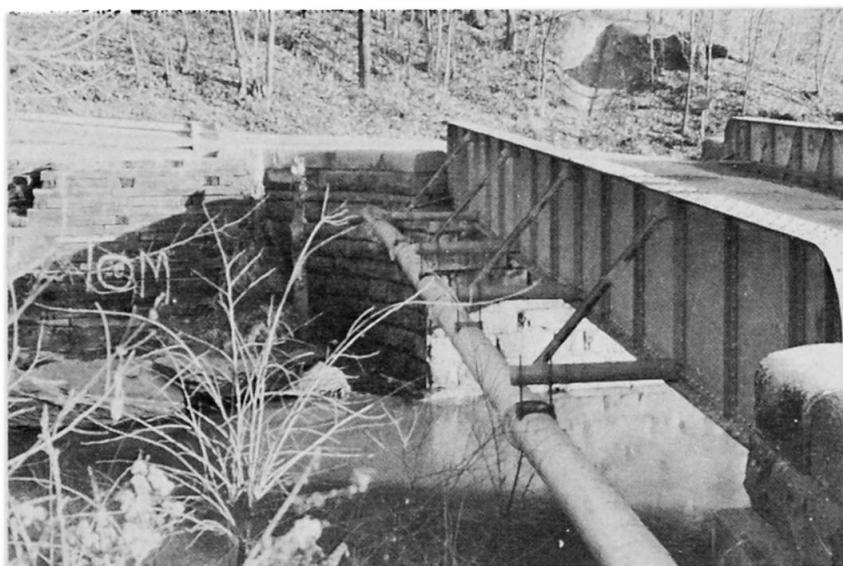
The second structure is a 54-ft (16.5 m) through-girder-span bridge built during the 1920s. The bridge served well as the primary access to a small community until deicing agents began to be used. Drainage from the crowned roadway flowed under the curb rail and over the edge of the timber deck onto the nine inch (0.23 m) steel floor beams. These steel floor beams, bracing, connections and bottom girder flanges rapidly deteriorated, and a load limit of three tons

(2722 kg) was placed on the span. In the last 15 years, deicing agents caused near-collapse status to occur, although for approximately 45 years prior to their use, the steel performed well. After approximately 55 years, the timber deck with a bituminous concrete wearing surface was still functioning adequately, but was hiding the severely corroded steel beams. This replaced bridge is shown in Photograph 3.

Photograph 3: Case Study 2 - Deteriorated steel through-girder bridge.
