Band: 11 (1980)

Artikel: Wood truss repair by epoxy injection

Autor: Sanders, Paul H. / Avent, R. Richard

**IX****Wood Truss Repair by Epoxy Injection**

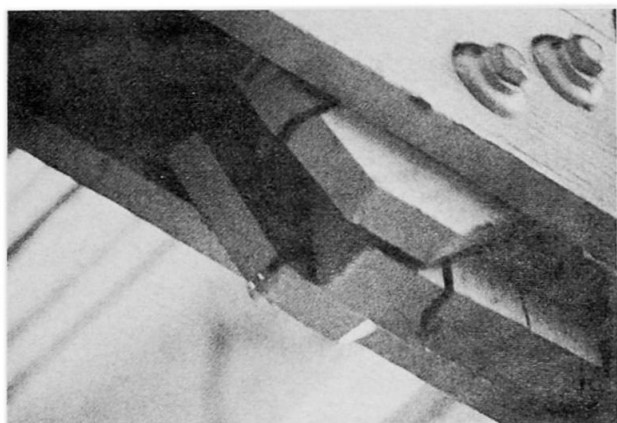
- 1. End Splits of Members. - This was the most common defect found, typically at bolted connections of web and lower chord members, as shown in Figure 1. Approximately 50% of defects found were of this type.
- 2. End Splits of Bolted Splice Plates. - Approximately 30% of defects found were of this type, depicted in Figure 2.
- 3. Interior Longitudinal Splits. - Eighteen percent of defects found were of this type, as shown in Figure 3 (note banding repair).
- 4. Broken Members. - Less than 1% of defects were in this category.
- 5. Rotten Members. - An insignificant number of these were found, usually in areas of rain leakage.
- 6. Warped Members. - A few cases of this defect were found, with no other visible defect in the member.

Fig. 1 - End Splits of Members

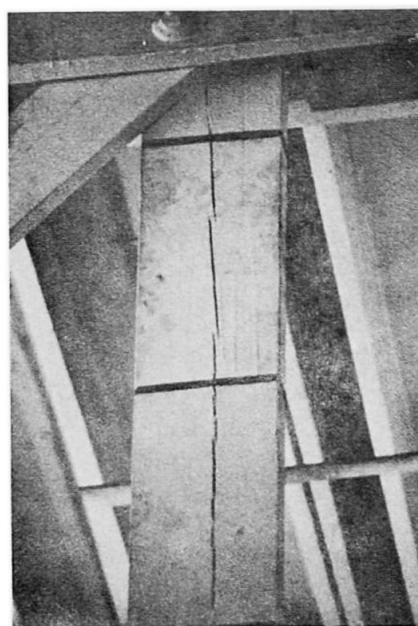
Fig. 3 - Longitudinal Split, Interior of Member
