Artikel: Wood truss repair by epoxy injection

Autor: Sanders, Paul H. / Avent, R. Richard

Wood Truss Repair by Epoxy Injection

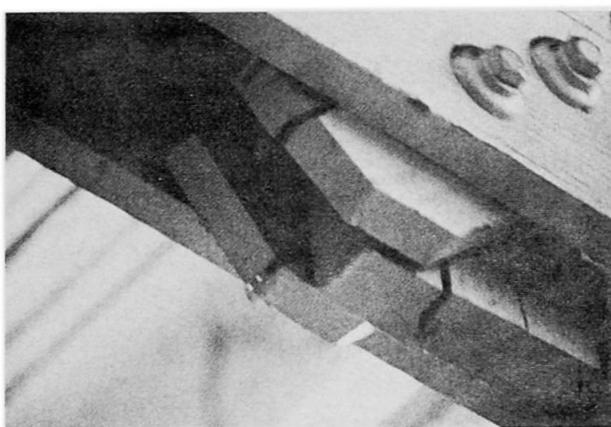
- 1. End Splits of Members. - This was the most common defect found, typically at bolted connections of web and lower chord members, as shown in Figure 1. Approximately 50% of defects found were of this type.
- 2. End Splits of Bolted Splice Plates. - Approximately 30% of defects found were of this type, depicted in Figure 2.
- 3. Interior Longitudinal Splits. - Eighteen percent of defects found were of this type, as shown in Figure 3 (note banding repair).
- 4. Broken Members. - Less than 1% of defects were in this category.
- 5. Rotten Members. - An insignificant number of these were found, usually in areas of rain leakage.
- 6. Warped Members. - A few cases of this defect were found, with no other visible defect in the member.

Fig. 1 - End Splits of Members

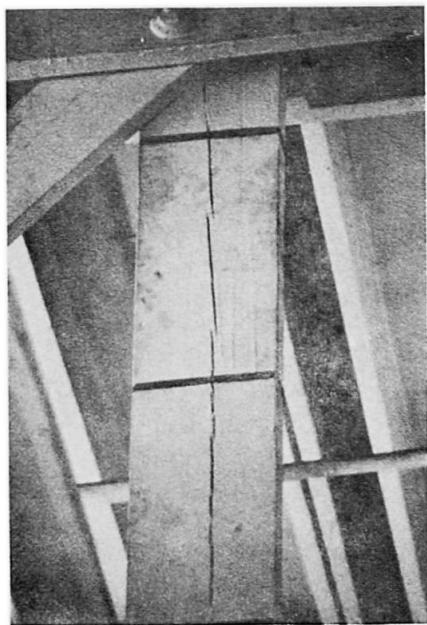
Fig. 3 - Longitudinal Split,
Interior of Member

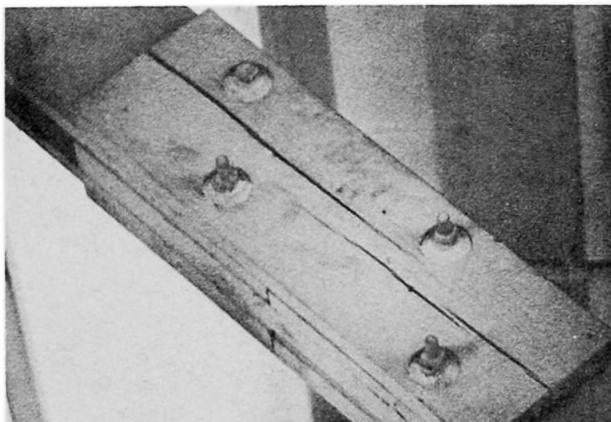
Fig. 2 - End Splits of Bolted Splice Plates
