Artikel: Damages due to snow loads

Autor: Johansson, Germund / Johannesson, Bengt

Damages Due to Snow Loads

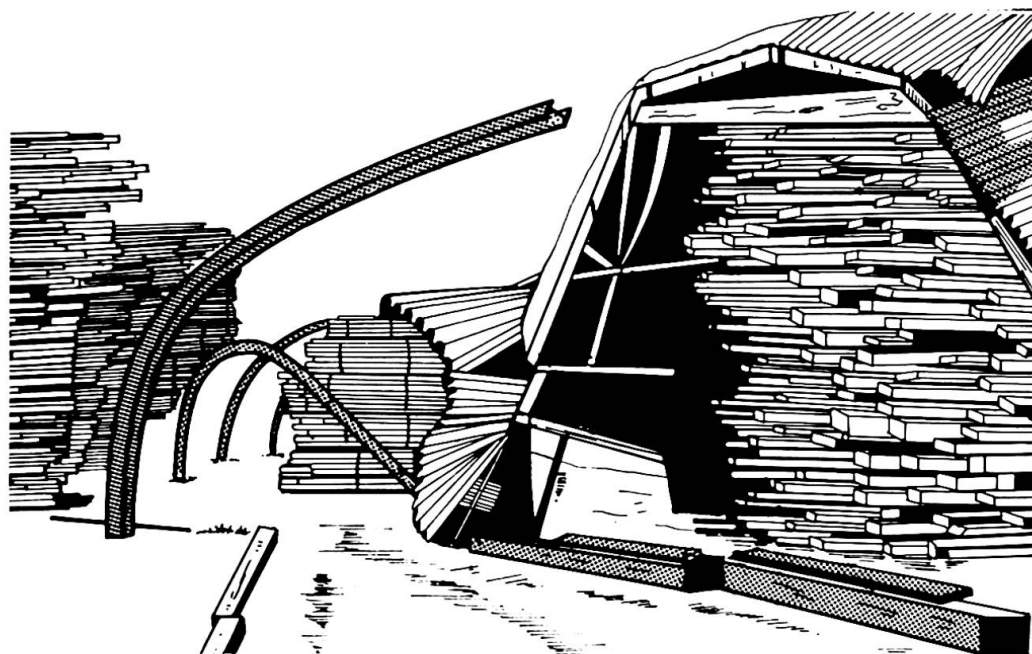
The whole structure collapsed due to overall column buckling (Fig.5). The roof snow depth was 0.55 m. The unit weight of snow varied between 2.6 and 2.9 kN/m^3 which means that the roof was subjected to a snow load of approximately 1.5 kN/m^2 .

The column load caused by dead load and snow load was estimated at 360 kN. Assuming Eulers *first* buckling case the column buckling load is 105 kN and the slenderness ratio about 400. On the other hand the buckling load 360 kN corresponds to the buckling length 1.08 times the column length. That is very close to Eulers *second* buckling case. This means that the stiffness of the connections between the columns and the roof girders have a certain influence on the buckling load. It probably also means that the columns were bracing each other due to smaller differences in loads etc.

This case is an example of a poor design. With diagonal bracings the collapse should probably have been avoided.

Fig.5 Buckled columns.
