Artikel: Damages due to snow loads

Autor: Johansson, Germund / Johannesson, Bengt

Damages Due to Snow Loads

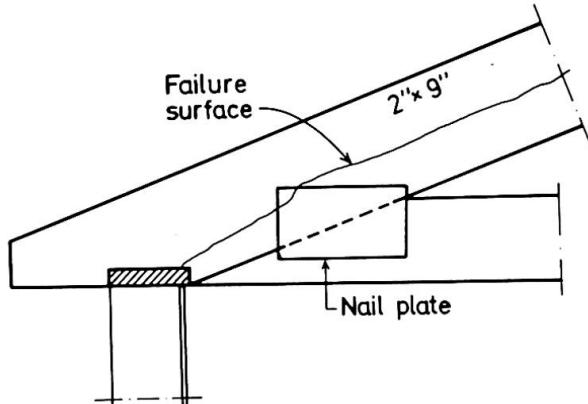
Timber connections with *nail plates* (punched metal plates) are sensitive to misplacements of the nail plates since the plate size often is small. Collapses of roof trusses were found to be due to too small nail plates at the heel joint. These small plates were placed so that cracks could develop in the rafter and then cause a collapse. When nail plates are used it is necessary not only to determine the minimum size of the plate but also to take into consideration the possibility for cracks to develop.

Fig.2 Heel joints with a too small nail plate.

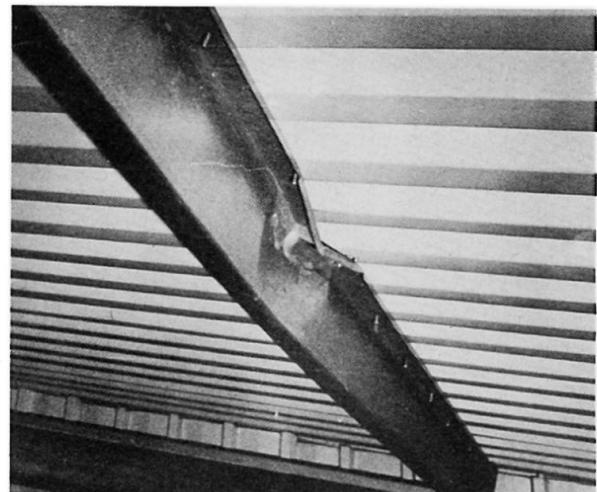
Fig.3 Buckled Z-purlin.

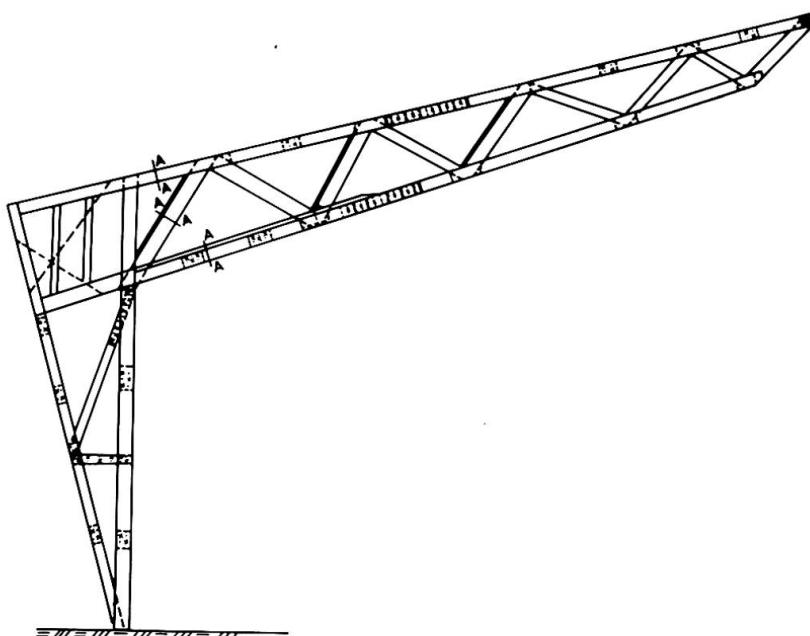
This building was used as a cold storage. The primary structure was a three-hinged wooden truss frame. After about 20 years of service in one place the building was moved to another place. A drawing of one-half of the truss is shown in Fig.4. The flanges in the truss-beam were made of two 2"×5". When the building was moved the contractor cut the frames in the sections A-A (Fig.4). In these joints lap splices of 2"×5" were nailed with just a few nails to each part. The lengths of the lap splices were about 1 m.

The whole building collapsed due to failure in the joints A-A. Probably this was a progressive failure starting in one frame. At failure the snow load was estimated at 1.1 kN/m² based on in situ measurements. According to the Swedish Building Code the joint in the tension flange should have been nailed with about 130 nails. The estimated number of nails actually used in the joint correspond to an *allowable* load of 0. kN/m² which is less than the dead load .4 kN/m. 0.3 kN/m². The total load at failure was estimated at 1.4 kN/m².

Fig.4 One half of a three-hinged truss frame, spanning 15.5 m, with joints at A-A.

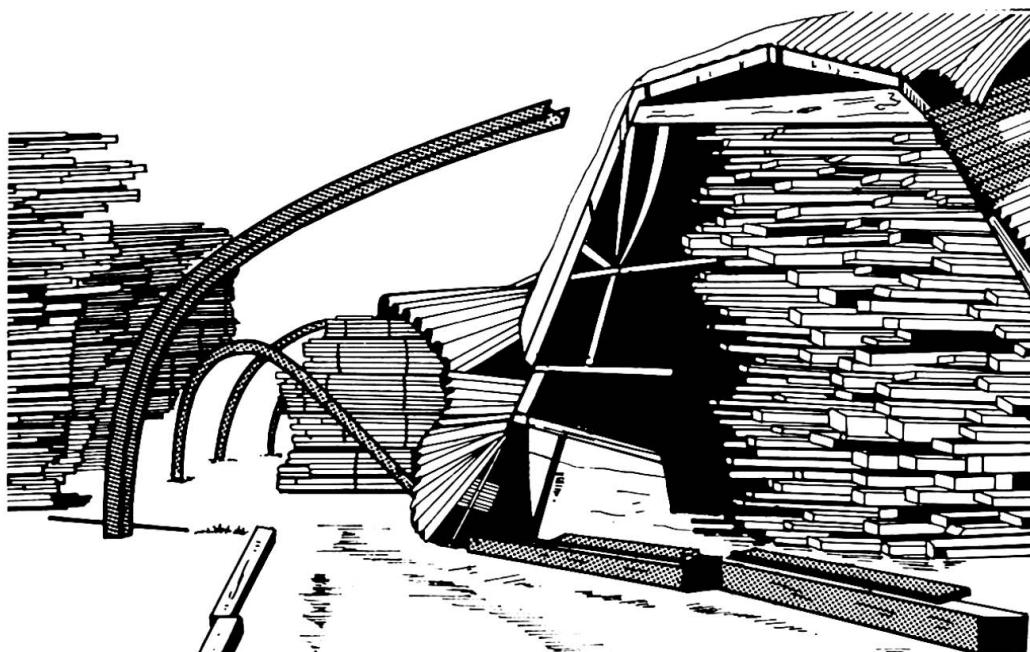
The whole structure collapsed due to overall column buckling (Fig.5). The roof snow depth was 0.55 m. The unit weight of snow varied between 2.6 and 2.9 kN/m^3 which means that the roof was subjected to a snow load of approximately 1.5 kN/m^2 .

The column load caused by dead load and snow load was estimated at 360 kN. Assuming Eulers first buckling case the column buckling load is 105 kN and the slenderness ratio about 400. On the other hand the buckling load 360 kN corresponds to the buckling length 1.08 times the column length. That is very close to Eulers second buckling case. This means that the stiffness of the connections between the columns and the roof girders have a certain influence on the buckling load. It probably also means that the columns were bracing each other due to smaller differences in loads etc.

This case is an example of a poor design. With diagonal bracings the collapse should probably have been avoided.

Fig.5 Buckled columns.
