**Zeitschrift:** IABSE congress report = Rapport du congrès AIPC = IVBH  
Kongressbericht

**Artikel:** Damages due to snow loads

**Autor:** Johansson, Germund / Johannesson, Bengt

## Damages Due to Snow Loads

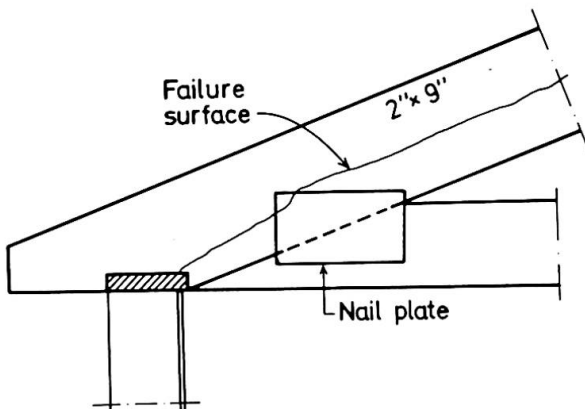
Timber connections with *nail plates* (punched metal plates) are sensitive to misplacements of the nail plates since the plate size often is small. Collapses of roof trusses were found to be due to too small nail plates at the heel joint. These small plates were placed so that cracks could develop in the rafter and then cause a collapse. When nail plates are used it is necessary not only to determine the minimum size of the plate but also to take into consideration the possibility for cracks to develop.

**Fig.2** Heel joints with a too small nail plate.

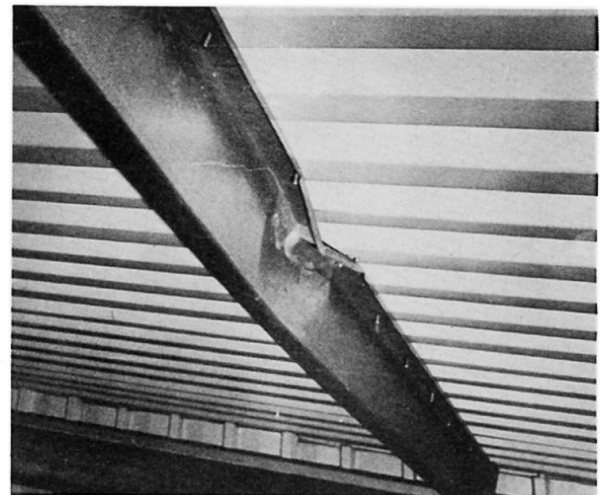
**Fig.3** Buckled Z-purlin.

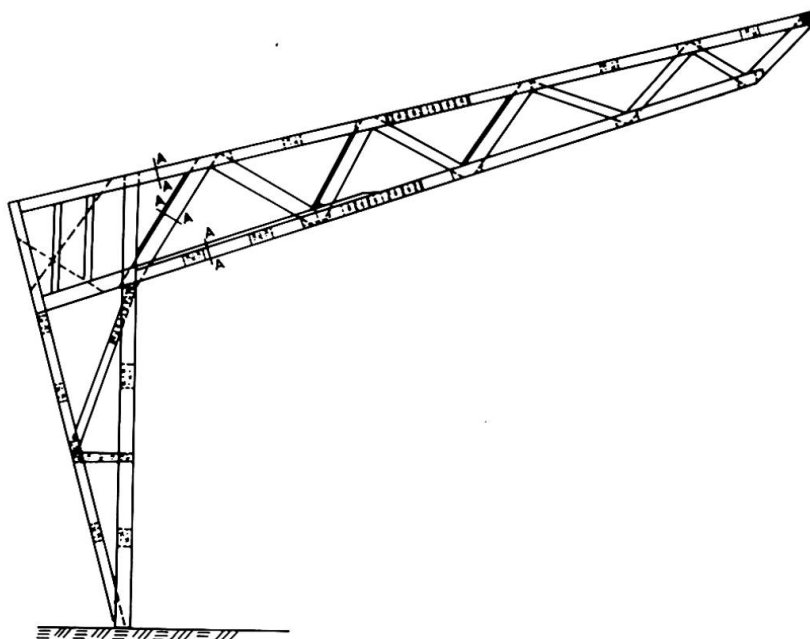
This building was used as a cold storage. The primary structure was a three-hinged wooden truss frame. After about 20 years of service in one place the building was moved to another place. A drawing of one-half of the truss is shown in Fig.4. The flanges in the truss-beam were made of two 2"×5". When the building was moved the contractor cut the frames in the sections A-A (Fig.4). In these joints lap splices of 2"×5" were nailed with just a few nails to each part. The lengths of the lap splices were about 1 m.

The whole building collapsed due to failure in the joints A-A. Probably this was a progressive failure starting in one frame. At failure the snow load was estimated at  $1.1 \text{ kN/m}^2$  based on in situ measurements. According to the Swedish Building Code the joint in the tension flange should have been nailed with about 130 nails. The estimated number of nails actually used in the joint correspond to an *allowable* load of  $0. \text{ kN/m}^2$  which is less than the dead load  $.4 \text{ kN/m}$ .  $0.3 \text{ kN/m}^2$ . The total load at failure was estimated at  $1.4 \text{ kN/m}^2$ .

Fig.4 One half of a three-hinged truss frame, spanning 15.5 m, with joints at A-A.

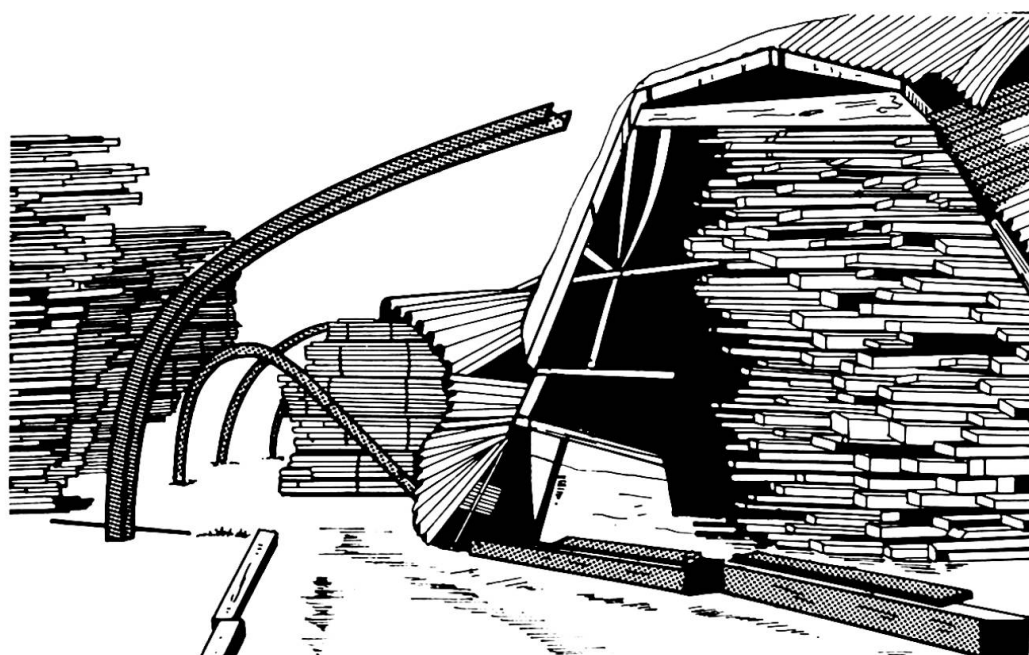
The whole structure collapsed due to overall column buckling (Fig.5). The roof snow depth was 0.55 m. The unit weight of snow varied between 2.6 and  $2.9 \text{ kN/m}^3$  which means that the roof was subjected to a snow load of approximately  $1.5 \text{ kN/m}^2$ .

The column load caused by dead load and snow load was estimated at 360 kN. Assuming Eulers *first* buckling case the column buckling load is 105 kN and the slenderness ratio about 400. On the other hand the buckling load 360 kN corresponds to the buckling length 1.08 times the column length. That is very close to Eulers *second* buckling case. This means that the stiffness of the connections between the columns and the roof girders have a certain influence on the buckling load. It probably also means that the columns were bracing each other due to smaller differences in loads etc.

This case is an example of a poor design. With diagonal bracings the collapse should probably have been avoided.

Fig.5 Buckled columns.
