Artikel: Rehabilitation of post-tensioned bridge deck

Rehabilitation of Post-Tensioned Bridge Deck

Klaus H. OSTENFELD

Motorway Bridge, Denmark

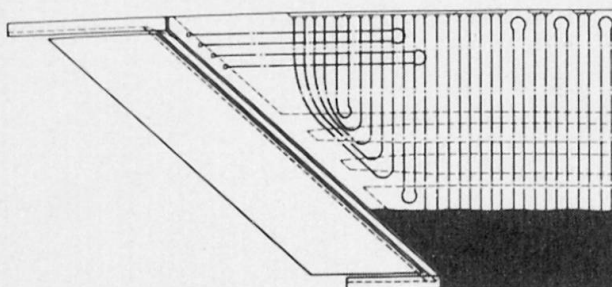
Plan section

Existing transverse and longitudinal prestressing. The 12 x 5 mm transverse prestressing wires were re-used, but cut off at the edge of the bridge deck.
