# Behaviour of Four Prestressed Concrete Platform Roofs Between 1955 and 1963

P. W. ABELES

London

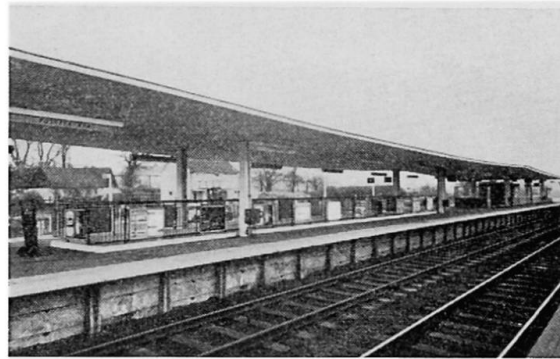
excessive deformation and by the infiltration of water into a lightweight concrete topping (which was afterwards provided at the centre portion to improve the drainage), the deadload was appreciably increased and exceeded there the working load with the consequence that cracks developed at the underside i. e. where compressive stresses were expected, as described in more detail elsewhere<sup>1</sup>). Consequently, modifications were made by removal of the "lightweight" concrete topping and roofing cover over the centre portion of the roof and ensuring satisfactory drainage, thereby keeping the dead load within the design value, when all cracks at the underside closed. Figs. 3 and 4 show the

roof after this modification, when the deformations were greatly reduced and the recoveries were in good agreement with the anticipation based on the calculation with an  $E$ -value more appropriate to the actual strength.

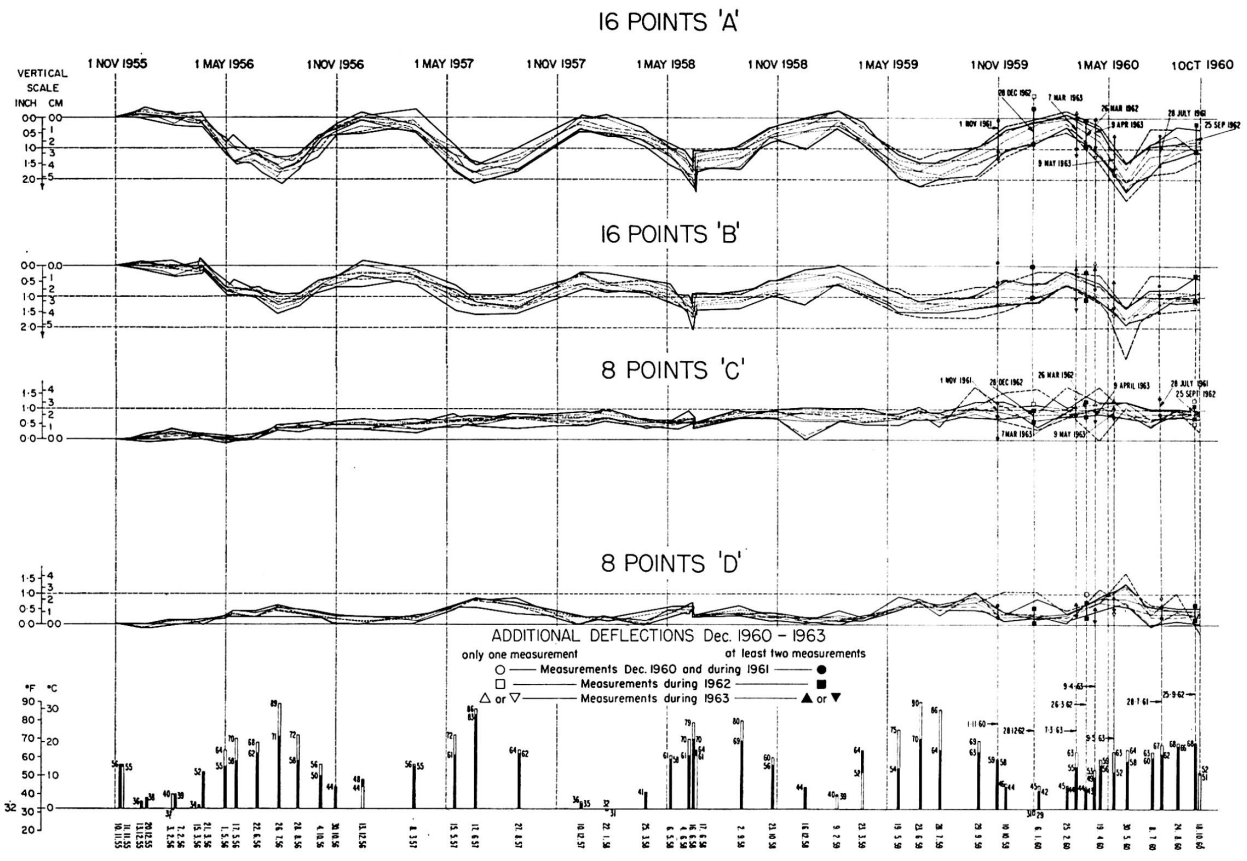
Fig. 5.

Measurements of the levels of the four corners  $A$ , of the four cantilever ends  $B$  and of the two points  $C$  and  $D$  at the centre of the roofs have been made for all four roofs at certain intervals. In Fig. 5 the maximum and minimum levels of each roof have been plotted for the time between November 1955 and November 1960. The abscissa representing the time is divided into 10 divisions, each of which indicates half a year, and the date is given underneath. The maximum and minimum of deflections of all four roofs are shown by solid lines when at least two readings were available and by dotted lines where only a single reading applied. Fig. 5 relates to the measurements of 16 points each at the corners  $A$  and the cantilever ends  $B$ , and covers the points  $C$  and  $D$  at the centres where eight readings each were taken.

It is seen that the deflections varied to a great extent during each year and were mainly dependent on the temperature. Obviously, also, sunshine and relative humidity are of some influence. However, it was impossible, as originally intended, to make some distinction between the effect of temperature, sunshine and relative humidity. The latter was ascertained since Autumn 1959 and varied between 36 and 88 per cent relative humidity. The weather in England, as is well known, is very changeable and thus appreciable differences in temperature and humidity occurred often between the levelling of the first and last roof. This accounts for great variations between the minimum at individual measurements.

Sudden changes in temperature caused immediate deviation in deflections as can be seen for the measurements on 4, 16 and 17 June 1958. The sudden increase in temperature on the 16th June and the subsequent reduction brought about immediate changes in the deflections.

Greater variations between maximum and minimum deflections occurred in 1963 after a prolonged sustained loading due to snow in January and February 1963. Already at the loading on 28th December 1962 snow was on the roof, but the deformations differ relatively little from those obtained at investigations without live load. However, greater deviations occurred at the measurements in March 1963. For this reason further investigations were carried out in April and May 1963.
