# The analysis, design and remedial repairs for a fire damaged two-way roof truss structure

## The Analysis, Design and Remedial Repairs for a Fire Damaged Two-Way Roof Truss Structure

Stanley D. Lindsey & Associates, Ltd.  
Nashville, USA

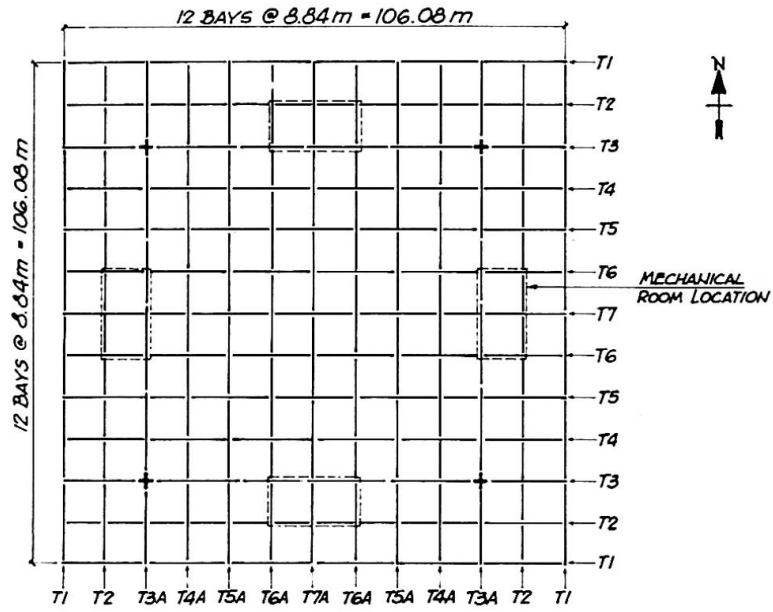
FIGURE 1. ROOF FRAMING PLAN

Nashville. The roof framework is a symmetrical two-way truss system supported on four columns as shown in Figure 1. The structural system is considered a space grid to obtain the local distribution on each truss. The four main support trusses spanning between the four columns serve to distribute the load equally to the support columns.

During the construction stage of the project (after all steel trusses, bar joists, and roof decking were in place and with the majority of the dead load present), a flash fire broke out on a scaffolding platform adjacent to and just below one of the mechanical rooms. This was just to the side and at midspan of one of the main support trusses. While the fire was under control within thirty minutes, the heat in the roof reached a minimum temperature of 540°C causing a major reduction in the strength of the steel and expansion of several of the truss members. As a result of these changes, several members deformed, thus weakening the structure and causing it to be on the verge of collapse. Immediate action was necessary.

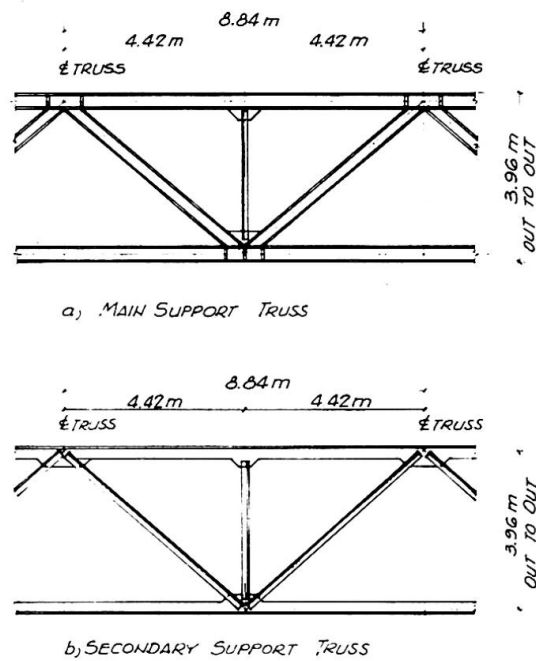
FIGURE 2. TRUSS ELEVATIONS

- a. The top chord of the main support truss had major flange buckling and lateral deformations.
- b. Virtually all bar joists and bridging were damaged beyond repair.
- c. The top chords of several adjacent trusses had warped stems.
- d. Several diagonals composed of double angles had buckled.
- e. Virtually all the miscellaneous support steel for the mechanical equipment was deformed.

The first option was that of reshoring and jacking the truss structure back to its original elevation and replacing those members, joists, etc., that were damaged by the fire. This procedure required the same shoring arrangements that were defined for the construction stage of the project. Once the truss was in its original elevation, the damaged members, joists, and bridging would have to be replaced. The buckled portion of the top chord truss 3A would have to be replaced while the top chord of truss 2 at mid-span of truss 6 and truss 7 would have to be reinforced. Also, it was decided that all high strength bolts in the top chord connections at the intersection of trusses 6 and 7 and truss 3 should be replaced individually once the roof structure is back to its zero elevation.

The apparent advantage of this option was that it returned the structural system to its original design before the fire with the exception of the reinforcement of the top chord of truss 2 and the two splices required to insert a new top chord section of truss 3. The deflections were then very close to the original design deflections. The apparent disadvantages were that the entire structure must be reshored back to its zero elevation and thus restrict work underneath the roof structure. This in turn could result in a delay in the project plan plus increase the labor involved in reshoring and jacking. Also, it should be noted that while the shoring pattern to raise the truss was defined, the jacking procedure was not well
