**Artikel:** Fracture and retrofit of Dan Ryan Rapid Transit Structure

**Autor:** Fisher, J.W. / Hanson, J.M. / Hausammann, H.

**IX****Fracture and Retrofit of Dan Ryan Rapid Transit Structure**

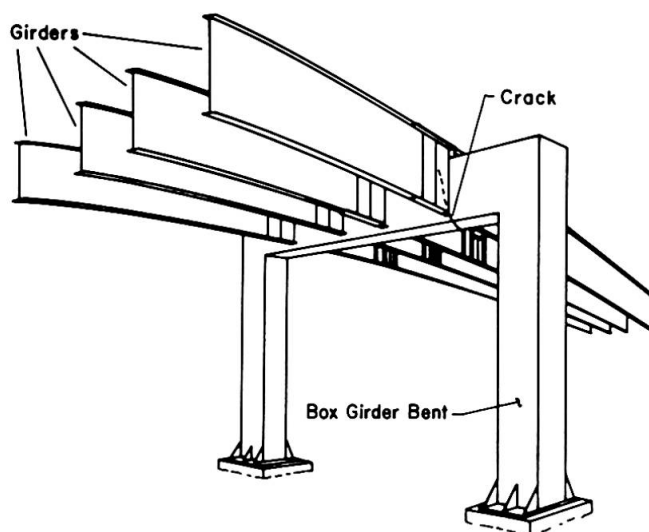
The bents have a box-shaped cross-section consisting of two column legs and a horizontal box member, as shown in Fig. 1. The top flanges of the plate girders pass over the top flanges of the boxes. The bottom flanges pierce the boxes through flame-cut slots near the bottom of the box side plates. In the fractured bents, the intersections were connected by heavy fillet welds on the outside and little or no weld on the inside. At other locations, the intersections were sometimes filled with welds. The girders intersect the boxes at different angles. The bents and the girders are fabricated of American Society for Testing of Materials (ASTM) A36 steel.

Fig. 1 Schematic Showing Box-Shaped Bent and Girders with Crack Location

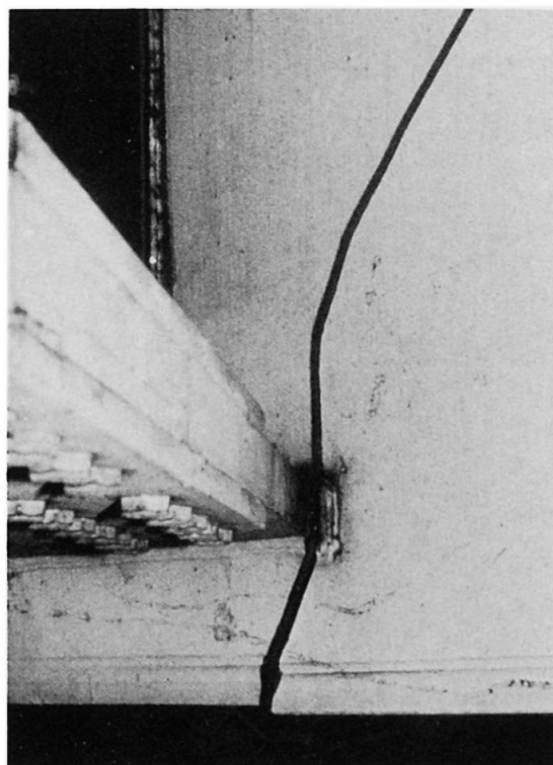
The initial field examination of the fracture indicated that all of the cracks started at the welded junction of the plate girder flange tip to the box side plate, as illustrated in Fig. 2. All three cracks completely severed the bottom flange of the box girders and the webs. Openings at the bottom flange of about 20 mm were measured.

Fig. 2 Cracked Box Side Plate

The cracks were arrested near or in the top flange. The cracks in the bottom flanges were inclined approximately 20 degrees to a normal to the longitudinal axis of the bent above the flanges of the girders. Two crack surfaces were found to be slightly corroded, the third one had a heavy oxide coating.

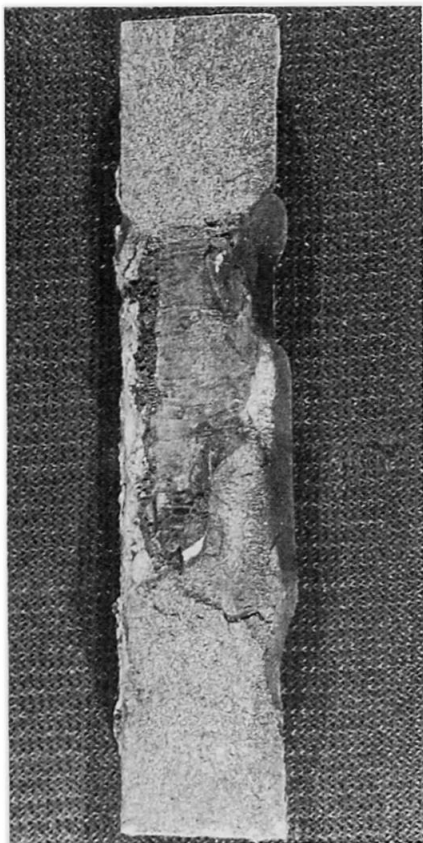
The crack surfaces of the side plates of the box girders adjacent to the flange tip were examined. Chevron markings found on the fracture surface indicated that the crack originated near the tip of the girder flange. A photograph and schematic of one fracture surface are shown in Figs. 3a and 3b. The overall fracture surface shows that the weldment connecting the flange tip to the box had a large lack of fusion area. Paint was found in some of these areas, which had penetrated from the inside of the box. The largest lack of fusion area was approximately 18 mm by 83 mm and was approximately elliptical shaped.

Fig. 3a Fracture Surface of Box Girder Web Plate

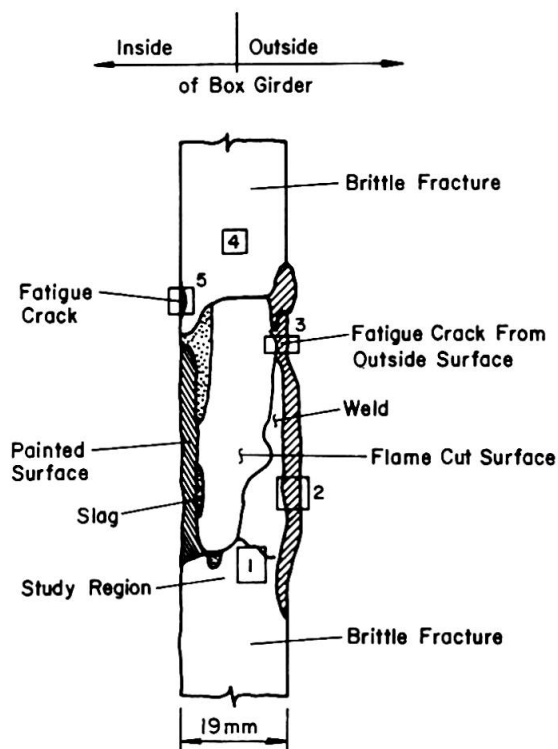
Fig. 3b Schematic of Fracture Surface

Surface replicas were prepared from different locations of the crack surface indicated in Fig. 3b and investigated with the transmission electron microscope. Fatigue striations (see Fig. 4) were found on all three fracture surfaces. These striations represent the extension of the crack front during one load cycle and confirmed the development of fatigue crack growth. Striation markings were found in regions 2 and 3 in Fig. 3b; the measured growth rate was  $2.10^{-5}$  mm/cycle near the exterior surface and  $5.10^{-5}$  mm/cycle near the lack of fusion area. The examination of region 4 near the upper end of the discontinuity showed mainly cleavage fracture with river patterns. The examination of each fracture surface confirmed that fatigue crack growth originated at the lack of fusion area and at the exterior weld surface at the weld toe on the box side plate. It was estimated that about 6 mm of fatigue crack growth was experienced before the cracks became unstable.

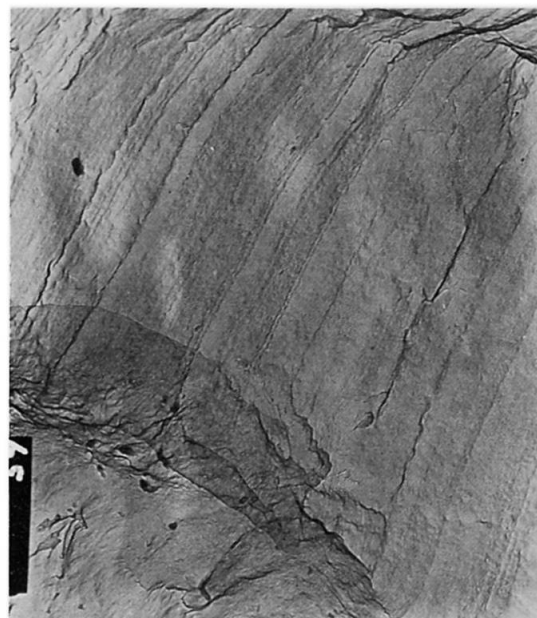
Fig. 4 Fatigue Striation Markings on Box Girder Web Surface

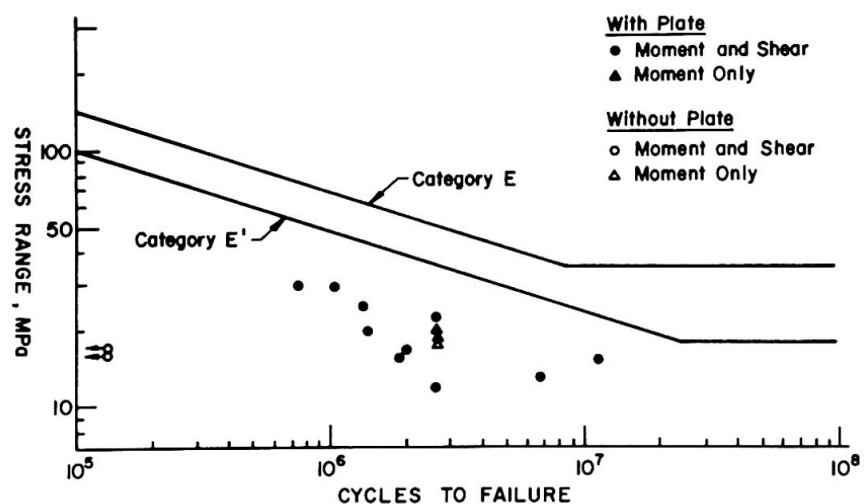
After the discovery of the fracture in the Dan Ryan Rapid Transit, fatigue tests of similar details were carried out at Fritz Engineering Laboratory, Lehigh University [4]. It was found that the fatigue strength of a web detail which simulated the penetration of a girder flange through the web was well below the most severe design category in the AASHTO Specifications [5]. Figure 5 shows the fatigue resistance provided by the tests of the simulated web penetration insert detail [4].

Fig. 5 Fatigue Strength of Simulated Web Penetration

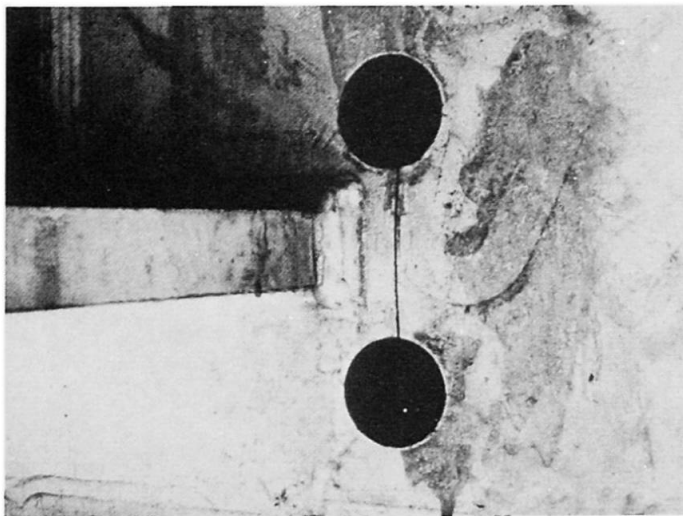
Fig. 6a Retrofitted Box Side Plate

Any retrofit must minimize the severe stress concentration at the intersection of the girder flange and the box girder webs and reduce the high residual stresses from the weld shrinkage. To accomplish this aim, those locations with small or negligible cracks at the flange tips were retrofitted by cutting holes and sawing between them to create a "dumbbell" configuration in the box side plates near the edges of the girder flanges, as shown in Fig. 6. This method of retrofitting was considered to release the residual stress field at the flange tip and to shield the critical location from the bending stresses.

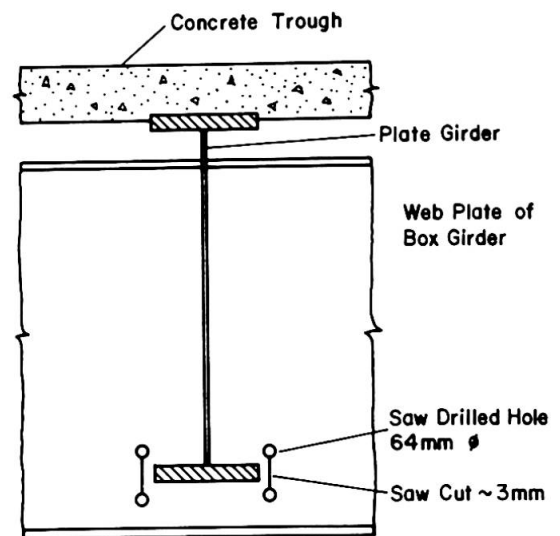
Fig. 6b Schematic of Retrofitted Detail
