# Timber bridge replacement to resist deicing agents

## Timber Bridge Replacement to Resist Deicing Agents

J.R. VERNA President Verna Engineering, Inc. Carnegie, PA, USA J.M. SHANNON
Senior Engineer
Verna Engineering, Inc.
Carnegie, PA, USA

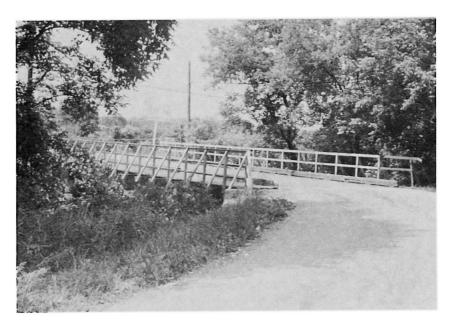
Photograph 1: Case Study 1 - Bridge prior to renovation.

Two case studies are presented. The first deals with a deck replacement and the second with the replacement of the entire bridge structure. In 1947, a steel beam bridge structure with a mechanically laminated wood deck was constructed in Allegheny County, Pennsylvania, U.S.A. Thirty years later the deck had become weakened from use without a protective wearing surface. Where the wood had been worn from traffic and damaged with snow plows, decay by natural organisms had done the damage that water, temperature, and deicing agents had not been able to do, as shown on Photograph 1.

The 61 ft (18.6 m) span with two nine-ft (2.7 m) lanes and a four ft (1.2 m) sidewalk was designed to carry coal trucks weighing 60,000 lb (27,215 kg) to a mining site. The rehabilitated structure was to be able to carry 73,280 lb (33,239 kg) trucks in an AASHTO (American Association of State Highway and Transportation Officials) HS-20-44 configuration in two ll-ft (3.3 m) lanes while continuing to support the cantilevered sidewalk, as shown on Photograph 2.

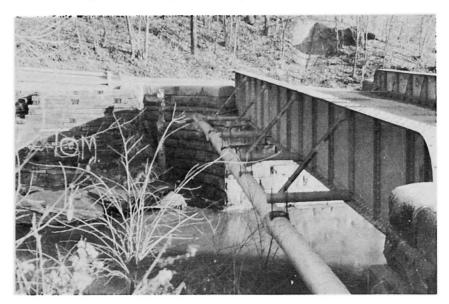
Photograph 3: Case Study 2 - Deteriorated steel through-girder bridge.

The second structure is a 54-ft (16.5 m) through-girder-span bridge built during the 1920s. The bridge served well as the primary access to a small community until deicing agents began to be used. Drainage from the crowned roadway flowed under the curb rail and over the edge of the timber deck onto the nine inch (0.23 m) steel floor beams. These steel floor beams, bracing, connections and bottom girder flanges rapidly deteriorated, and a load limit of three tons

(2722 kg) was placed on the span. In the last 15 years, deicing agents caused near-collapse status to occur, although for approximately 45 years prior to their use, the steel performed well. After approximately 55 years, the timber deck with a bituminous concrete wearing surface was still functioning adequately, but was hiding the severely corroded steel beams. This replaced bridge is shown in Photograph 3.
