Wood truss repair by epoxy injection

**IX****Wood Truss Repair by Epoxy Injection**

PAUL H. SANDERS

R. RICHARD AVENT

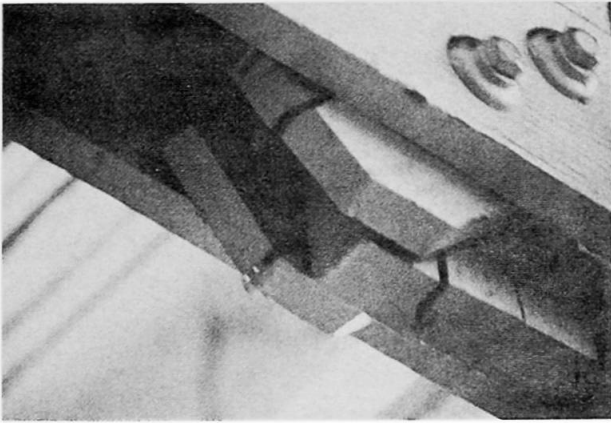
- 1. End Splits of Members. - This was the most common defect found, typically at bolted connections of web and lower chord members, as shown in Figure 1. Approximately 50% of defects found were of this type.
- 2. End Splits of Bolted Splice Plates. - Approximately 30% of defects found were of this type, depicted in Figure 2.
- 3. Interior Longitudinal Splits. - Eighteen percent of defects found were of this type, as shown in Figure 3 (note banding repair).
- 4. Broken Members. - Less than 1% of defects were in this category.
- 5. Rotten Members. - An insignificant number of these were found, usually in areas of rain leakage.
- 6. Warped Members. - A few cases of this defect were found, with no other visible defect in the member.

Fig. 1 - End Splits of Members

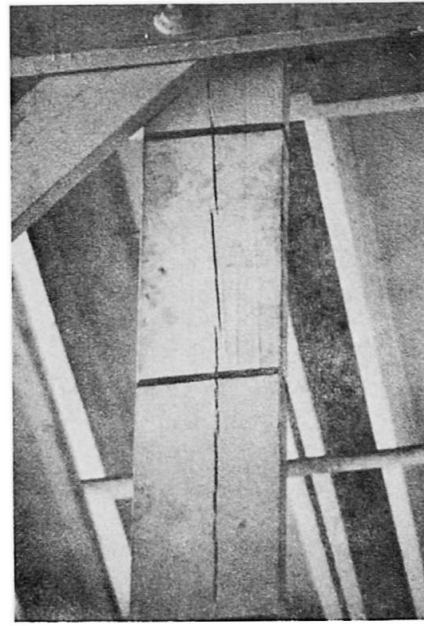
Fig. 3 - Longitudinal Split,
Interior of Member
