**Rubrik:** Seminar 3: Structures to withstand natural disasters: experiences and applications

## Seismic Damage and Retrofit to California's Urban Concrete Bridge Structures

### **Frieder SEIBLE**

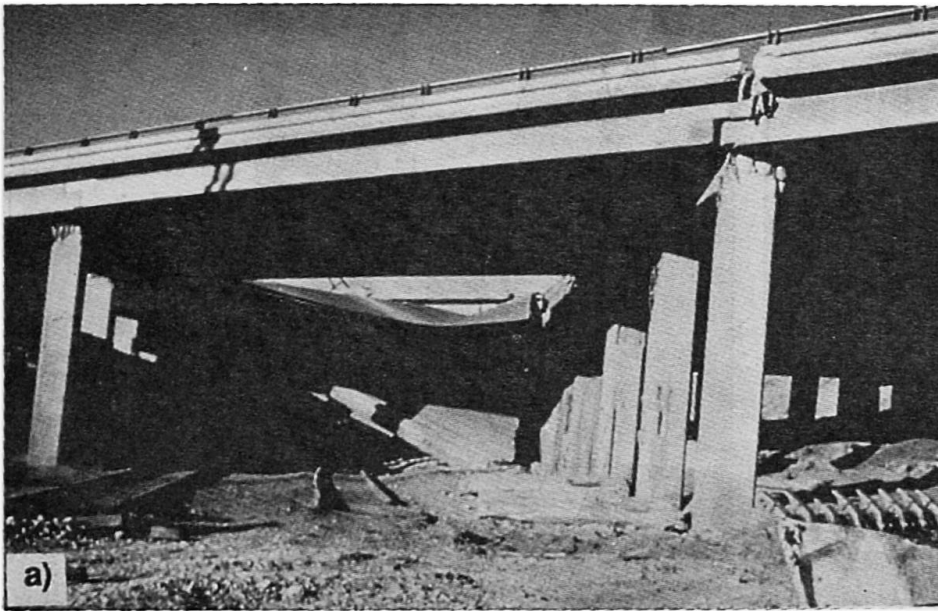
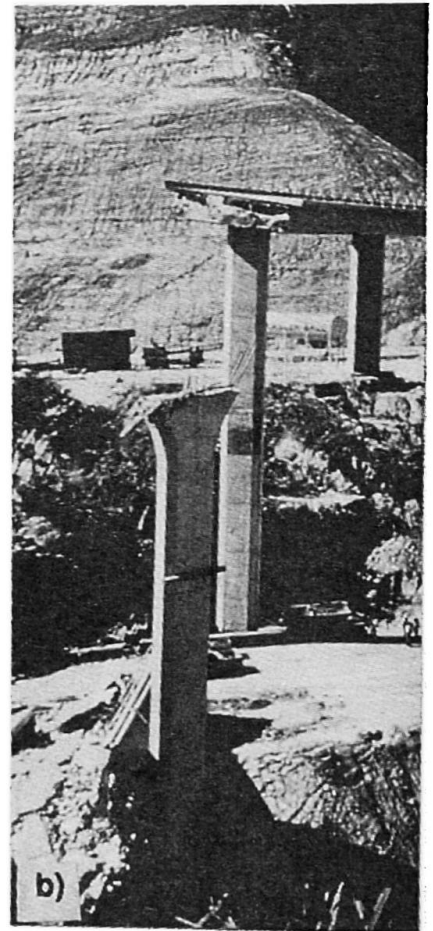
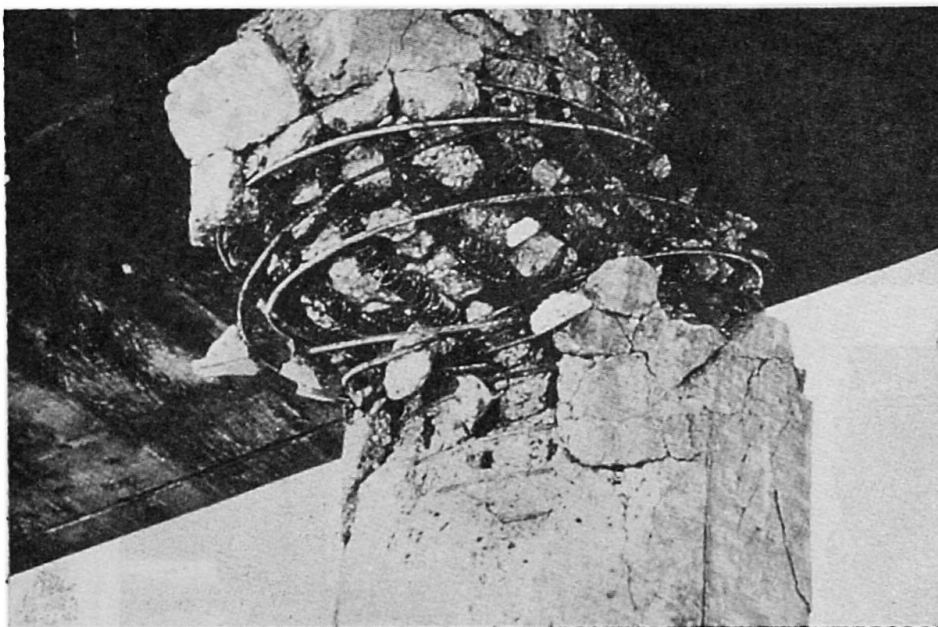
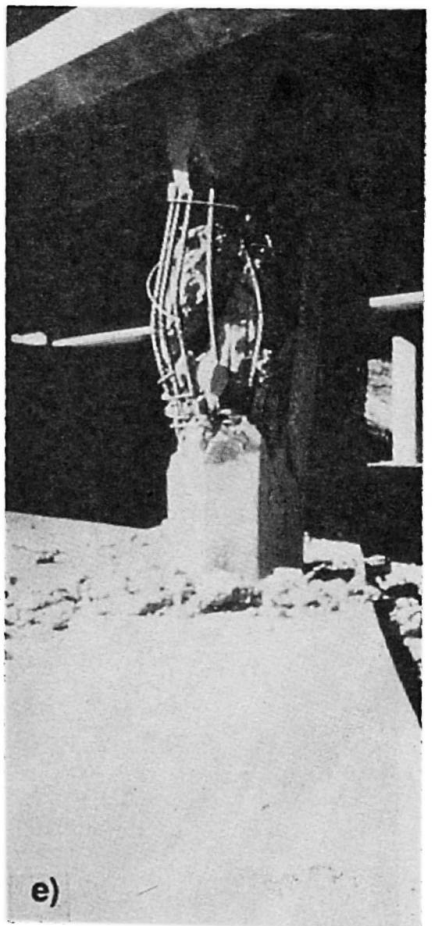
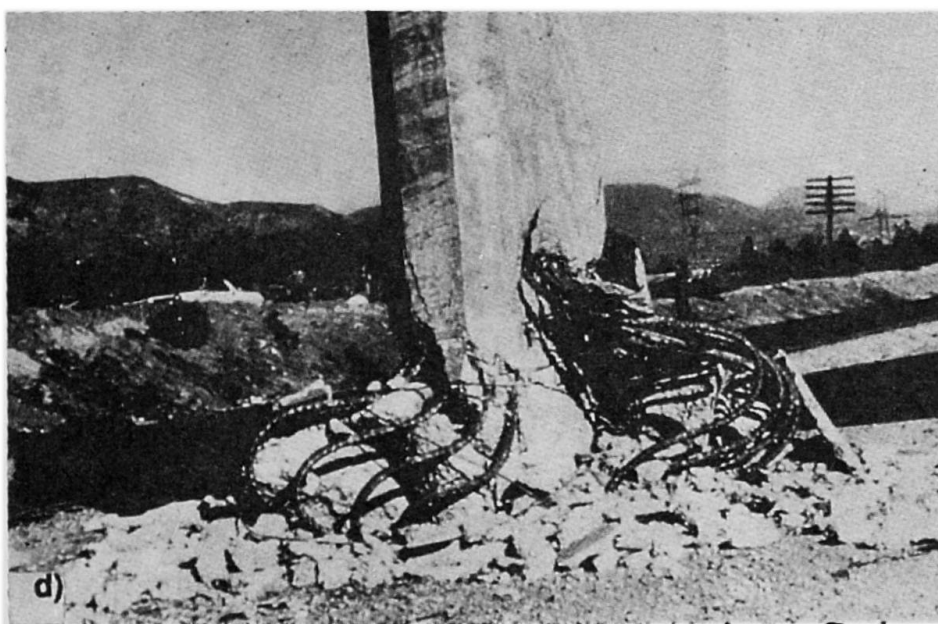
**Fig 1. Bridge Damage During the 1971 San Fernando Earthquake**

The 1971 San Fernando earthquake caused significant bridge damage, particularly to newly constructed interstate bridges. Key problems identified ranged from excessive seismic displacements and subsequent unseating of complete bridge spans at movement joints, see Figs. 1a and b, inadequate confinement of flexural plastic hinge regions in columns, see Figs. 1c and d, and Figs. 2a and b, anchorage problems with large diameter  $\varnothing$  57 mm (#18) column reinforcement into the footing, see Fig. 2d, brittle shear failure of short columns with insufficient shear reinforcement, see Fig. 1e, and joint failures of knee joints due to the lack of joint shear reinforcement, see Fig. 2c. It is of interest to note that subsequent earthquakes such as Whittier (1987) and Loma Prieta (1989) did not uncover completely new problem areas which were not already identified in San Fernando (1971) but rather reemphasized some of the above mentioned problems.

While design guidelines for new bridge structures were immediately changed to reflect higher seismic force levels, confinement of column concrete particularly in potential plastic hinge regions and increased force and displacement requirements for movement joints, seismic retrofitting of existing bridge structures focussed initially on movement joint restrainers to prevent unseating and span collapse.

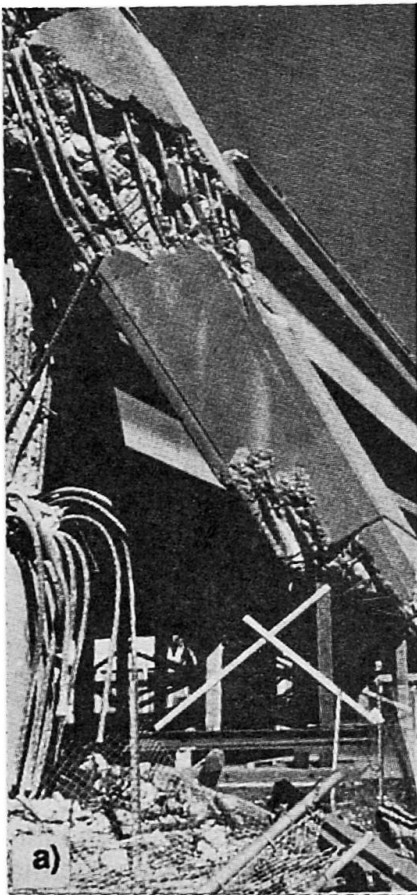
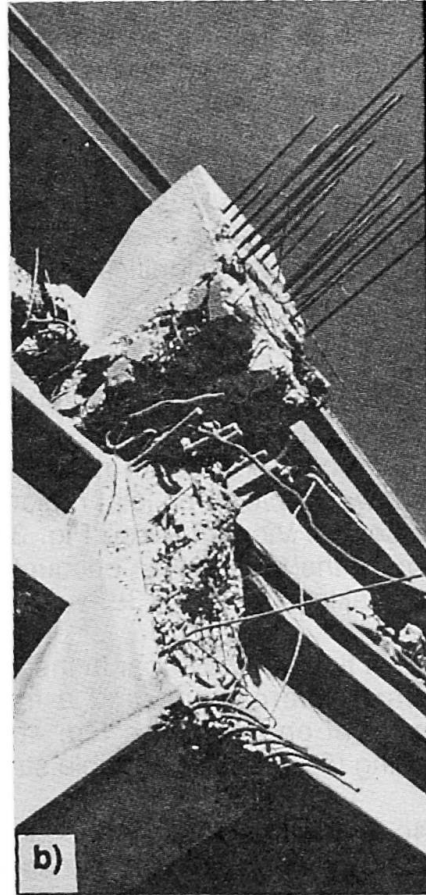
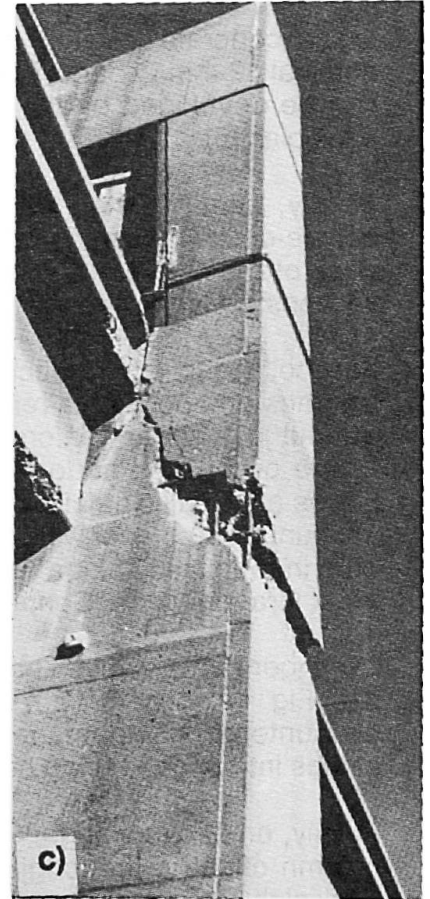
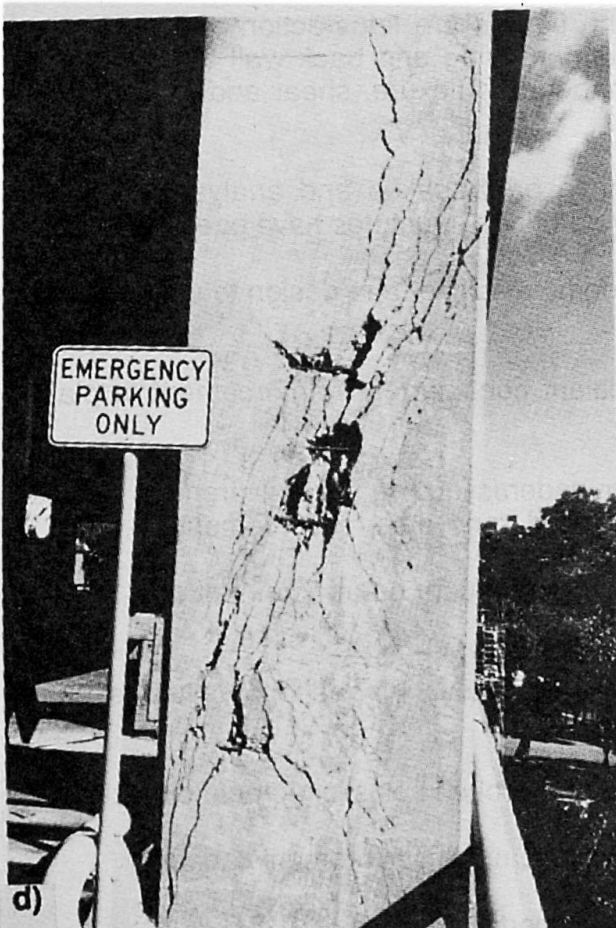
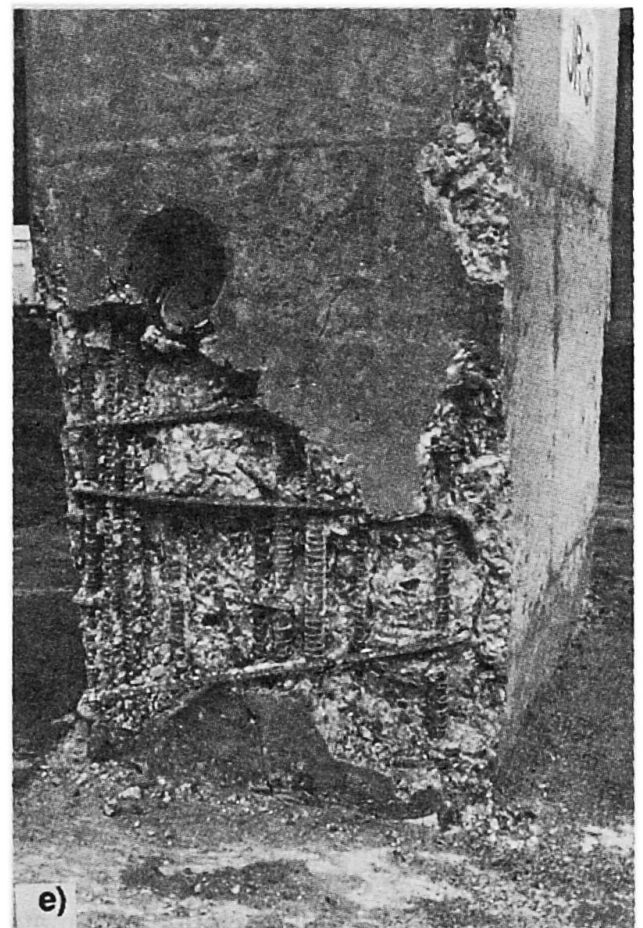
**Fig 3. Bridge Damage, Loma Prieta 1989 (M7.1)**

Finally, Loma Prieta (1989) revisited all previously encountered problems with emphasis on double-deck viaduct structures through the collapse of a 1 km (0.7 mile) long section of the upper deck of the Cypress Viaduct in Oakland, and significant damage to other double-deck viaduct sections in San Francisco.

The collapsed upper deck of the Cypress Viaduct in Oakland is shown in Fig. 3a, featuring columns and pedestals reinforced with 12 mm  $\varnothing$  ties @ 300 mm (#4 @ 12 in.) and joint regions without joint shear reinforcement. Figure 3b depicts a lower cap/column connection with pullout failure of top and bottom cap reinforcement due to inadequate anchorage length and Fig. 3c shows a typical joint failure of the lower cap/column joint region. Typical column shear failure was encountered on Highway 101 – Central Viaduct – see Fig. 3d, and lap-splice failure of column bars in the plastic hinge at the top of the footing was encountered in single-column bents on the West Grand Avenue Connector in Oakland, see Fig. 3e.

Following the Loma Prieta earthquake, several double-deck viaducts in San Francisco were closed to traffic and temporary retrofit strategies were designed to prevent collapse in the case of additional seismic activity in the near future. Some of the temporary retrofits were fully or partially implemented, see Figs. 6a, b and c. However, their ineffectiveness in providing required lateral confinement levels and their lack of global structural seismic retrofit strategy, see [3], prompted a reevaluation of these temporary retrofit schemes and resulted in the immediate design of permanent and final retrofit measures, which are currently being scrutinized, proof tested and implemented [3]. The difficulties encountered during the design process of the San Francisco double-deck viaduct retrofits and other ongoing retrofit projects showed the need for the development of consistent seismic assessment and retrofit strategies for bridge structures.

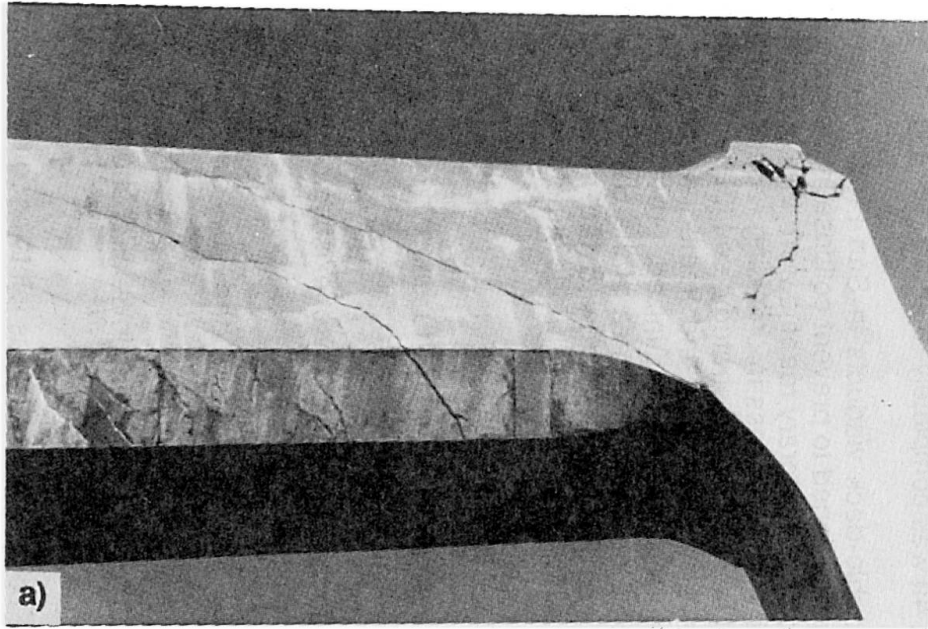
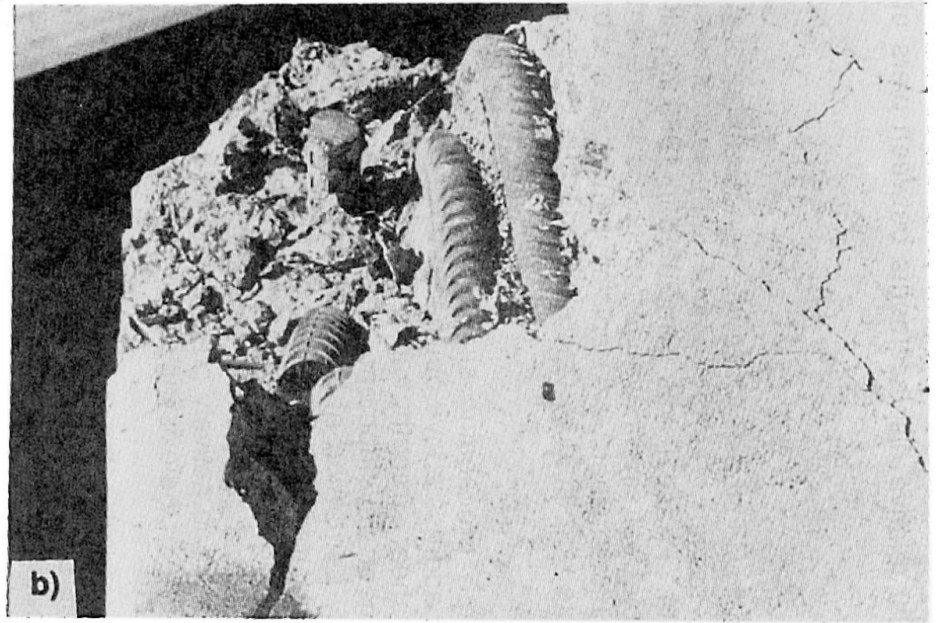
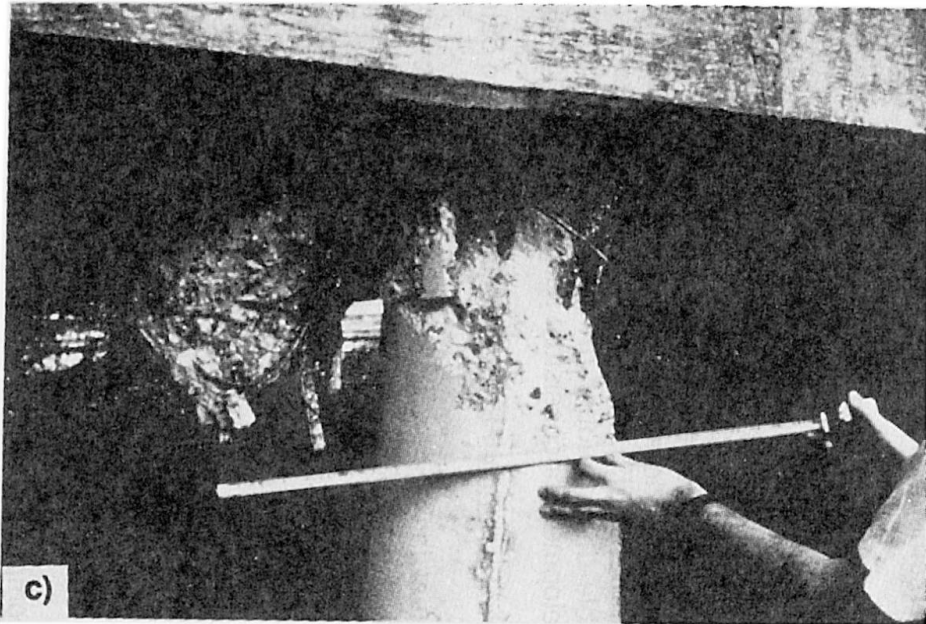
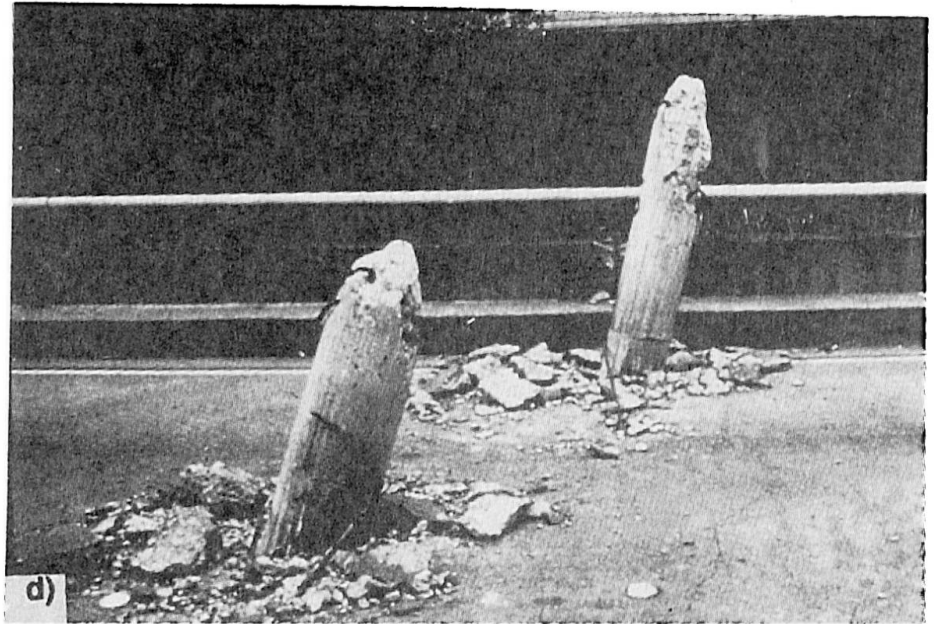
**Fig 4. Knee Joint and Plastic Hinge Failure, Loma Prieta 1989**

Outrigger bents showed problems in flexure and shear in the cap and shear failure of knee joints, see Fig. 4a, due to lack of shear reinforcement, and a fractured 57 mm  $\varnothing$  (#18) bar was encountered in a damaged knee joint on I-980, see Fig. 4b, which can be attributed to large strains introduced during bar bending (6.25%) and possible strain aging effects.

Finally, on struve slough, Figs. 4c and d, the plastic hinge at the column top sheared off and the column offset in the longitudinal bridge direction and punched through the reinforced concrete deck slab.

A flared pier wall which experienced shear distress during the Loma Prieta earthquake was repaired and retrofitted with a full height steel jacket, see Fig. 5c, for increased shear capacity. The previously discussed joint shear failure in an outrigger knee joint of I-980, see Fig. 4b was repaired by full replacement of the joint concrete, see Fig. 6d, and added joint shear reinforcement, while the outrigger bent shown in Fig. 4a was completely replaced, see Fig. 5e.
