**Structures to Withstand Natural Disasters:
Experiences and Applications**

Seismic Damage and Retrofit to California's Urban Concrete Bridge Structures

Frieder SEIBLE
Prof. of Struct. Eng.
Univ. of California
San Diego La Jolla, CA, USA

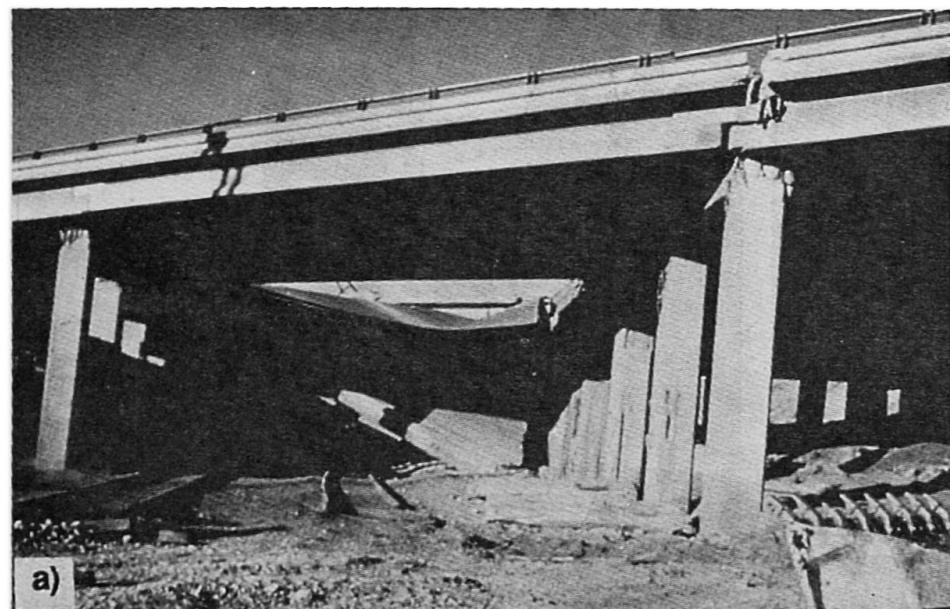
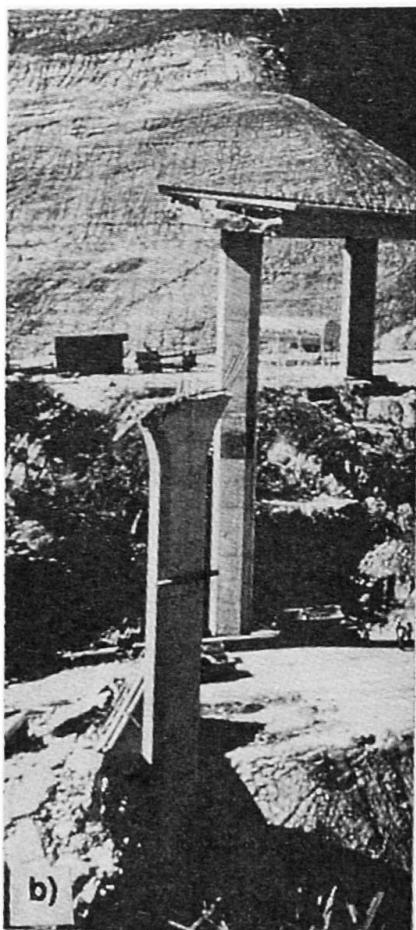
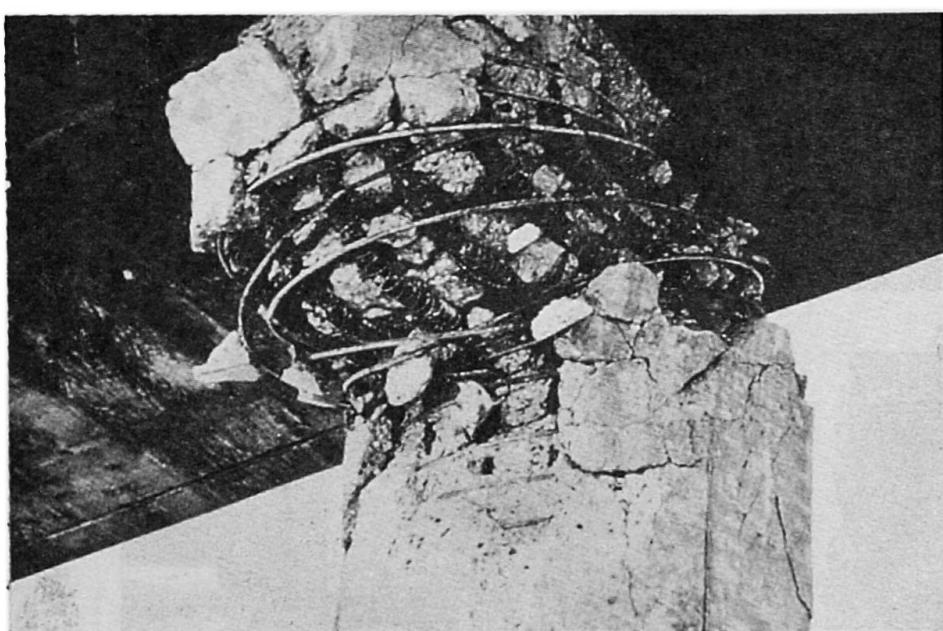
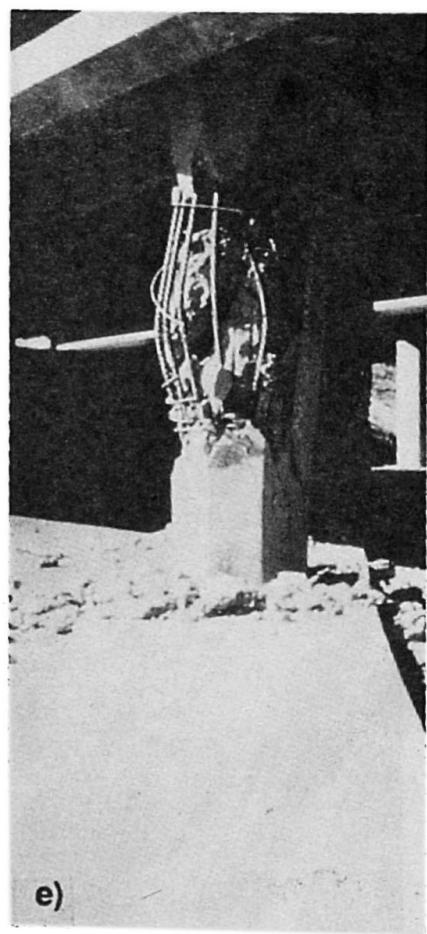
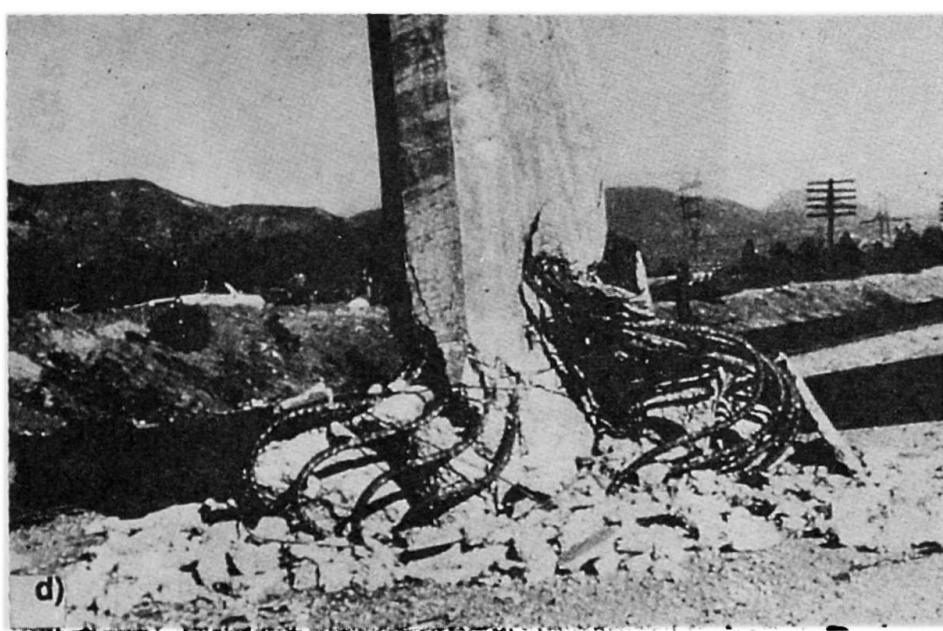
Fig 1. Bridge Damage During the 1971 San Fernando Earthquake

The 1971 San Fernando earthquake caused significant bridge damage, particularly to newly constructed interstate bridges. Key problems identified ranged from excessive seismic displacements and subsequent unseating of complete bridge spans at movement joints, see Figs. 1a and b, inadequate confinement of flexural plastic hinge regions in columns, see Figs. 1c and d, and Figs. 2a and b, anchorage problems with large diameter \varnothing 57 mm (#18) column reinforcement into the footing, see Fig. 2d, brittle shear failure of short columns with insufficient shear reinforcement, see Fig. 1e, and joint failures of knee joints due to the lack of joint shear reinforcement, see Fig. 2c. It is of interest to note that subsequent earthquakes such as Whittier (1987) and Loma Prieta (1989) did not uncover completely new problem areas which were not already identified in San Fernando (1971) but rather reemphasized some of the above mentioned problems.

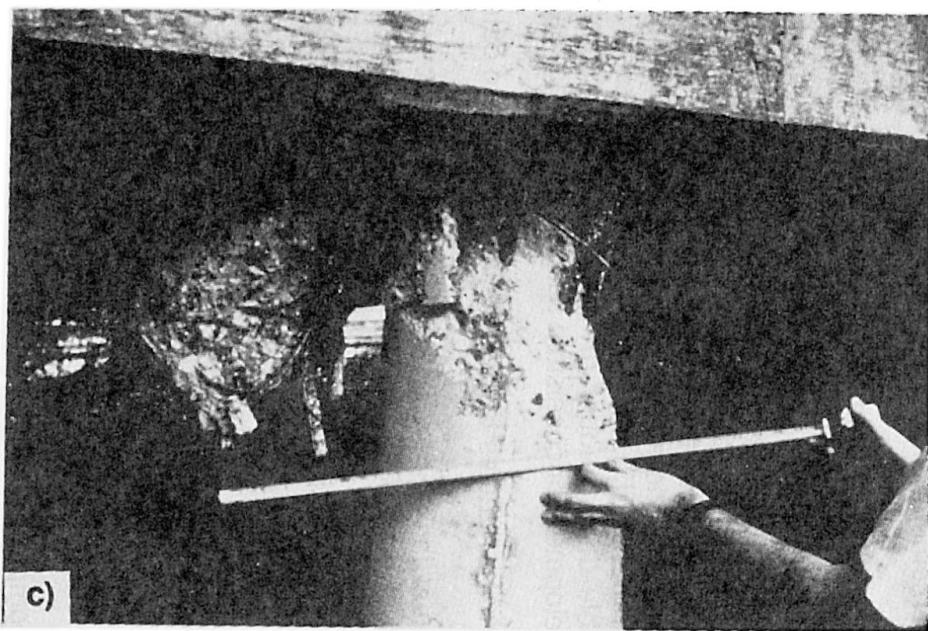
c)

Finally, on struve slough, Figs. 4c and d, the plastic hinge at the column top sheared off and the column offset in the longitudinal bridge direction and punched through the reinforced concrete deck slab.
