Artikel: Seismic damage and retrofit to California's urban concrete bridge

structures

Autor: Seible, Frieder

Seismic Damage and Retrofit to California's Urban Concrete Bridge Structures

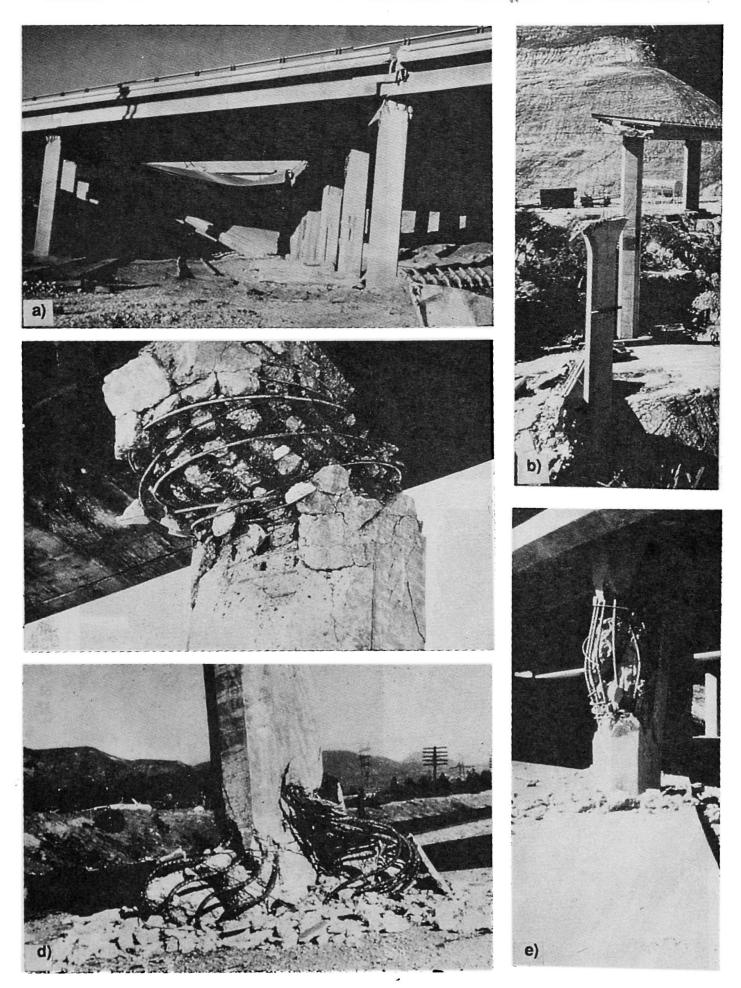
Fig 1. Bridge Damage During the 1971 San Fernando Earthquake

The 1971 San Fernando earthquake caused significant bridge damage, particularly to newly constructed interstate bridges. Key problems identified ranged from excessive seismic displacements and subsequent unseating of complete bridge spans at movement joints, see Figs. 1a and b, inadequate confinement of flexural plastic hinge regions in columns, see Figs. 1c and d, and Figs. 2a and b, anchorage problems with large diameter Ø 57 mm (#18) column reinforcement into the footing, see Fig. 2d, brittle shear failure of short columns with insufficient shear reinforcement, see Fig. 1e, and joint failures of knee joints due to the lack of joint shear reinforcement, see Fig. 2c. It is of interest to note that subsequent earthquakes such as Whittier (1987) and Loma Prieta (1989) did not uncover completely new problem areas which were not already identified in San Fernando (1971) but rather reemphasized some of the above mentioned problems.

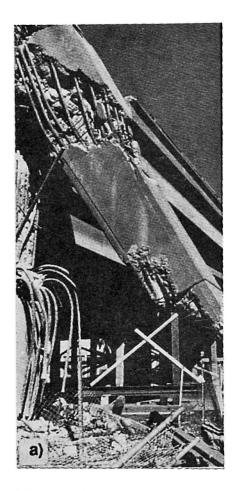
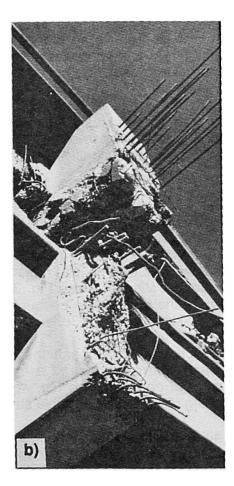
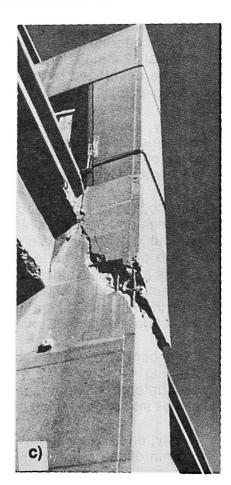
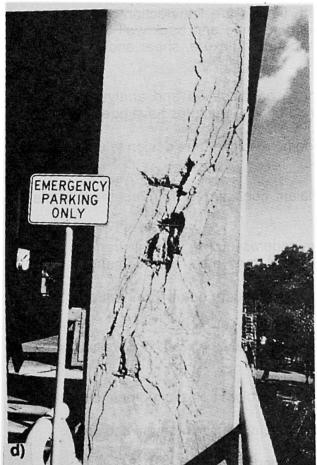
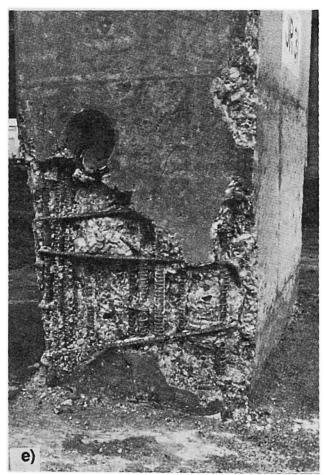
Fig 3. Bridge Damage, Loma Prieta 1989 (M7.1)

The collapsed upper deck of the Cypress Viaduct in Oakland is shown in Fig. 3a, featuring columns and pedestals reinforced with 12 mm Ø ties @ 300 mm (#4 @ 12 in.) and joint regions without joint shear reinforcement. Figure 3b depicts a lower cap/column connection with pullout failure of top and bottom cap reinforcement due to inadequate anchorage length and Fig. 3c shows a typical joint failure of the lower cap/column joint region. Typical column shear failure was encountered on Highway 101 – Central Viaduct – see Fig. 3d, and lap-splice failure of column bars in the plastic hinge at the top of the footing was encountered in single-column bents on the West Grand Avenue Connector in Oakland, see Fig. 3e.

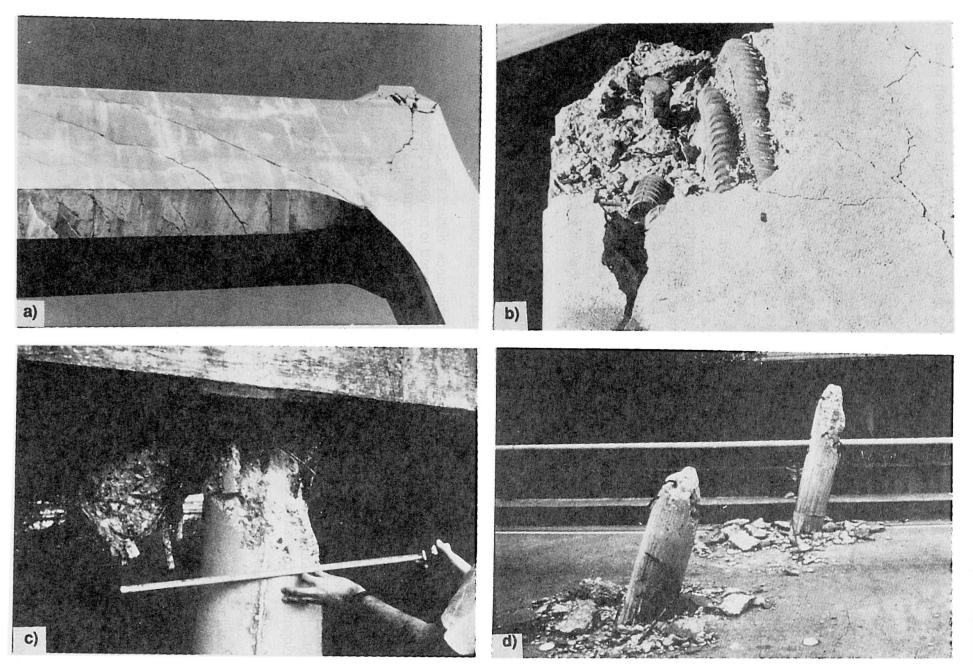
Fig 4. Knee Joint and Plastic Hinge Fallure, Loma Prieta 1989

Outrigger bents showed problems in flexure and shear in the cap and shear failure of knee joints, see Fig. 4a, due to lack of shear reinforcement, and a fractured 57 mm \emptyset (#18) bar was encountered in a damaged knee joint on I-980, see Fig. 4b, which can be attributed to large strains introduced during bar bending (6.25%) and possible strain aging effects.

Finally, on struve slough, Figs. 4c and d, the plastic hinge at the column top sheared off and the column offset in the longitudinal bridge direction and punched through the reinforced concrete deck slab.

A flared pier wall which experienced shear distress during the Loma Prieta earthquake was repaired and retrofitted with a full height steel jacket, see Fig. 5c, for increased shear capacity. The previously discussed joint shear failure in an outrigger knee joint of I-980, see Fig. 4b was repaired by full replacement of the joint concrete, see Fig. 6d, and added joint shear reinforcement, while the outrigger bent shown in Fig. 4a was completely replaced, see Fig. 5e.
