Zeitschrift: IABSE congress report = Rapport du congrès AIPC = IVBH
Kongressbericht

Artikel: Seismic damage and retrofit to California's urban concrete bridge
structures

Autor: Seible, Frieder

Seismic Damage and Retrofit to California's Urban Concrete Bridge Structures

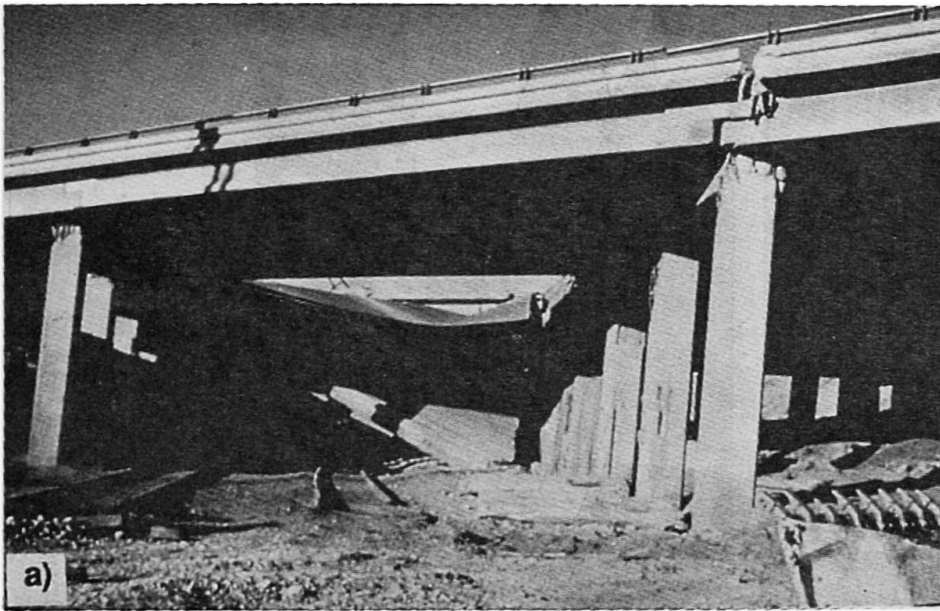
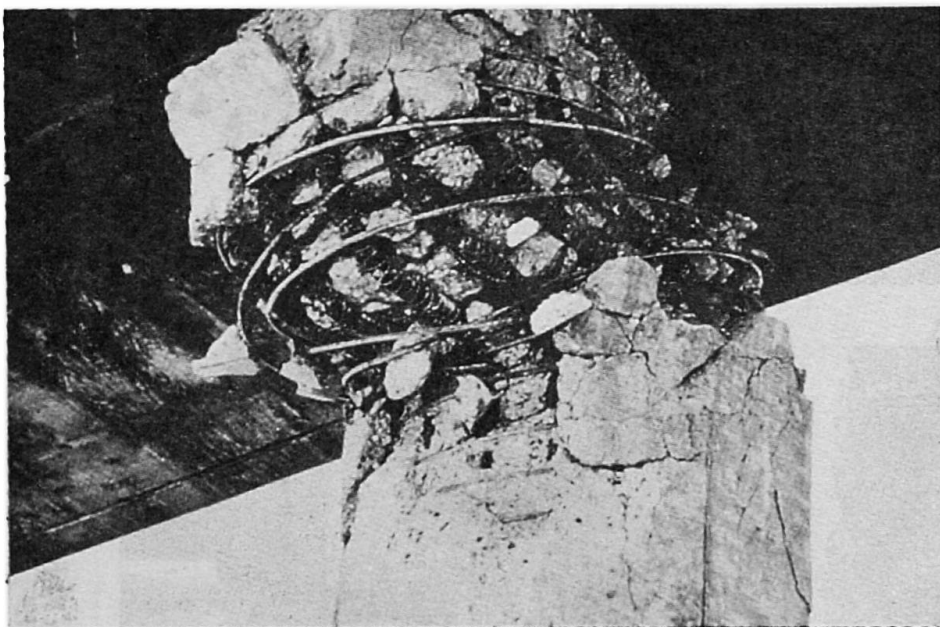
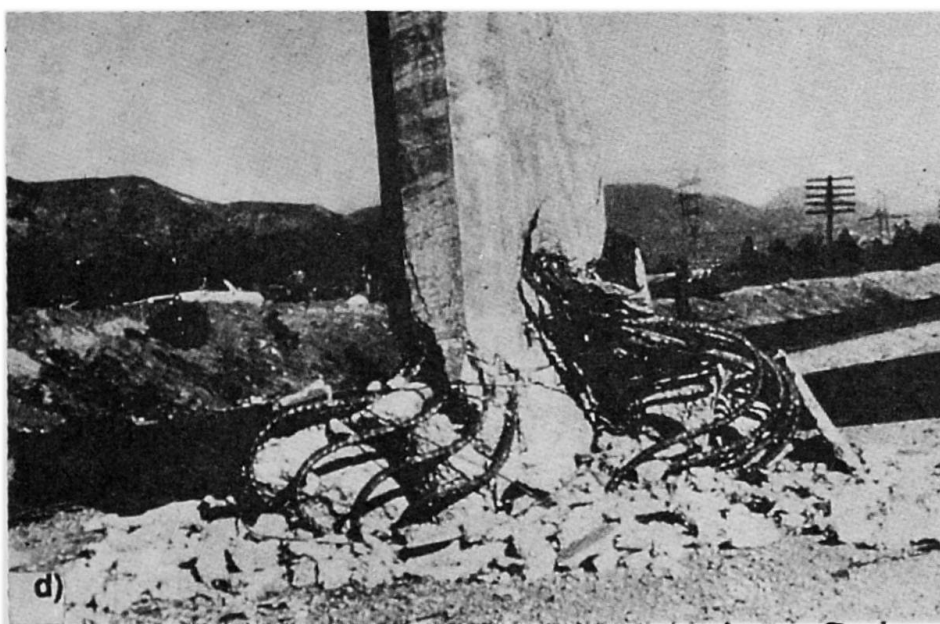
Fig 1. Bridge Damage During the 1971 San Fernando Earthquake

The 1971 San Fernando earthquake caused significant bridge damage, particularly to newly constructed interstate bridges. Key problems identified ranged from excessive seismic displacements and subsequent unseating of complete bridge spans at movement joints, see Figs. 1a and b, inadequate confinement of flexural plastic hinge regions in columns, see Figs. 1c and d, and Figs. 2a and b, anchorage problems with large diameter \varnothing 57 mm (#18) column reinforcement into the footing, see Fig. 2d, brittle shear failure of short columns with insufficient shear reinforcement, see Fig. 1e, and joint failures of knee joints due to the lack of joint shear reinforcement, see Fig. 2c. It is of interest to note that subsequent earthquakes such as Whittier (1987) and Loma Prieta (1989) did not uncover completely new problem areas which were not already identified in San Fernando (1971) but rather reemphasized some of the above mentioned problems.

While design guidelines for new bridge structures were immediately changed to reflect higher seismic force levels, confinement of column concrete particularly in potential plastic hinge regions and increased force and displacement requirements for movement joints, seismic retrofitting of existing bridge structures focussed initially on movement joint restrainers to prevent unseating and span collapse.
