# **RECORDED FAILURES OF ELECTRICALLY WELDED WROUGHT-IRON AND MILD STEEL BRIDGES.**

H. J. L. BRUFF, Bridge Engineer, North Eastern Area, London and North Eastern Railway,  
York.

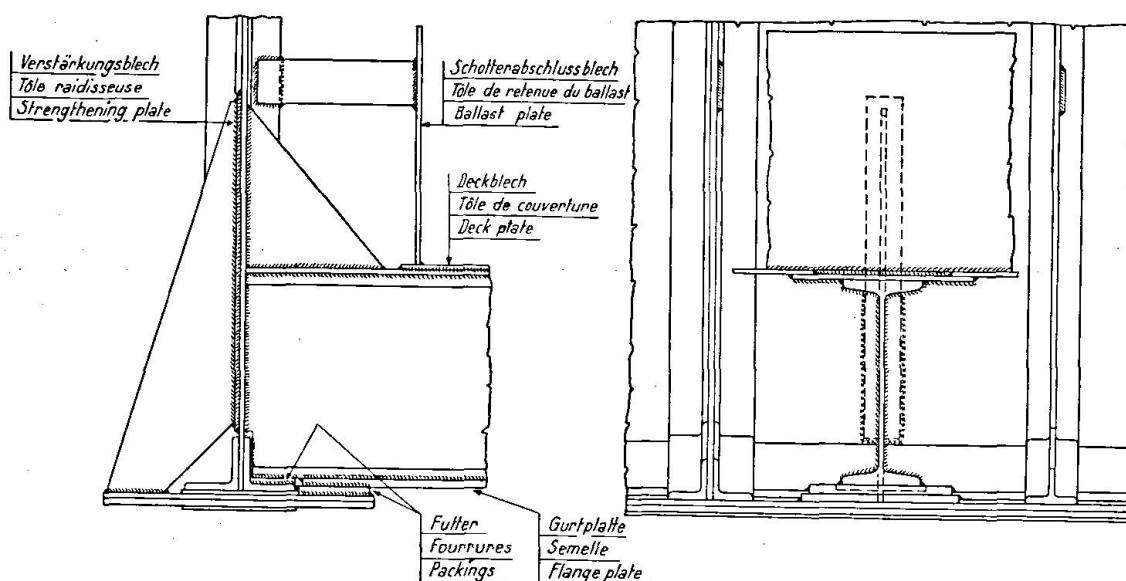
Einzelheiten von Knotenblech- und Stegblechsausteifungen (Brücke No. 32, South shields Linie).  
 Détails des goussets et raidisseurs de l'âme. (Pont n° 32, ligne South shields).  
 Details of gussets and web stiffeners. (Bridge N° 32, South shields branch).

The first experience of this type of failure occurred in the case of the reconditioning of a large plate main girder of a wrought iron bridge the floor of which was entirely renewed. As it was necessary to place the new cross girders between the old cross girders, where there were no web stiffeners, provision had to be made at these points for proper distribution of end fixing moments and shear from the cross girder ends. A strengthening plate was therefore welded to the outside of the web of the main girders and a triangular gusset plate welded on to it directly opposite the new cross girder end, as shown on Fig. 1.

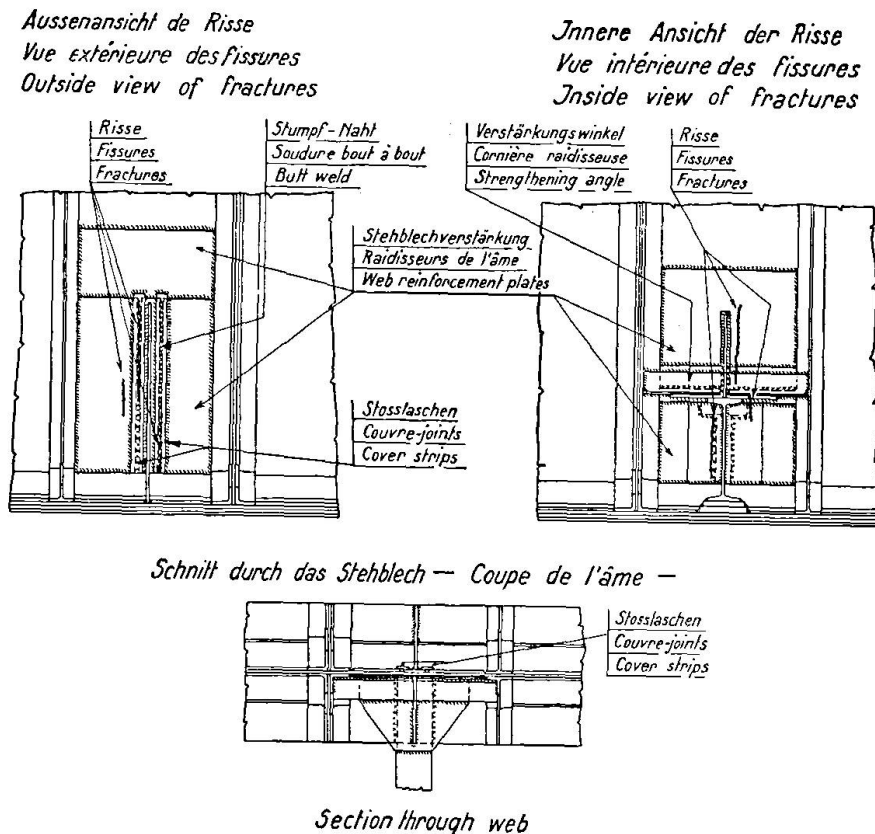
Fig. 2.

Einzelheiten eines reparierten gerissenen Stegblechfeldes.  
*Détail d'un champ réparé de l'âme où celle-ci était fissurée.*  
 Details of repaired panel of fractured web.

The webs of the main girders were badly corroded and in places reduced down to 1/16" and less in thickness. On welding the flat strengthening plates to the main girder web plates, fractures developed in two instances, which travelled up the web plate at the same rate as the weld was run. As the crack formed while the weld metal was being deposited and not during the cooling down of the heated part of the girder, it is reasonable to assume that the stress set up by the contraction of the weld metal added to the existing shear stress brought the total stress up beyond the ultimate strength of the web plate. Fig. 2 shows the repairs.

Extra web cover plates were therefore tack welded to the "T", angle stiffener and strengthening plate, the fracture having been "V'd" out and butt welded previously. The new web reinforcement plates were then finally butt

welded to the strengthening plate and the toes of the "T" and angle stiffeners of the girder.

In the case of repair work like this, where the webs are thin, web strengthening plates are now always provided, which are welded to the adjoining main angles and stiffeners.

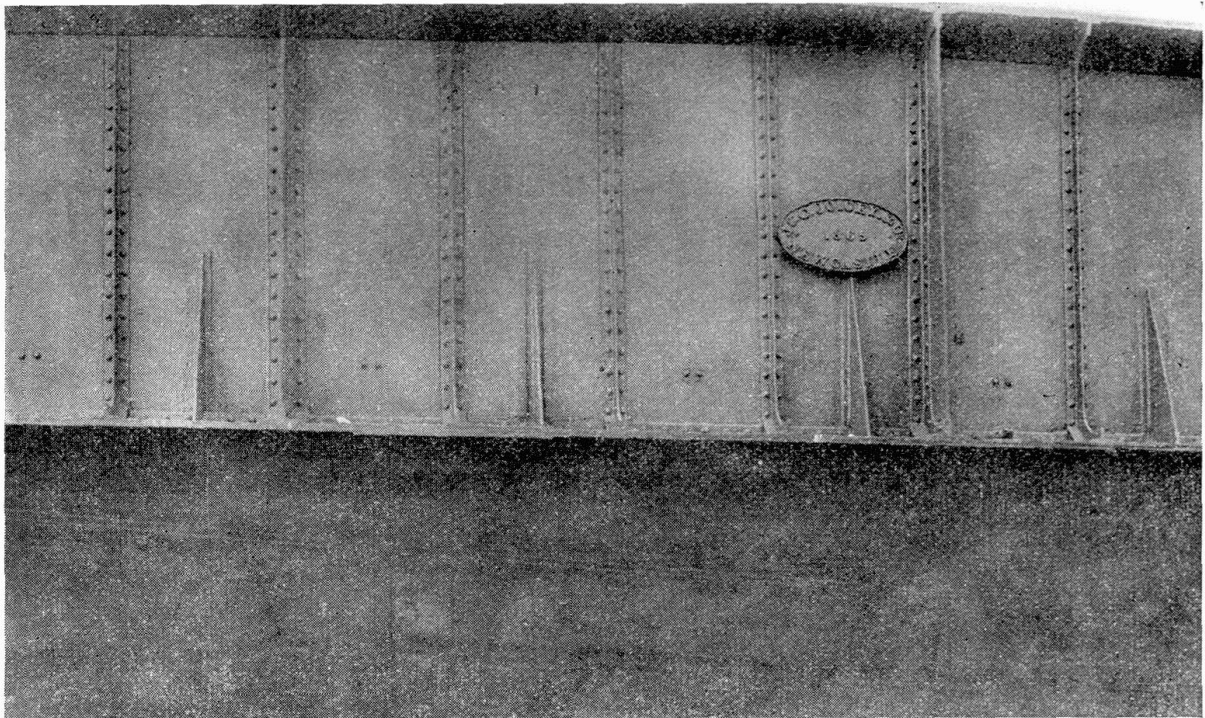
Fig. 3.  
Lichtbild des reparierten Stegbleches. Außen- und Innenansicht.  
Ame réparée. Vue extérieure et intérieure.  
Photograph of repaired web; outside and inside.

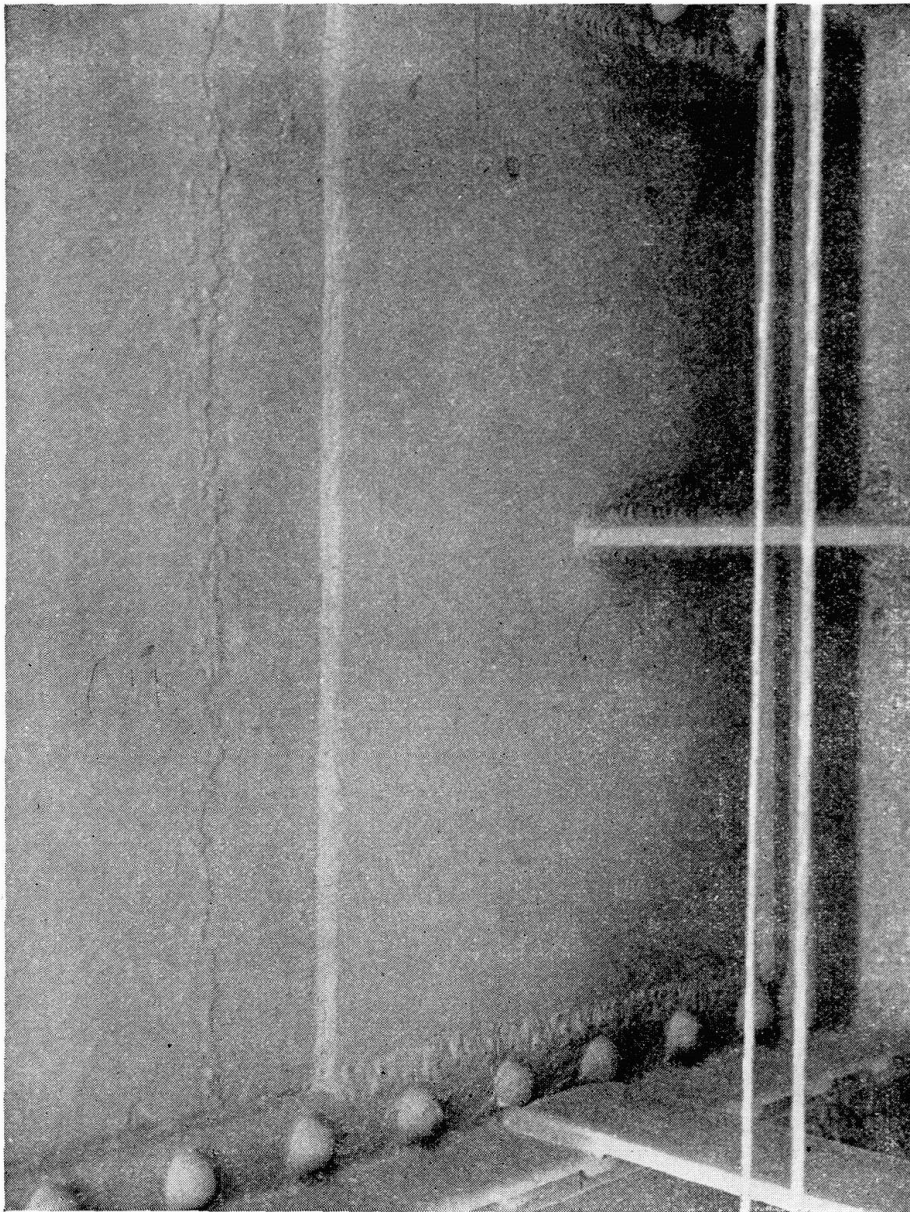
Fig. 4.

In another instance where the webs of the main girders had been holed through corrosion and the webs required to be repaired, fractures took place along the welded seams which were probably due to the contraction of the heated parts of the girder. The failures which were fairly numerous were all identical, being fractures of the vertical butt welds between the new web streng-

thening plate and the toes of the "T" and angle stiffeners. Fig. 4 shows details of construction.

As will be seen from the section it was intended that the welds should not only unite the strengthening plates and the toes of the "T" or angle stiffeners, but also the old web itself. On cutting out the fractured welds, as shown in Fig. 5, it was found, that good penetration had been obtained between the strengthening plate and the "T" but that there was no penetration in the case of the web, as will be seen from the photograph of a part of the "T", strengthening plate and web which were cut out in order that the cause of the fracturing might be ascertained.

The gap between the strengthening plate and the "T" had been prescribed to be  $1/16$ ", but apparently this had not been worked to in all cases, the weld cut out was barely  $1/16$ " and it appeared that the strengthening plate had not

been in full contact with the web plate. Out of 48 welds 17 were found to be fractured, these were all cut out and in not a single instance had penetration with the web been secured. The practice is now to make the gap  $1/16$ " min. the face of the chamfer the same, using a No. 10 electrode with a slightly higher

Einzelheiten von Stegblechreparaturen. (Brücke No. 2, Monkwearmouth Güter-Linie).  
Details de réparations de l'âme. (Pont n° 2, ligne Monkwearmouth — trains de marchandises).  
Details of repairs to web. (Bridge N° 2, Monkwearmouth Goods Branch).

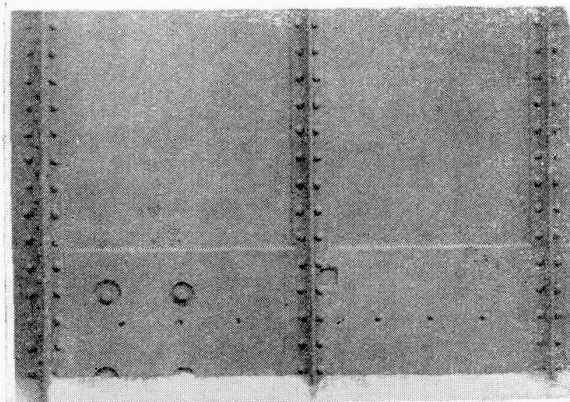
Fig. 5.

Schnitt durch die gerissene Schweißung.  
Coupe à travers la soudure rompue.  
Section of fractured weld.

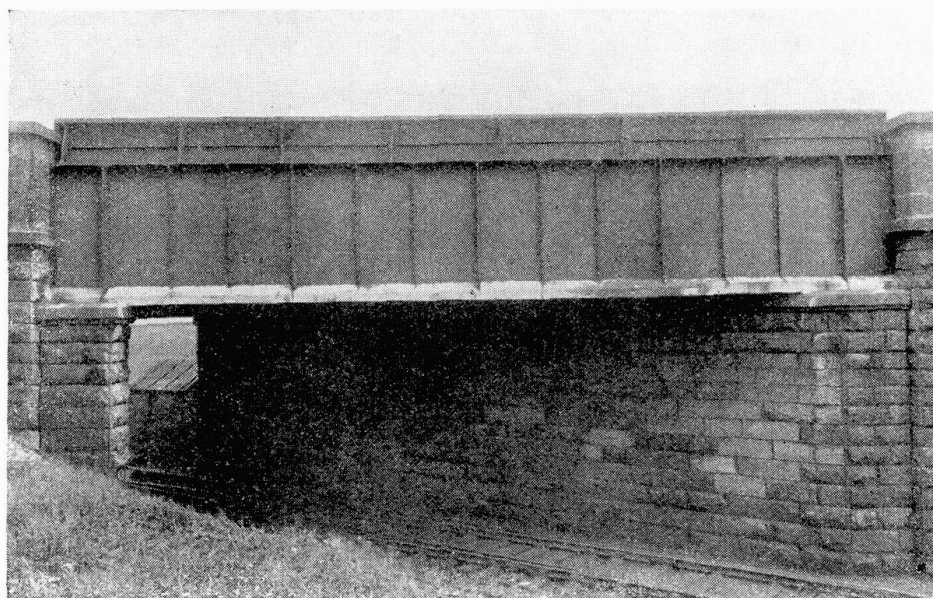
Fig. 6.

amperage than normal, which in the case of so light a run is not likely to over-heat the mild steel. Fig. 6 shows the repaired girder with removed section (Fig. 5) which was not replaced, the hole was merely fillet welded round the edges as there was ample section left for strength. The bottom flange, which the photo shows covered with gunite, was badly wasted by blast from engines,

Träger mit repariertem Stegblech. — Poutres dont l'âme est réparée.  
Girder showing repaired web.

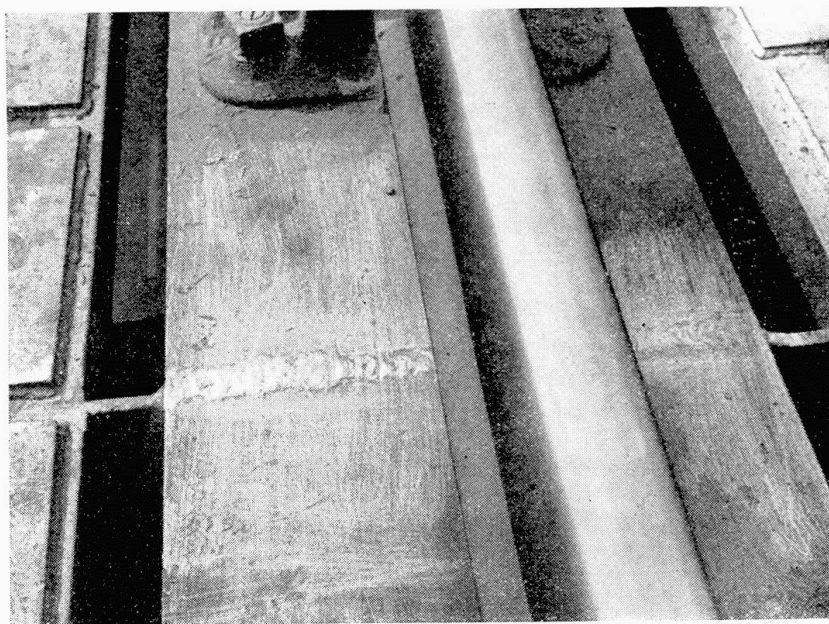
Another failure of similar nature was the fracturing of the butt weld between two channel way beams, of construction as shown in Fig. 7.

The gap intended to be  $1/16$ " wide was somewhat wider when fitted and to expedite the work two welders were put on to make the weld. One of the

men had advanced further than the other when they left off for a meal, when shortly afterwards the weld fractured with a loud report. The weld after all the old weld metal had been removed and the butt prepared afresh was rewelded by one man commencing at the centre, working slowly without unduly heating the channels, as it was thought that the unequal and rapid cooling off of the overheated weld had been the cause of the fracture. As this, as well as all the other welds of this construction, all have remained perfect, it is clear, that butt welds of free ended sections must not be allowed to become too hot when being run.

Stumpfschweißung an Längsträger (Schienenträger). (Brücke No. 41, Denaby Linie).  
Soudure bout à bout des longerons (sous les rails). (Pont n° 41 de la ligne Denaby).  
Butt weld of way beam. (Bridge No. 41 Denaby Branch).

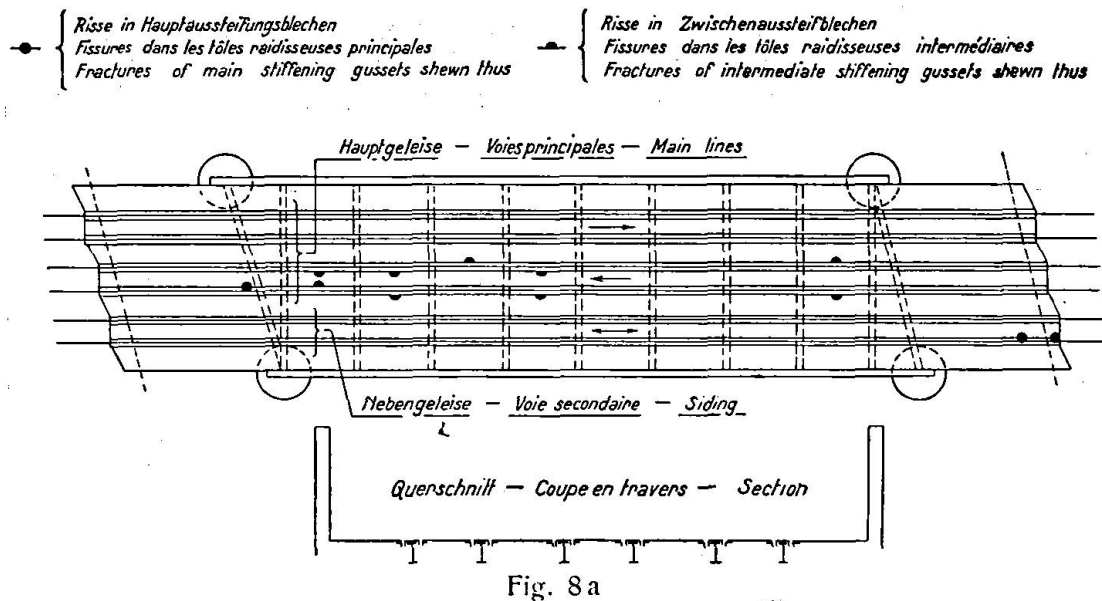
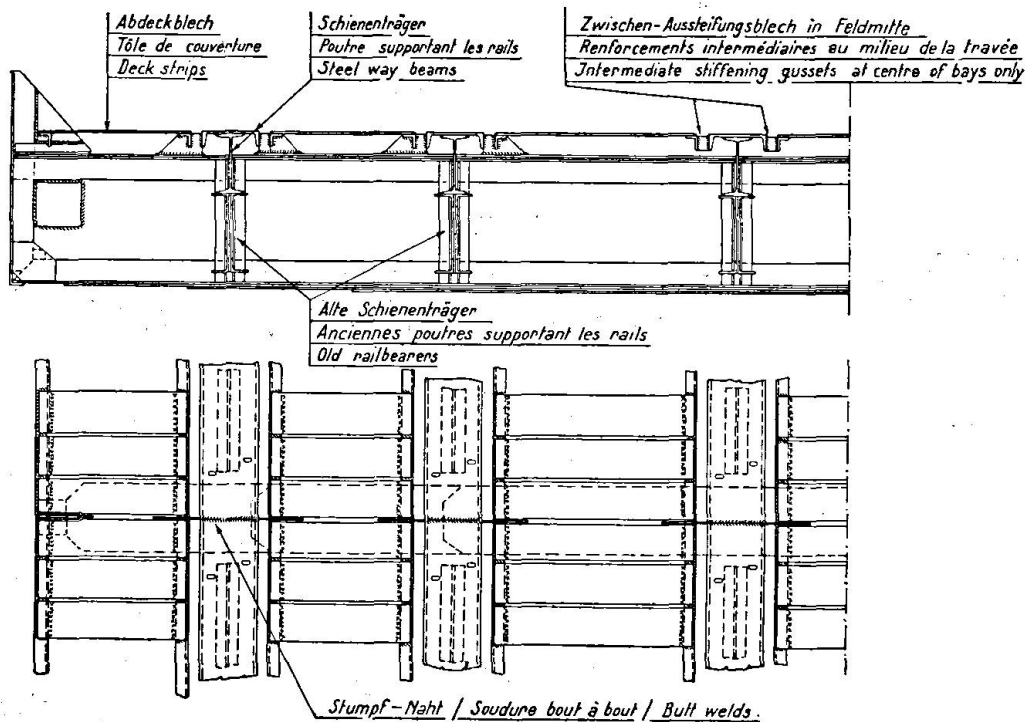
As will be seen the rails and chairs were bolted to the webs of the steel channels, which again were welded to rolled steel beams resting on the top flanges of the old rail bearers to which they in turn were welded. At each cross girder gusset plates were welded to the vertical channel flanges and to the top flange plates of the cross girders, for the purpose of taking up any side sway

of the steel way beams (consisting of the rolled steel beam and the channel). Two of these gussets at one end of the bridge, where there is a switch, have fractured. The position of the fractures are indicated on Fig. 7 and on the photograph of the bridge end, Fig. 9.

Grundriß und Einzelheiten der Brücke. — Plan et détails du pont.  
Plan and details of bridge.

Similar fractures have also developed where some small tie plates have been welded on to the way beam channels, for the purpose of adding support to the angles carrying the deck strips, the ties being welded on between the deck angles and the channel flanges along four of the channels (see Fig. 8). These ties also take up some side sway of the way beams. Of 348 welds (two to each tie) 10 have fractured, probably due to shock, as they fractured shortly after the centre track, where they were located, was brought into use. On close examination of the fractures it has been found that the welds are all indifferently

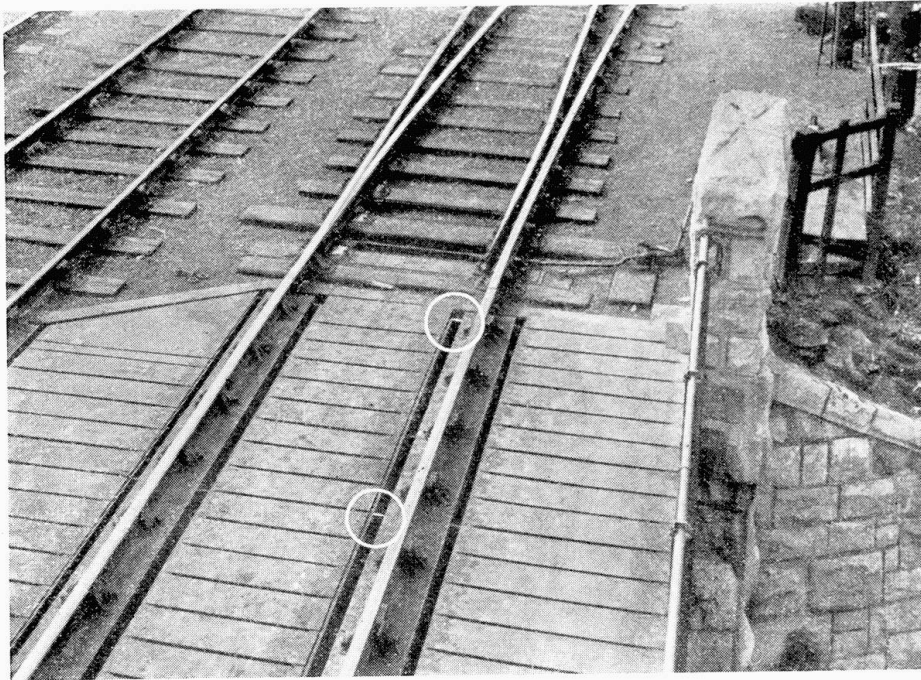
Fig. 9.

As will be noted the position of the fractured gussets occur on the convex side of the curve, where tension will be produced through the rigidity of the wheel base of engine counteracting the centrifugal action. A close up photograph of the fracture is shown in Fig. 10.

Brückenende und Weiche. Lage der Risse.  
Extrémité du pont et aiguille. Emplacement des fissures.  
Bridge end and switch. Position of fractures.

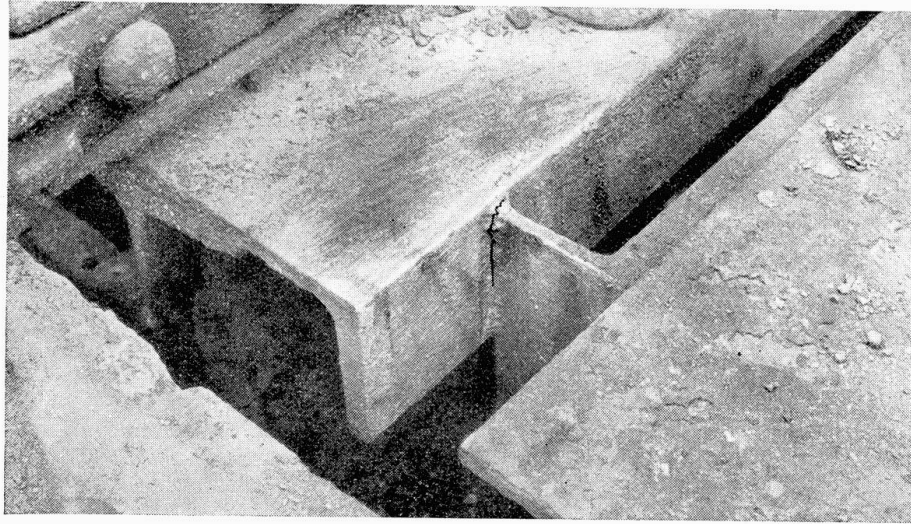
Fig. 10.

Gerissenes Knotenblech. — Tôle fissurée d'un gousset. — Fractured gusset.

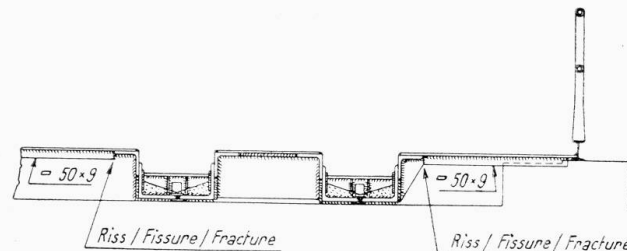
Fig. 11.

The bridge shown in Fig. 11 has a steel deck which is stiffened with  $2" \times 3/8"$  flats on edge. Besides these there are transverse diaphragms between the two sets of troughs. When erected it was found that the brick abutments

Half section through bridge. (Bridge N° 25, York and Doncaster).

As mentioned above the bridge carries two separate main lines, and is therefore very busy, the average number of trains per 24 hours being 250 representing about  $5\frac{1}{2}$  million stress variations annually, the traffic being about the same in both directions. Under these circumstances it will be realised that the enormous frequency of stress reversals which occur will tend to produce fatigue effects in parts unduly stressed. From the construction it will be appreciated that severe stresses must be set up in the transverse stiffeners of the deck plates due to such unequal deflections, which are enhanced by the settlement of the bedstones.

The welds connecting the deck plates and the  $2" \times 3/8"$  stiffeners are not very large and even normally they are rather heavily stressed, with the consequence that 19 out of 20 have fractured.

heavy steel grillages embedded in concrete are now always provided. These grillages are most carefully and truly set, so as to reduce unequal settlement of adjoining troughs to a minimum. In addition to the grillages the stiffeners for the deck plates are not carried through and welded to the flanges, thereby permitting the deck plates to flexure and so give a little play which absorbs unequal deflections.

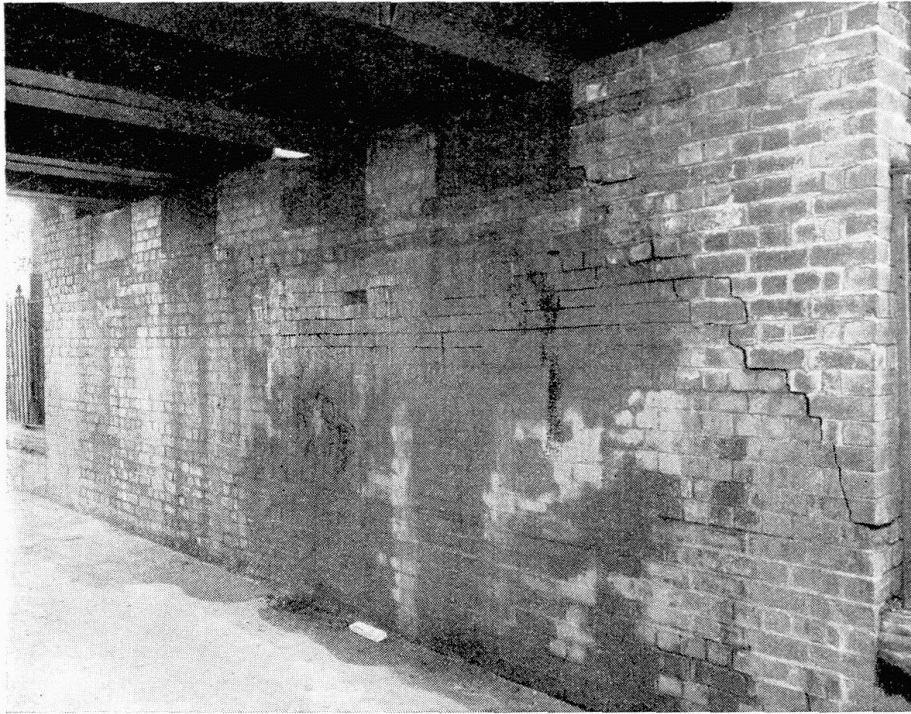
Fig. 12.

when bared were not very good, showing fractures below the bedstones on which the troughs would be seated. The bedstones were carefully levelled before the girders were erected on them, but possibly owing to the more rigid construction and absence of cushioning due to steel bearers instead of timber way beams in the troughs, the fractures in the abutments increased and caused unequal depression of the girder ends which set up transverse bending moments

Gerissenes Widerlager. — Culée fissurée. — Fractured abutment.

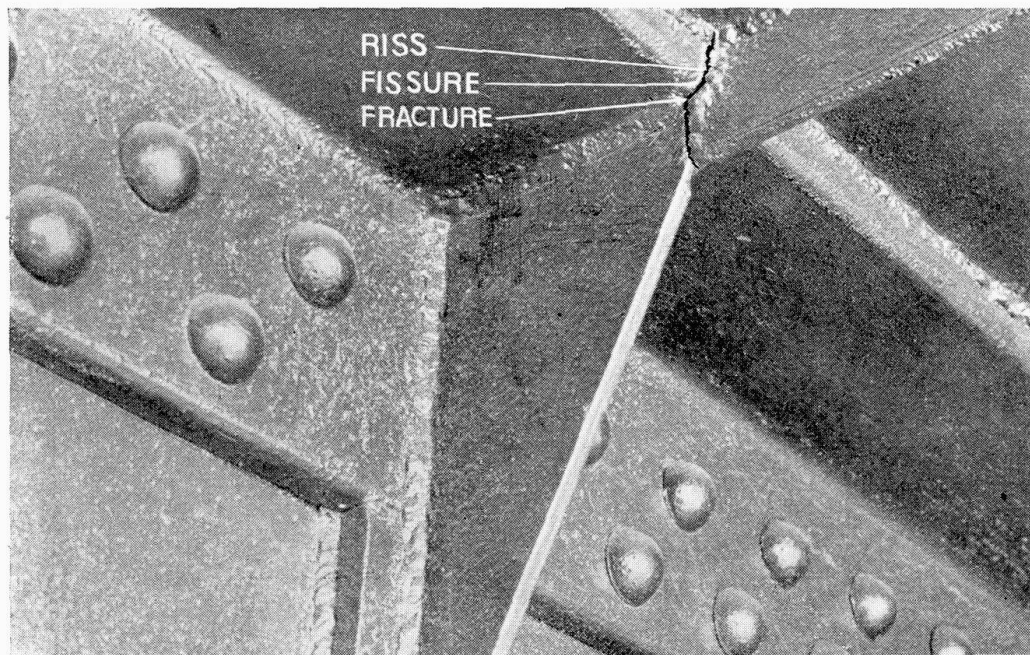
Fig. 13.

Gerissene Schweißung. — Soudure fissurée. — Fractured weld.
