Artikel: Recorded failures of electrically welded wrought-iron and mild steel bridges

RECORDED FAILURES OF ELECTRICALLY WELDED WROUGHT-IRON AND MILD STEEL BRIDGES.

H. J. L. BRUFF, Bridge Engineer, North Eastern Area, London and North Eastern Railway,
York.

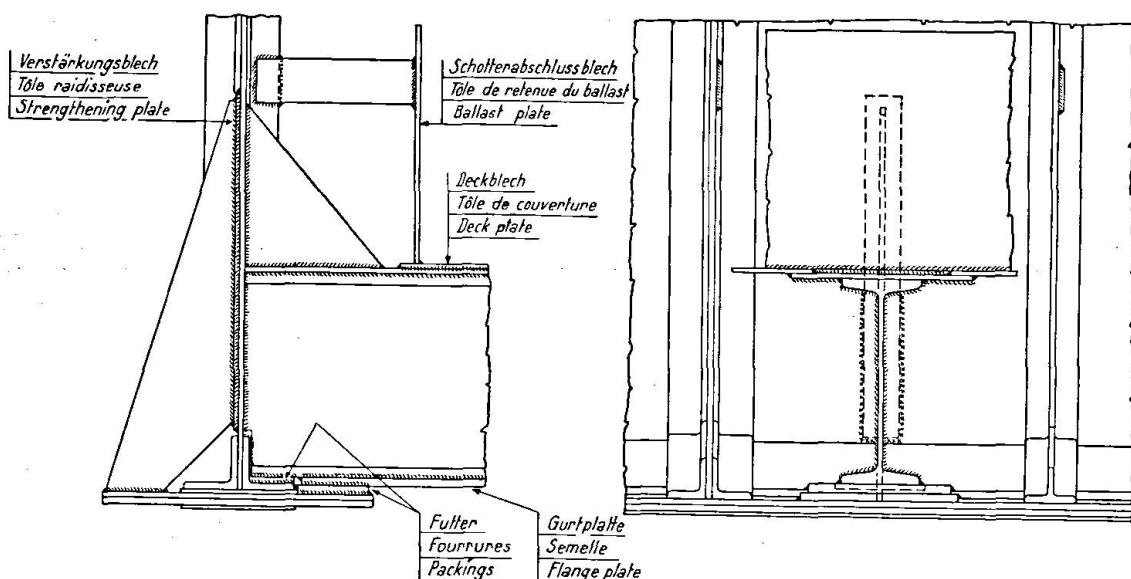
Einzelheiten von Knotenblech- und Stegblechaussteifungen (Brücke No. 32, South shields Linie).
Détails des goussets et raidisseurs de l'âme. (Pont n° 32, ligne South shields).
Details of gussets and web stiffeners. (Bridge N° 32, South shields branch).

The first experience of this type of failure occurred in the case of the re-conditioning of a large plate main girder of a wrought iron bridge the floor of which was entirely renewed. As it was necessary to place the new cross girders between the old cross girders, where there were no web stiffeners, provision had to be made at these points for proper distribution of end fixing moments and shear from the cross girder ends. A strengthening plate was therefore welded to the outside of the web of the main girders and a triangular gusset plate welded on to it directly opposite the new cross girder end, as shown on Fig. 1.

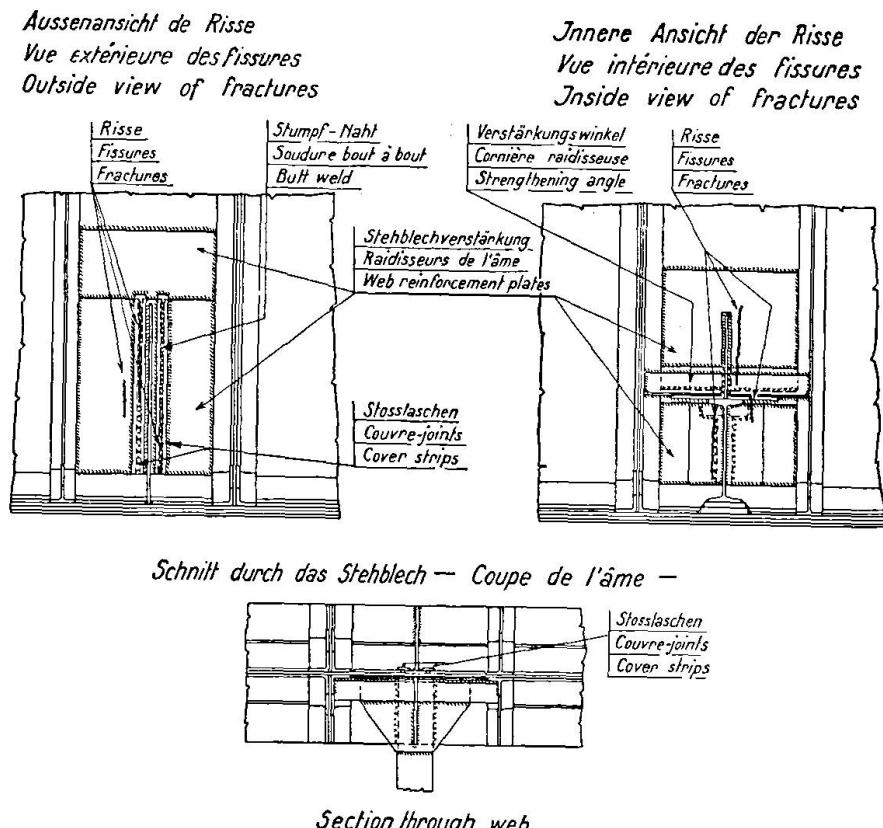
Fig. 2.
Einzelheiten eines reparierten gerissenen Stehblechfeldes.
Détail d'un champ réparé de l'âme où celle-ci était fissurée.
Details of repaired panel of fractured web.

The webs of the main girders were badly corroded and in places reduced down to $1/16$ " and less in thickness. On welding the flat strengthening plates to the main girder web plates, fractures developed in two instances, which travelled up the web plate at the same rate as the weld was run. As the crack formed while the weld metal was being deposited and not during the cooling down of the heated part of the girder, it is reasonable to assume that the stress set up by the contraction of the weld metal added to the existing shear stress brought the total stress up beyond the ultimate strength of the web plate. Fig. 2 shows the repairs.

Extra web cover plates were therefore tack welded to the "T", angle stiffener and strengthening plate, the fracture having been "V' d" out and butt welded previously. The new web reinforcement plates were then finally butt

welded to the strengthening plate and the toes of the "T" and angle stiffeners of the girder.

In the case of repair work like this, where the webs are thin, web strengthening plates are now always provided, which are welded to the adjoining main angles and stiffeners.

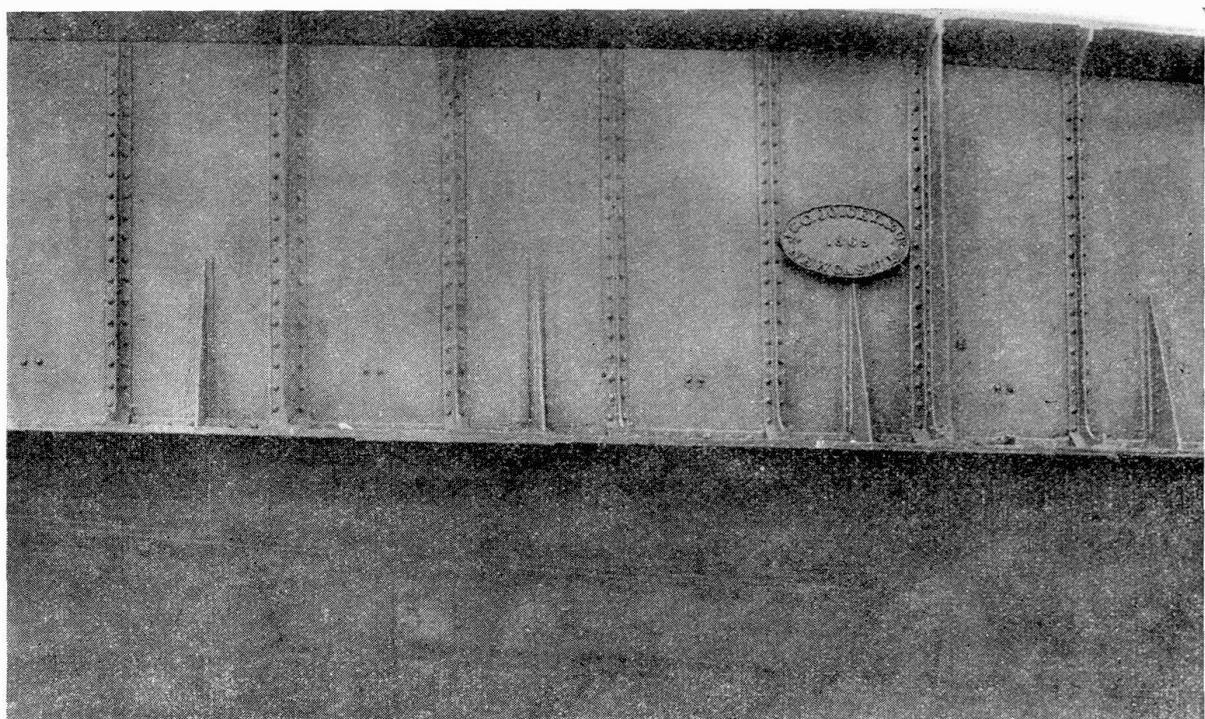
Fig. 3.
Lichtbild des reparierten Stegbleches. Außen- und Innenansicht.
Ame réparée. Vue extérieure et intérieure.
Photograph of repaired web; outside and inside.

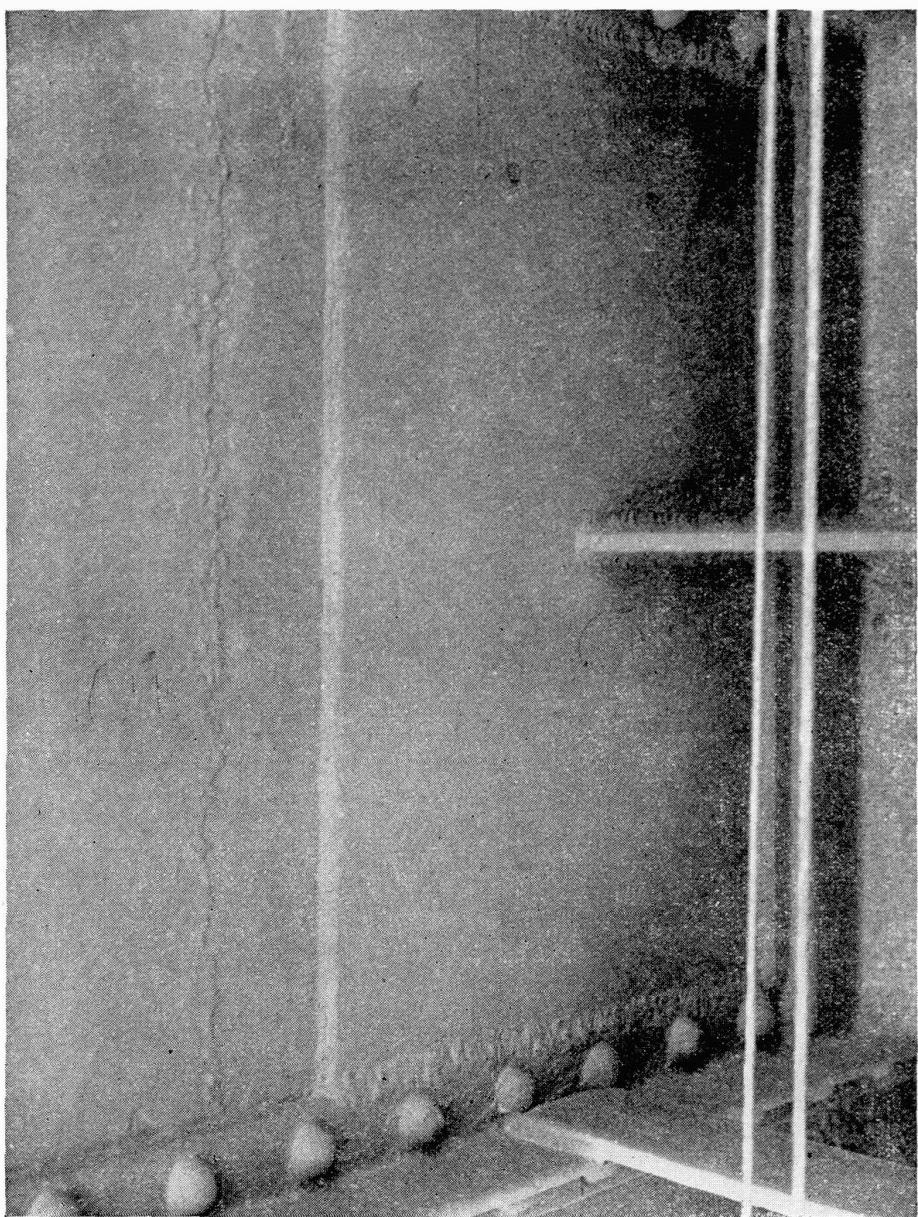
Fig. 4.

In another instance where the webs of the main girders had been holed through corrosion and the webs required to be repaired, fractures took place along the welded seams which were probably due to the contraction of the heated parts of the girder. The failures which were fairly numerous were all identical, being fractures of the vertical butt welds between the new web strength-

thening plate and the toes of the "T" and angle stiffeners. Fig. 4 shows details of construction.

As will be seen from the section it was intended that the welds should not only unite the strengthening plates and the toes of the "T" or angle stiffeners, but also the old web itself. On cutting out the fractured welds, as shown in Fig. 5, it was found, that good penetration had been obtained between the strengthening plate and the "T" but that there was no penetration in the case of the web, as will be seen from the photograph of a part of the "T", strengthening plate and web which were cut out in order that the cause of the fracturing might be ascertained.

The gap between the strengthening plate and the "T" had been prescribed to be $1/16$ ", but apparently this had not been worked to in all cases, the weld cut out was barely $1/16$ " and it appeared that the strengthening plate had not

been in full contact with the web plate. Out of 48 welds 17 were found to be fractured, these were all cut out and in not a single instance had penetration with the web been secured. The practice is now to make the gap $1/16$ " min. the face of the chamfer the same, using a No. 10 electrode with a slightly higher

Einzelheiten von Stegblechreparaturen. (Brücke No. 2, Monkwearmouth Güter-Linie).
 Details de réparations de l'âme. (Pont n° 2, ligne Monkwearmouth — trains de marchandises).
 Details of repairs to web. (Bridge N° 2, Monkwearmouth Goods Branch).

ampereage than normal, which in the case of so light a run is not likely to overheat the mild steel. Fig. 6 shows the repaired girder with removed section (Fig. 5) which was not replaced, the hole was merely fillet welded round the edges as there was ample section left for strength. The bottom flange, which the photo shows covered with gunite, was badly wasted by blast from engines,

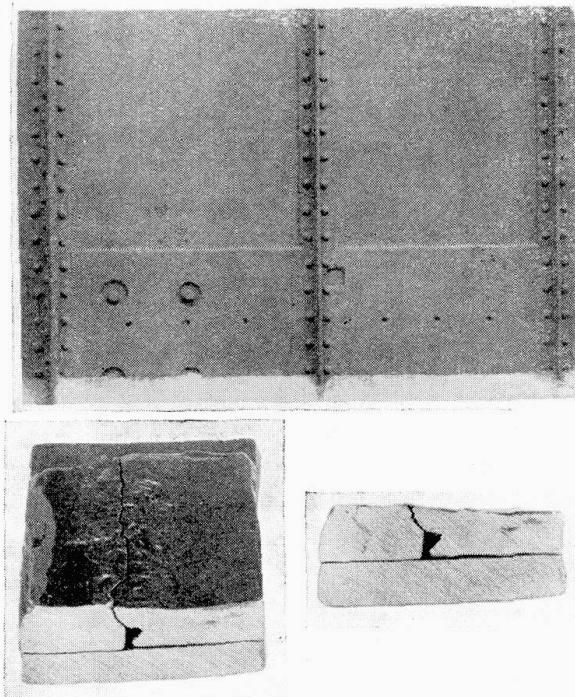
Fig. 5.

Schnitt durch die gerissene Schweißung.
Coupe à travers la soudure rompue.
Section of fractured weld.

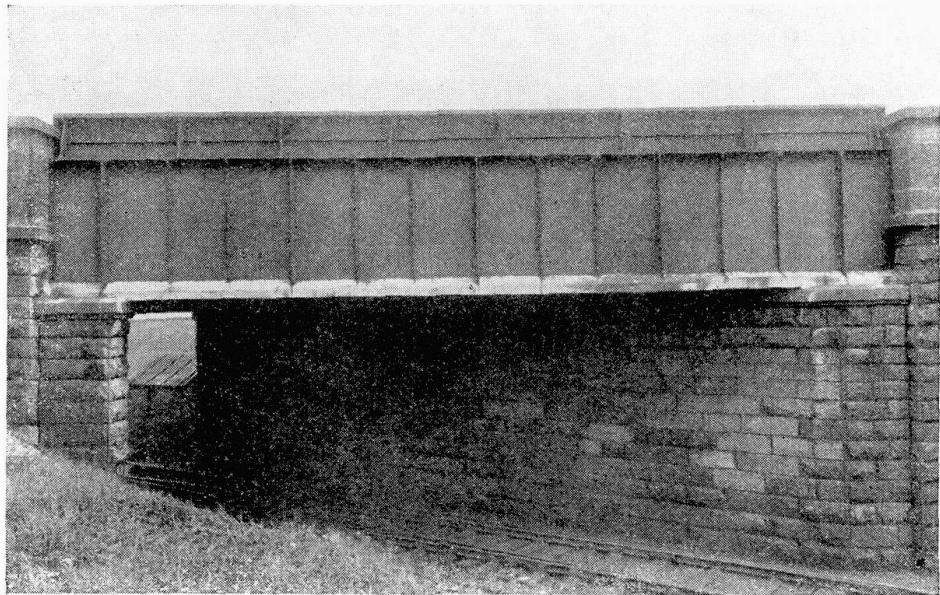
Fig. 6.

Träger mit repariertem Stegblech. — Poutres dont l'âme est réparée.
Girder showing repaired web.

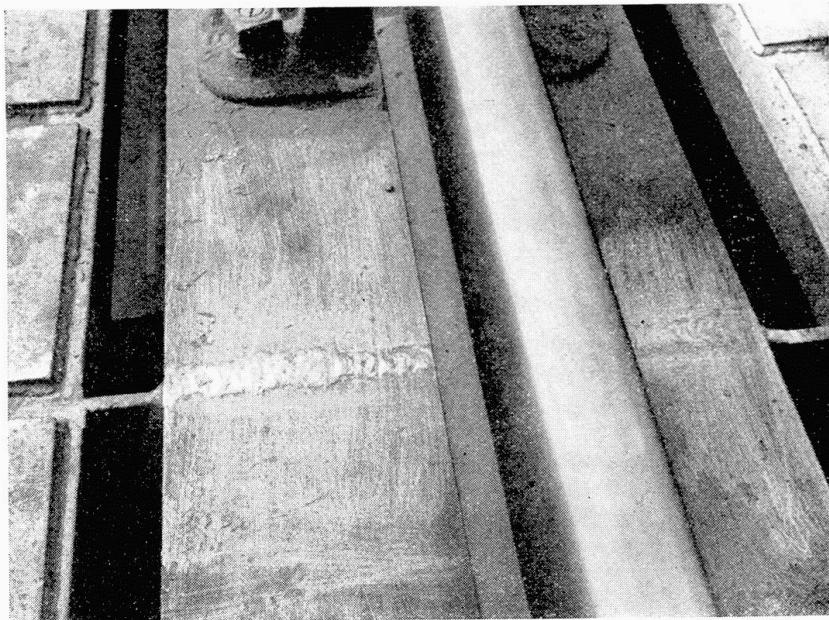
Another failure of similar nature was the fracturing of the butt weld between two channel way beams, of construction as shown in Fig. 7.

The gap intended to be $1/16"$ wide was somewhat wider when fitted and to expedite the work two welders were put on to make the weld. One of the

men had advanced further than the other when they left off for a meal, when shortly afterwards the weld fractured with a loud report. The weld after all the old weld metal had been removed and the butt prepared afresh was rewelded by one man commencing at the centre, working slowly without unduly heating the channels, as it was thought that the unequal and rapid cooling off of the overheated weld had been the cause of the fracture. As this, as well as all the other welds of this construction, all have remained perfect, it is clear, that butt welds of free ended sections must not be allowed to become too hot when being run.

Stumpfschweißung an Längsträger (Schienenträger). (Brücke No. 41, Denaby Linie).
Soudure bout à bout des longerons (sous les rails). (Pont n° 41 de la ligne Denaby).
Butt weld of way beam. (Bridge No. 41 Denaby Branch).

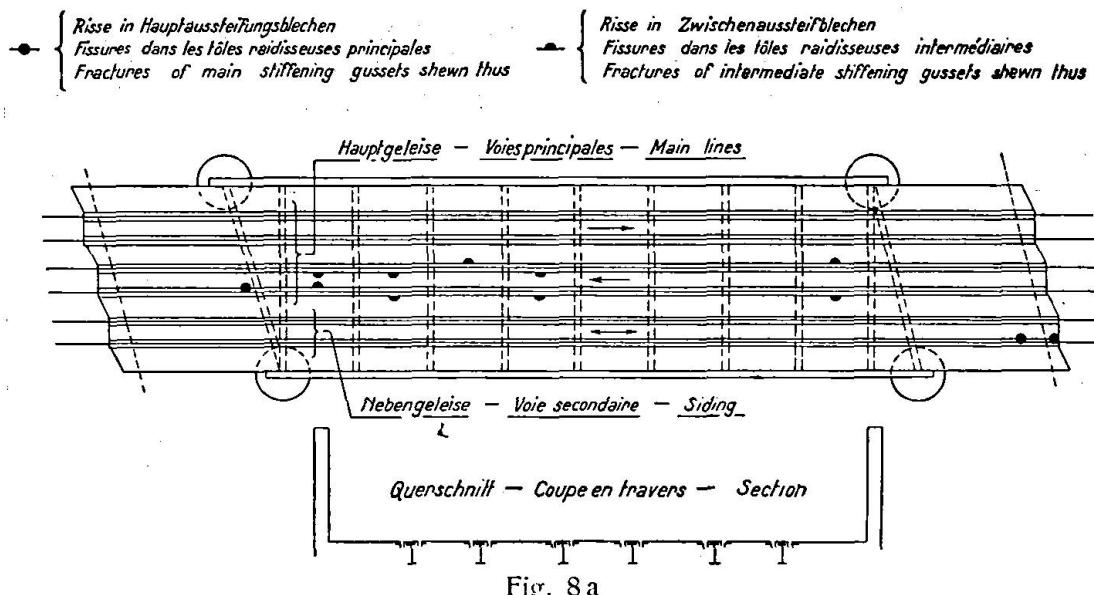
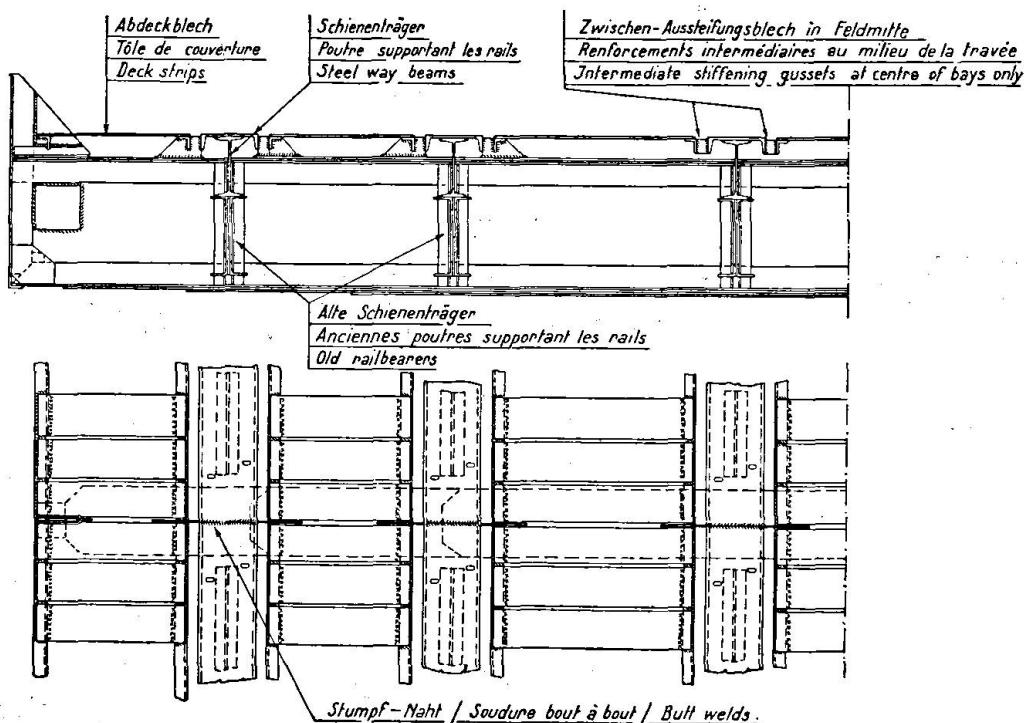
The welded work in question comprised the connections of a welded way beam, illustrated in Fig. 7, further details are shown in Fig. 8.

As will be seen the rails and chairs were bolted to the webs of the steel channels, which again were welded to rolled steel beams resting on the top flanges of the old rail bearers to which they in turn were welded. At each cross girder gusset plates were welded to the vertical channel flanges and to the top flange plates of the cross girders, for the purpose of taking up any side sway

of the steel way beams (consisting of the rolled steel beam and the channel). Two of these gussets at one end of the bridge, where there is a switch, have fractured. The position of the fractures are indicated on Fig. 7 and on the photograph of the bridge end, Fig. 9.

Grundriß und Einzelheiten der Brücke. — Plan et détails du pont.
Plan and details of bridge.

Similar fractures have also developed where some small tie plates have been welded on to the way beam channels, for the purpose of adding support to the angles carrying the deck strips, the ties being welded on between the deck angles and the channel flanges along four of the channels (see Fig. 8). These ties also take up some side sway of the way beams. Of 348 welds (two to each tie) 10 have fractured, probably due to shock, as they fractured shortly after the centre track, where they were located, was brought into use. On close examination of the fractures it has been found that the welds are all indifferently

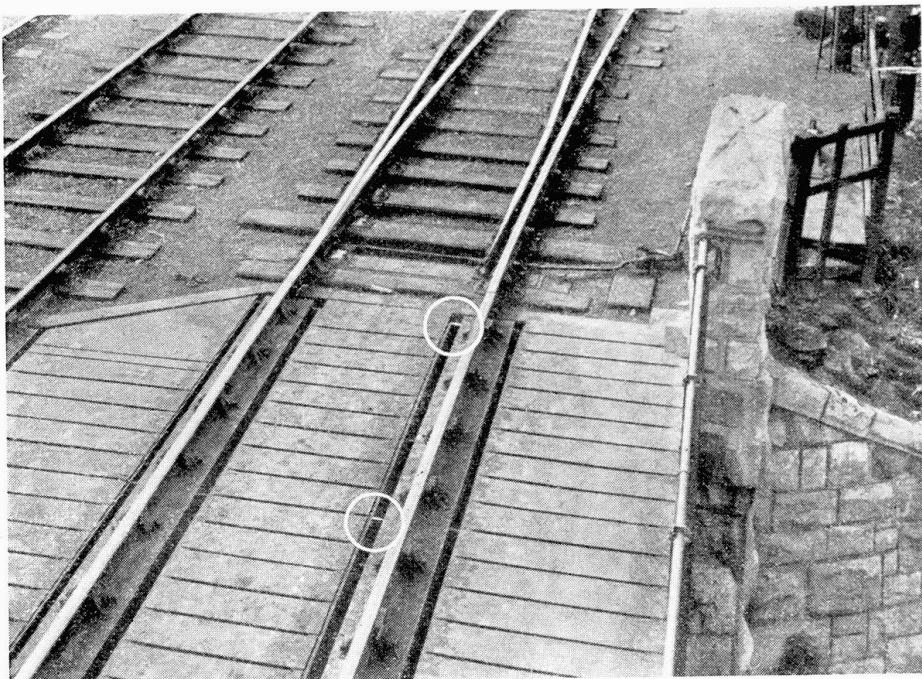
Fig. 9.

As will be noted the position of the fractured gussets occur on the convex side of the curve, where tension will be produced through the rigidity of the wheel base of engine counteracting the centrifugal action. A close up photograph of the fracture is shown in Fig. 10.

Brückeende und Weiche. Lage der Risse.
Extrémité du pont et aiguille. Emplacement des fissures.
Bridge end and switch. Position of fractures.

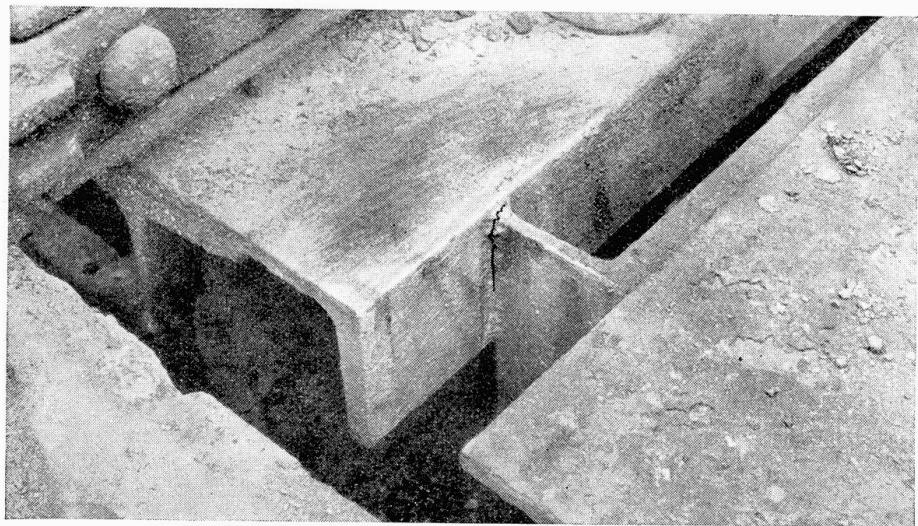
Fig. 10.
Gerissenes Knotenblech. — Tôle fissurée d'un gousset. — Fractured gusset.

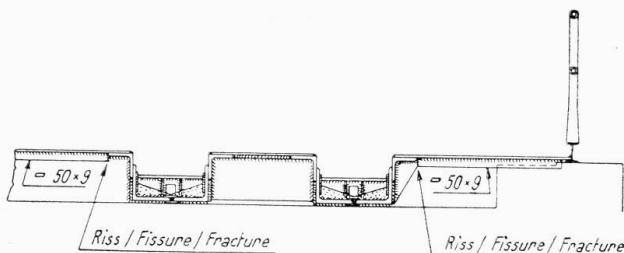
The bridge shown in Fig. 11 has a steel deck which is stiffened with $2'' \times 3/8''$ flats on edge. Besides these there are transverse diaphragms between the two sets of troughs. When erected it was found that the brick abutments

when bared were not very good, showing fractures below the bedstones on which the troughs would be seated. The bedstones were carefully levelled before the girders were erected on them, but possibly owing to the more rigid construction and absence of cushioning due to steel bearers instead of timber way beams in the troughs, the fractures in the abutments increased and caused unequal depression of the girder ends which set up transverse bending moments

in the deck stiffeners, which were not anticipated. Such transverse bending moments would be additional to the bending moments caused by deflection of one set of troughs when one trough was loaded and the other was not simultaneously loaded by passing traffic.

Fig. 11.
Halber Schnitt durch die Brücke. (Brücke No. 25, York und Doncaster).
Demi-coupe à travers le pont. (Pont n° 25, York et Doncaster).
Half section through bridge. (Bridge N° 25, York and Doncaster).

As mentioned above the bridge carries two separate main lines, and is therefore very busy, the average number of trains per 24 hours being 250 representing about $5\frac{1}{2}$ million stress variations annually, the traffic being about the same in both directions. Under these circumstances it will be realised that the enormous frequency of stress reversals which occur will tend to produce fatigue effects in parts unduly stressed. From the construction it will be appreciated that severe stresses must be set up in the transverse stiffeners of the deck plates due to such unequal deflections, which are enhanced by the settlement of the bedstones.

The welds connecting the deck plates and the $2'' \times 3/8''$ stiffeners are not very large and even normally they are rather heavily stressed, with the consequence that 19 out of 20 have fractured.

heavy steel grillages embedded in concrete are now always provided. These grillages are most carefully and truly set, so as to reduce unequal settlement of adjoining troughs to a minimum. In addition to the grillages the stiffeners for the deck plates are not carried through and welded to the flanges, thereby permitting the deck plates to flexure and so give a little play which absorbs unequal deflections.

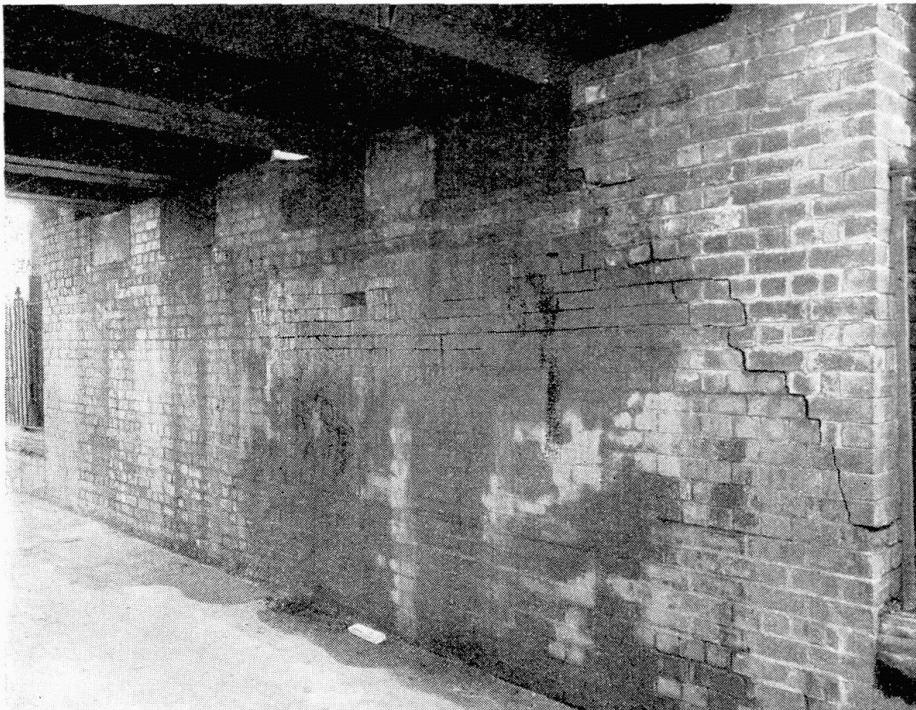
Fig. 12.

Gerissen's Widerlager. — Culée fissurée. — Fractured abutment.

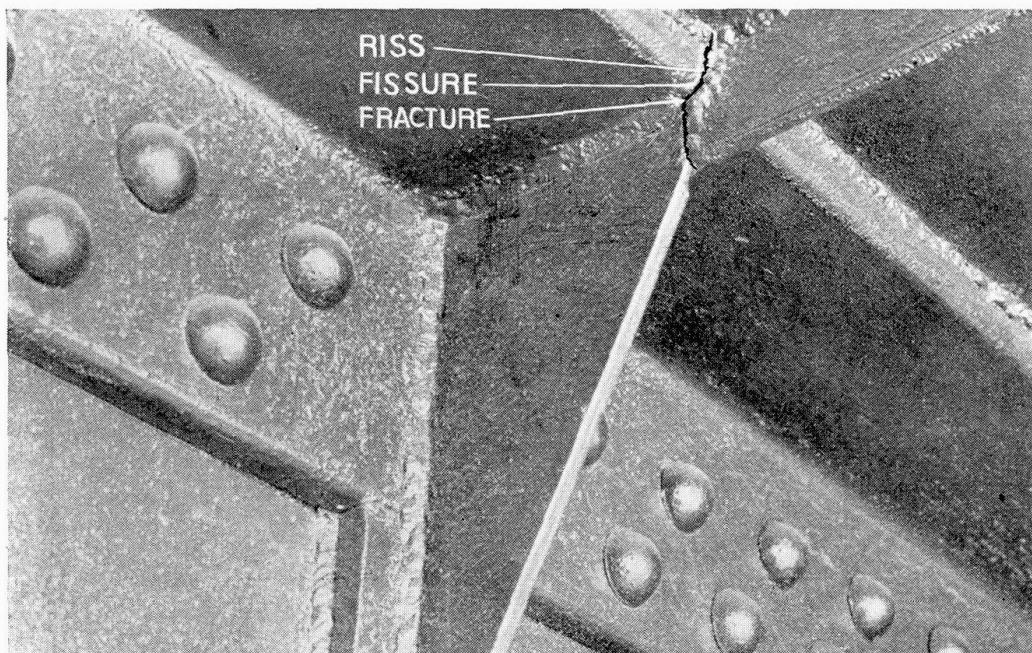
Fig. 13.
Gerissene Schweißung. — Soudure fissurée. — Fractured weld.
