Zeitschrift: **IABSE publications = Mémoires AIPC = IVBH Abhandlungen**

Band (Jahr): **4 (1936)**

RECORDED FAILURES OF ELECTRICALLY WELDED WROUGHT-IRON AND MILD STEEL BRIDGES.

H. J. L. BRUFF, Bridge Engineer, North Eastern Area, London and North Eastern Railway,
York.

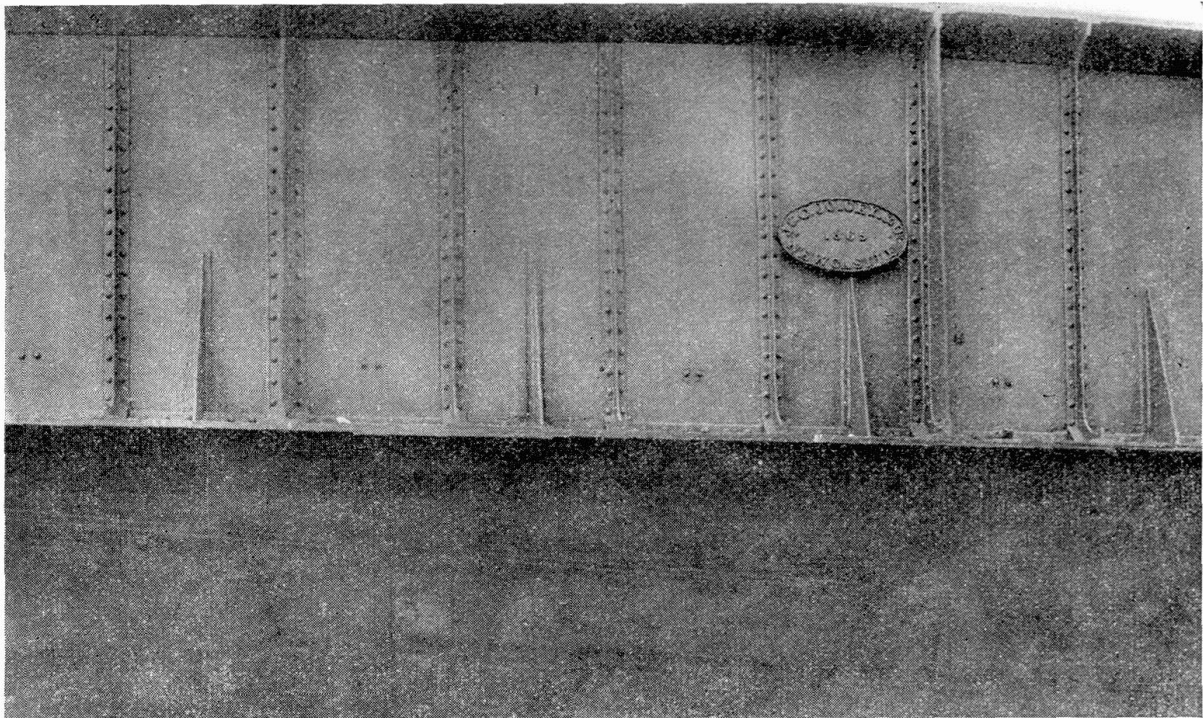
Fig. 3.
Lichtbild des reparierten Stegbleches. Außen- und Innenansicht.
Ame réparée. Vue extérieure et intérieure.
Photograph of repaired web; outside and inside.

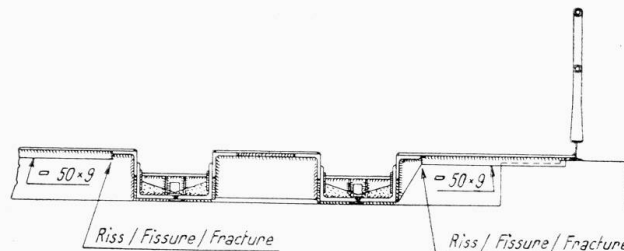
Fig. 11.

The bridge shown in Fig. 11 has a steel deck which is stiffened with $2" \times 3/8"$ flats on edge. Besides these there are transverse diaphragms between the two sets of troughs. When erected it was found that the brick abutments

when bared were not very good, showing fractures below the bedstones on which the troughs would be seated. The bedstones were carefully levelled before the girders were erected on them, but possibly owing to the more rigid construction and absence of cushioning due to steel bearers instead of timber way beams in the troughs, the fractures in the abutments increased and caused unequal depression of the girder ends which set up transverse bending moments

in the deck stiffeners, which were not anticipated. Such transverse bending moments would be additional to the bending moments caused by deflection of one set of troughs when one trough was loaded and the other was not simultaneously loaded by passing traffic.

Half section through bridge. (Bridge N° 25, York and Doncaster).

As mentioned above the bridge carries two separate main lines, and is therefore very busy, the average number of trains per 24 hours being 250 representing about $5\frac{1}{2}$ million stress variations annually, the traffic being about the same in both directions. Under these circumstances it will be realised that the enormous frequency of stress reversals which occur will tend to produce fatigue effects in parts unduly stressed. From the construction it will be appreciated that severe stresses must be set up in the transverse stiffeners of the deck plates due to such unequal deflections, which are enhanced by the settlement of the bedstones.

The welds connecting the deck plates and the $2" \times 3/8"$ stiffeners are not very large and even normally they are rather heavily stressed, with the consequence that 19 out of 20 have fractured.

heavy steel grillages embedded in concrete are now always provided. These grillages are most carefully and truly set, so as to reduce unequal settlement of adjoining troughs to a minimum. In addition to the grillages the stiffeners for the deck plates are not carried through and welded to the flanges, thereby permitting the deck plates to flexure and so give a little play which absorbs unequal deflections.
