8. Strengthening the Foundations of a Building in Helsinki (Finland)

Owner: Säästöpankkien Keskus-Osake-Pankki SKOP
Architectural planning: Järvinen Simo & Co.
Structural planning: Heiskanen RJ & Co. Ky
Building contractor: YIT-Yhtymä Oy
Execution time: 13 months
Execution year: 1986

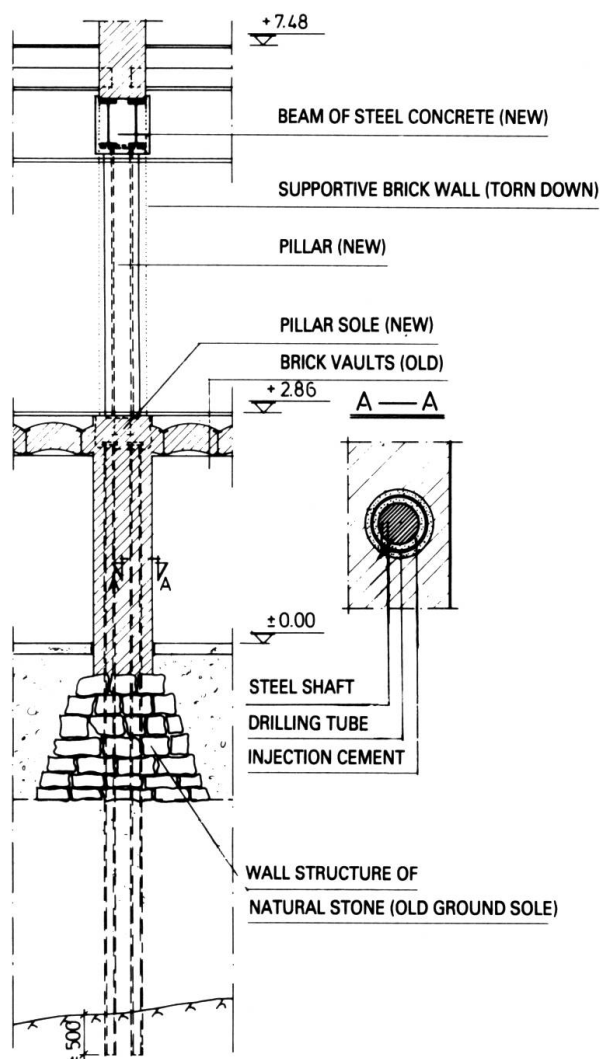
Fig. 1 Location of piling in the basement wall

The solution finally adopted was that the piles were driven from the ground floor level, through and within the walls of the basement restaurant level. Fig. 1 shows the applied solution. Through excavations in the supportive brick walls, later to be removed, holes were sunk vertically through the basement walls. The drilling was continued through the old foundations of natural stone, and further down, each drilling to penetrate no less than

0.5 metres into solid bedrock. The tubes used in the drilling process, $\varnothing 140 \times 4.0$, were left in position. The actual supportive piles, steel shafts, were then sunk into these holes, with each hole being filled with injection cement before insertion of the piles. Each steel concrete pillar is supported on a group of 3-5 such piles. The total length of piling was some 700 metres, with an average pile length of 7 metres, 2.5 metres of which was contained inside the brick walls of the basement restaurant. The piles were assembled on site from lengths of 1.5 metres, joined together by welding fig. 2.

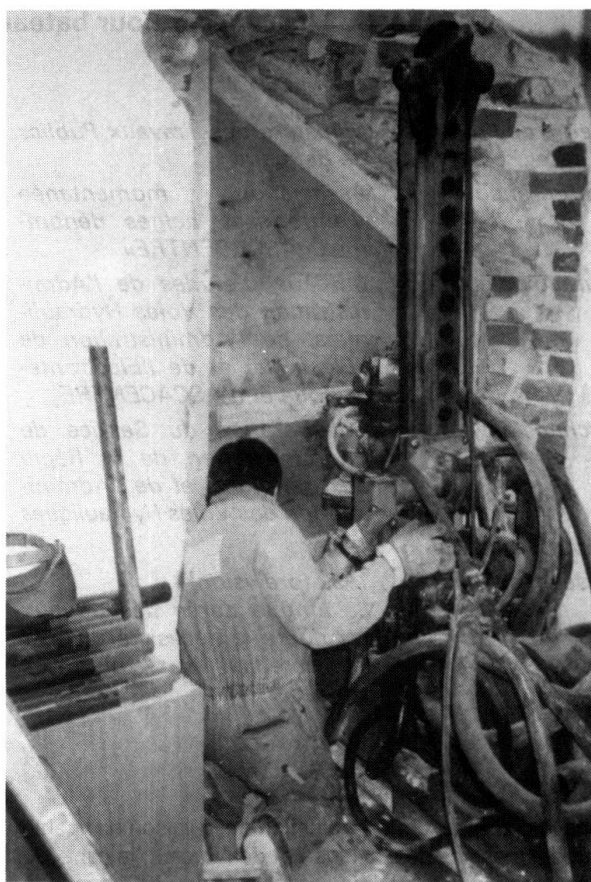
Fig. 2 Through excavations in the supportive brick walls holes were sunk vertically through the basement walls.
