Artikel: Strengthening the foundations of a building in Helsinki (Finland)

8. Strengthening the Foundations of a Building in Helsinki (Finland)

Owner: Säästöpankkien Keskus-

Architectural planning: Järvinen Simo & Co.
Structural planning: Heiskanen RJ & Co. Ky

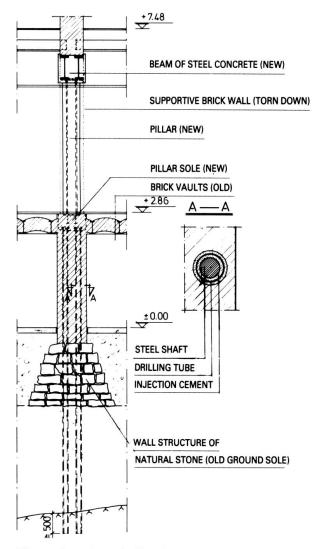
Fig. 1 Location of piling in the basement wall

The solution finally adopted was that the piles were driven from the ground floor level, through and within the walls of the basement restaurant level. Fig. 1 shows the applied solution. Through excavations in the supportive brick walls, later to be removed, holes were sunk vertically through the basement walls. The drilling was continued through the old foundations of natural stone, and further down, each drilling to penetrate no less than

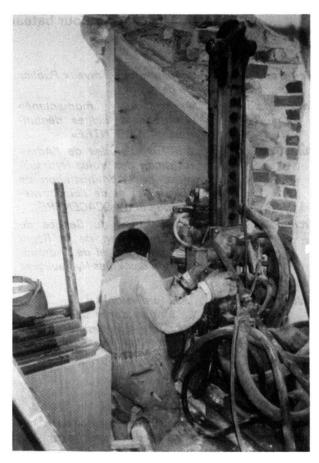
0.5 metres into solid bedrock. The tubes used in the drilling process, Ø 140×4.0, were left in position. The actual supportive piles, steel shafts, were then sunk into these holes, with each hole being filled with injection cement before insertion of the piles. Each steel concrete pillar is supported on a group of 3-5 such piles. The total length of piling was some 700 metres, with an average pile length of 7 metres, 2.5 metres of which was contained inside the brick walls of the basement restaurant. The piles were assembled on site from lengths of 1.5 metres, joined together by welding fig. 2.

Fig. 2 Through excavations in the supportive brick walls holes were sunk vertically through the basement walls.
