8. Strengthening the Foundations of a Building in Helsinki (Finland)

Owner:	Säästöpankkien Keskus-Osake-Pankki SKOP
Architectural planning:	Järvinen Simo & Co.
Structural planning:	Heiskanen RJ & Co. Ky
Building contractor:	YIT-Yhtymä Oy
Execution time:	13 months
Execution year:	1986

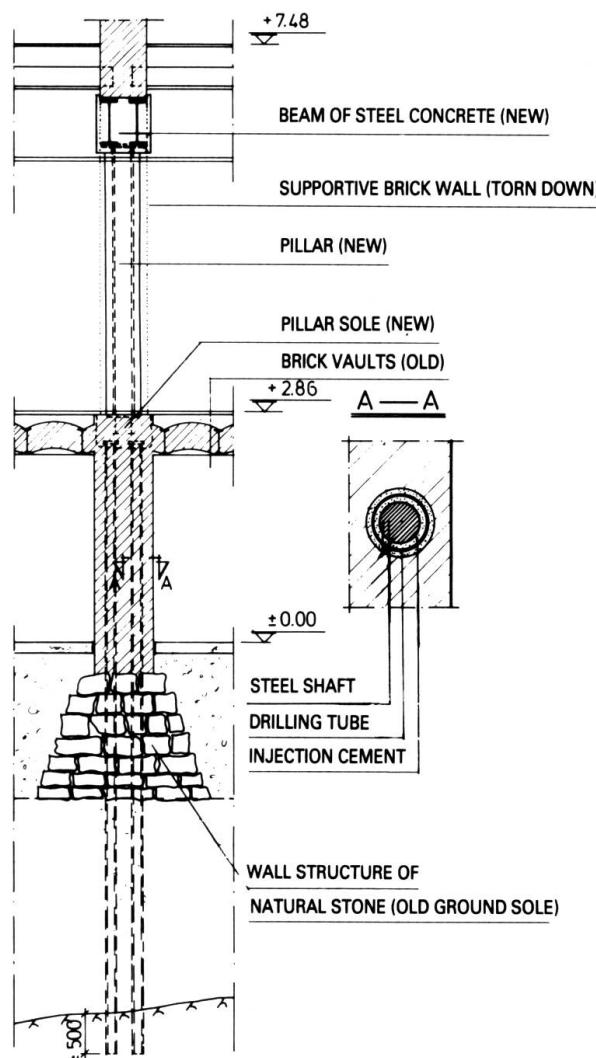
Fig. 1 Location of piling in the basement wall

The solution finally adopted was that the piles were driven from the ground floor level, through and within the walls of the basement restaurant level. Fig. 1 shows the applied solution. Through excavations in the supportive brick walls, later to be removed, holes were sunk vertically through the basement walls. The drilling was continued through the old foundations of natural stone, and further down, each drilling to penetrate no less than

0.5 metres into solid bedrock. The tubes used in the drilling process, $\varnothing 140 \times 4.0$, were left in position. The actual supportive piles, steel shafts, were then sunk into these holes, with each hole being filled with injection cement before insertion of the piles. Each steel concrete pillar is supported on a group of 3-5 such piles. The total length of piling was some 700 metres, with an average pile length of 7 metres, 2.5 metres of which was contained inside the brick walls of the basement restaurant. The piles were assembled on site from lengths of 1.5 metres, joined together by welding fig. 2.

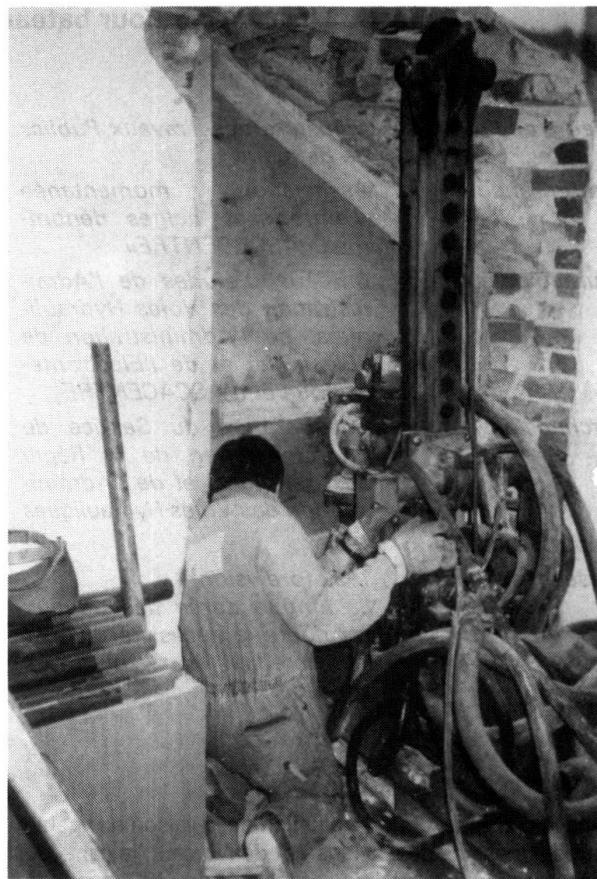
Fig. 2 Through excavations in the supportive brick walls holes were sunk vertically through the basement walls.
