**Zeitschrift:** IABSE structures = Constructions AIPC = IVBH Bauwerke  
**Band:** 12 (1988)  
**Heft:** C-45: Recent structures

**Artikel:** Strengthening the foundations of a building in Helsinki (Finland)  
**Autor:** Varstela, I. / Roitto, P. / Haapala, M.  
**DOI:** <https://doi.org/10.5169/seals-20917>

## 8. Strengthening the Foundations of a Building in Helsinki (Finland)

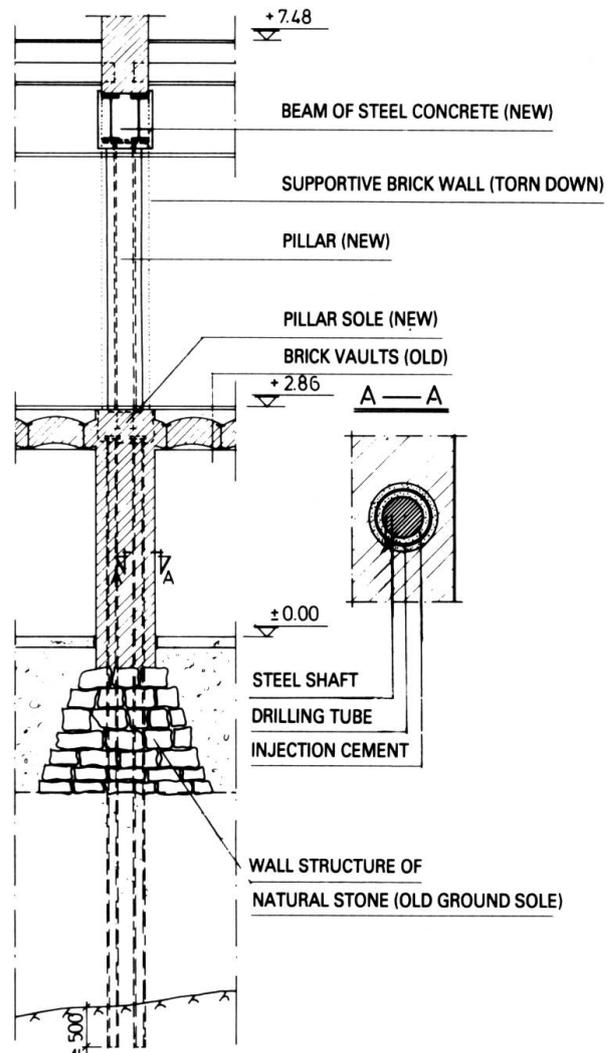
Fig. 1 Location of piling in the basement wall

The solution finally adopted was that the piles were driven from the ground floor level, through and within the walls of the basement restaurant level. Fig. 1 shows the applied solution. Through excavations in the supportive brick walls, later to be removed, holes were sunk vertically through the basement walls. The drilling was continued through the old foundations of natural stone, and further down, each drilling to penetrate no less than

0.5 metres into solid bedrock. The tubes used in the drilling process,  $\varnothing 140 \times 4.0$ , were left in position. The actual supportive piles, steel shafts, were then sunk into these holes, with each hole being filled with injection cement before insertion of the piles. Each steel concrete pillar is supported on a group of 3-5 such piles. The total length of piling was some 700 metres, with an average pile length of 7 metres, 2.5 metres of which was contained inside the brick walls of the basement restaurant. The piles were assembled on site from lengths of 1.5 metres, joined together by welding fig. 2.

The pile material was  $\varnothing 100$  solid steel shaft with the tensile strength classification Fe 37 B (lower yield point limit  $220 \text{ N/mm}^2$ ). The pile was dimensioned to form a slim supportive structure, with the surrounding earth as a flexible support. The permissible pile stresses thus achieved were 400 and 570 kN, depending on the length of the subterranean portion of each pile. The geotechnical supportive properties of such a pile is, according to Finnish regulations,  $90 \text{ MN/m}^2$ , which gives a permissible P value/pile ( $\varnothing 100 \text{ mm}$ ) of 707 kN.

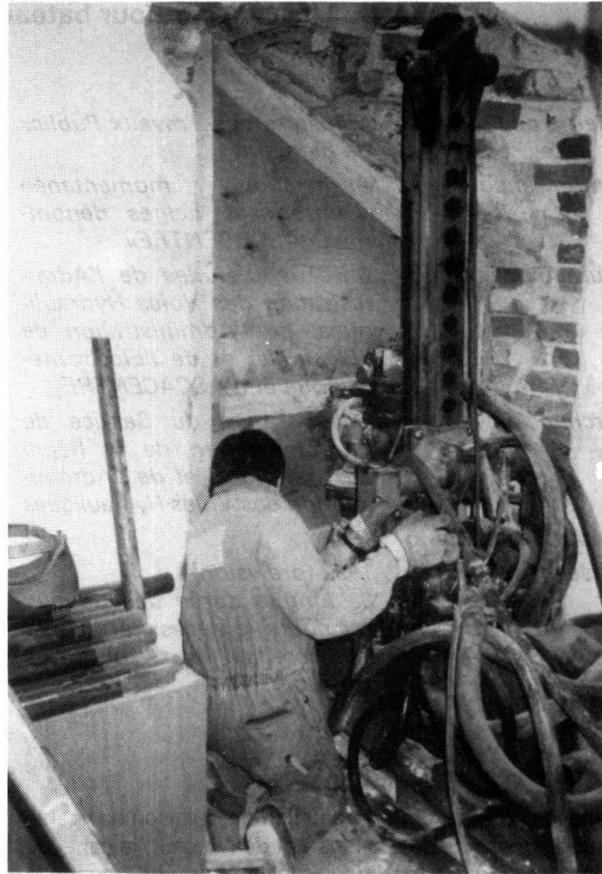
*Fig. 2 Through excavations in the supportive brick walls holes were sunk vertically through the basement walls.*
