**Artikel:** Repairing work of the Käyräjoki Bridge (Finland)  
**Autor:** Huura, Jorma / Falck, Kalevi  
**DOI:** <https://doi.org/10.5169/seals-20923>

#### 4. Repairing Work of the Käyräjoki Bridge (Finland)

Owner and contractor: Roads and Waterways Administration  
District of Kymi

Date of repairing: 1983

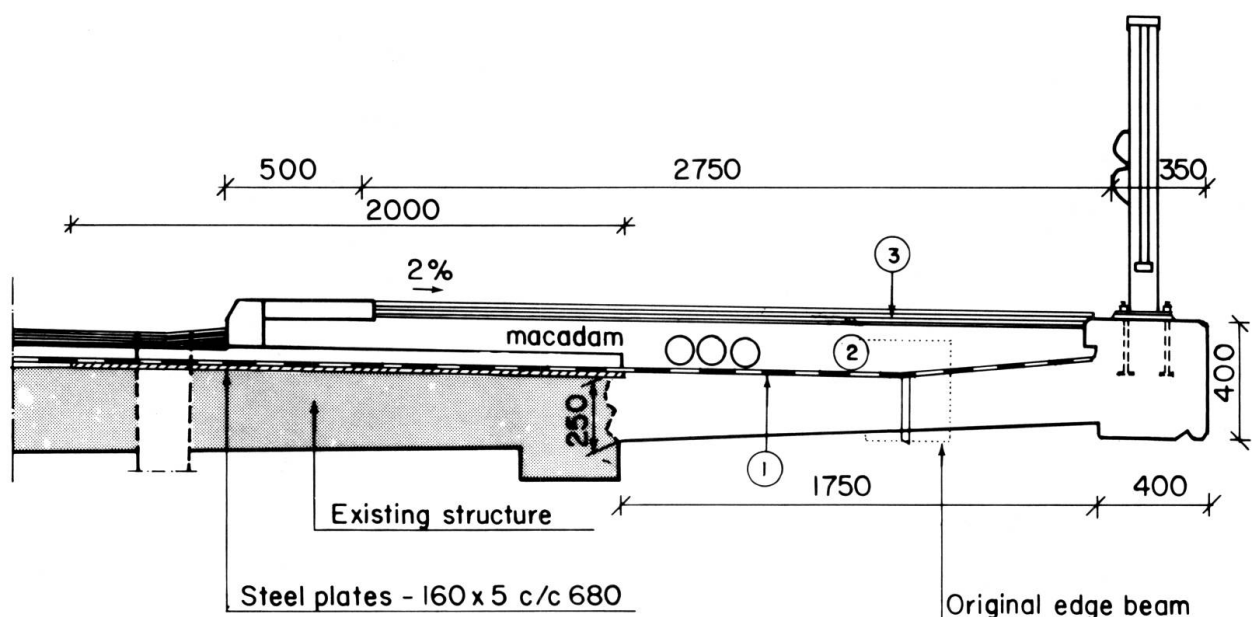
Fig. 2 The cross section of the cantilever edge with the clued steel plates

The edge of the existing structure was strengthened by two-meter-long steel plates which were clued by epoxy resin to the surface of the bridge deck (Fig. 2). The thickness of the joint between the plate and the concrete surface was 1 mm. Epoxy resin was injected into the joint. The shear strength requirement of the epoxy resin was  $1.0 \text{ MN/m}^2$ . The injection was done before removing the moulds and the scaffoldings. The work was based on the research done by Technical Research Centre of Finland. The corresponding method has been used afterwards successfully in various repairing works.

The protecting and surfacing layers of the repaired bridge deck were accomplished as follows (Fig. 2):

1. The waterproofing was made of rubberbitumen membrane, which was covered by ordinary bitumen sheets.
2. The levelling and drainage layer was made of macadam (without binder).
3. The wearing course was laid of asphaltic concrete.

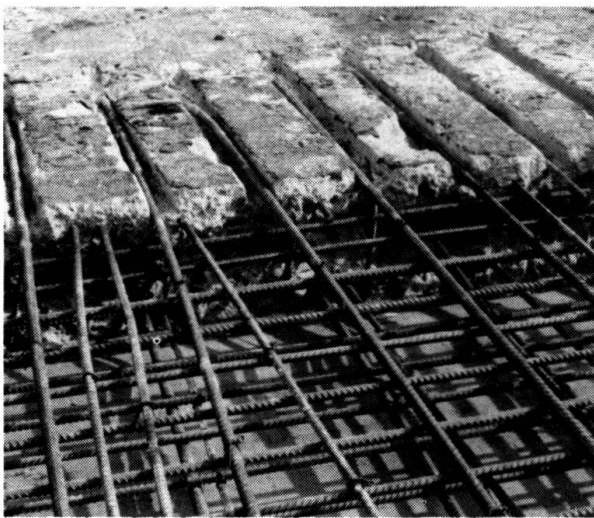
Fig. 3 The reinforcement of the cantilever

The reinforcement bars of the old structure were exposed about one meter and the new bars were anchored into the old concrete structure (Fig. 3). The quantity of the cement in concrete was  $300 \text{ kg/m}^3$  and the water-cement ratio was 0,50. The size of the aggregate was between 0 and 16 mm. Air entraining agent (aircontent 4,5–5,5%), plasticizer and retarder (retardation 24 h) were used. The concreting work started at noon and the work was finished the following morning at 6 o'clock. The air temperature was between +15 and +18°C.

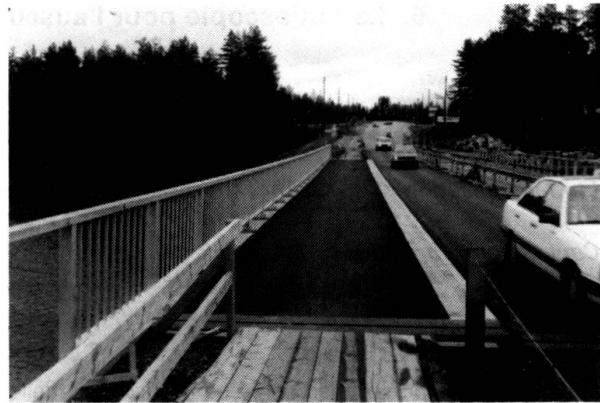
Fig. 4 The new sidewalk after the repairing work

The repairing work was made five years ago and the concrete structures are still in good condition. It is amazing that there are no cracks in the slender edge cantilever whatsoever.
