Zeitschrift: IABSE structures = Constructions AIPC = IVBH Bauwerke
Band: 12 (1988)
Heft: C-46: Repair and rehabilitation of bridges: case studies I

Artikel: Repairing work of the Käyräjoki Bridge (Finland)
Autor: Huura, Jorma / Falck, Kalevi
DOI: <https://doi.org/10.5169/seals-20923>

4. Repairing Work of the Käyräjoki Bridge (Finland)

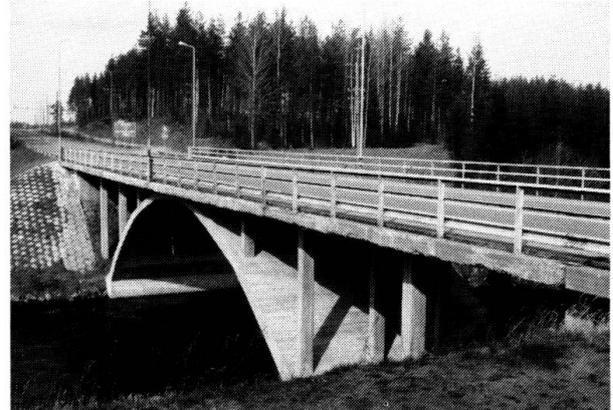
Fig. 1 The Käyräjoki bridge before repairing

The Käyräjoki bridge (Fig. 1) is located in a dell which causes that water is flowing on to the bridge more than otherwise. During wintertime the bridge is exposed to the salt-frost action. The bridge was built in 1963 when concrete was not air entrained. Consequently the concrete in the edge beams was scaling very badly twenty years after construction of the bridge.

During designing of the repairing work, the widening possibilities of the bridge were also studied. The calculations proved that the bridge could be made wider by one meter so that the total width of the walkway became 3,25 m. The cantilever edge was designed to carry 100 kN concentrated load which corresponds to the axle load of the vehicles used for road maintenance.

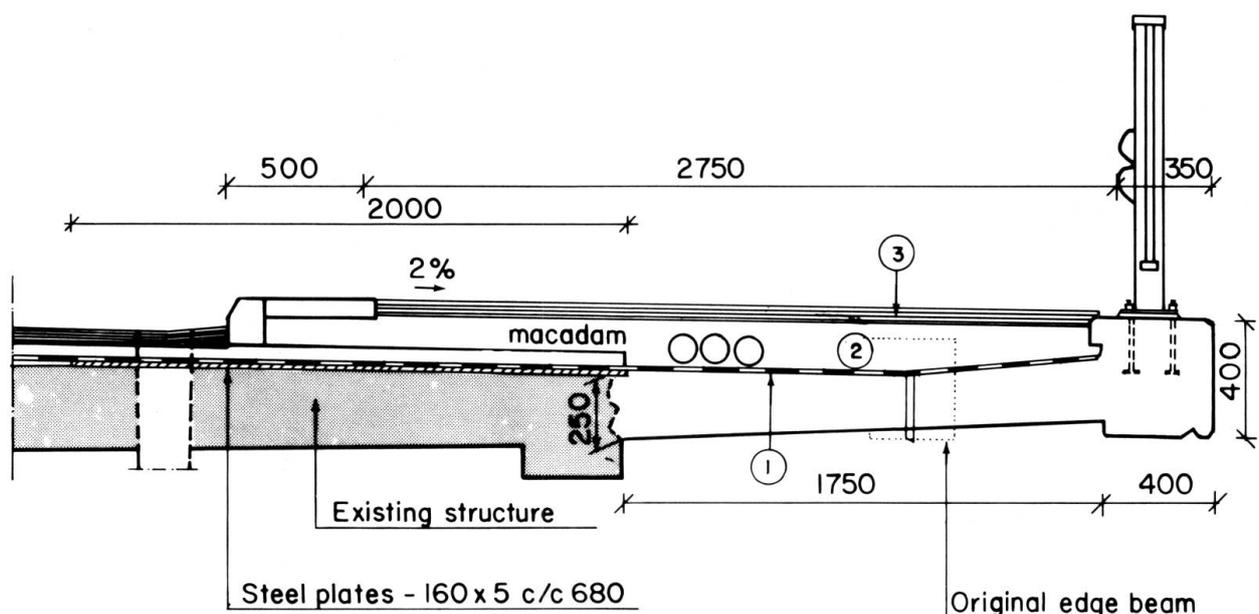
Fig. 2 The cross section of the cantilever edge with the clued steel plates

The edge of the existing structure was strengthened by two-meter-long steel plates which were clued by epoxy resin to the surface of the bridge deck (Fig. 2). The thickness of the joint between the plate and the concrete surface was 1 mm. Epoxy resin was injected into the joint. The shear strength requirement of the epoxy resin was 1.0 MN/m². The injection was done before removing the moulds and the scaffoldings. The work was based on the research done by Technical Research Centre of Finland. The corresponding method has been used afterwards successfully in various repairing works.

The protecting and surfacing layers of the repaired bridge deck were accomplished as follows (Fig. 2):

1. The waterproofing was made of rubberbitumen membrane, which was covered by ordinary bitumen sheets.
2. The levelling and drainage layer was made of macadam (without binder).
3. The wearing course was laid of asphaltic concrete.

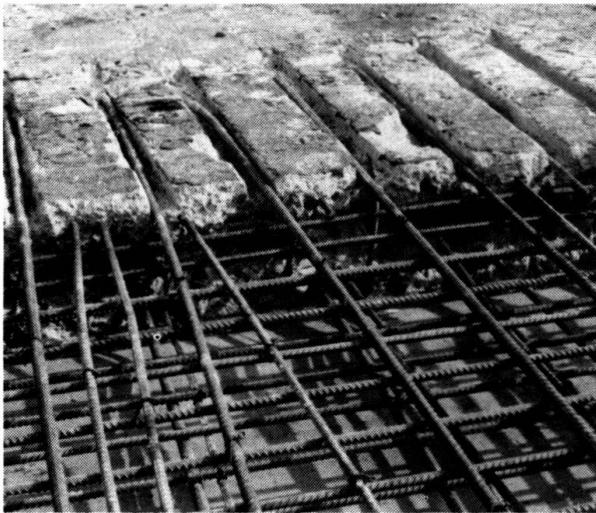
Fig. 3 The reinforcement of the cantilever

The reinforcement bars of the old structure were exposed about one meter and the new bars were anchored into the old concrete structure (Fig. 3). The quantity of the cement in concrete was 300 kg/m^3 and the water-cement ratio was 0,50. The size of the aggregate was between 0 and 16 mm. Air entraining agent (aircontent 4,5–5,5%), plasticizer and retarder (retardation 24 h) were used. The concreting work started at noon and the work was finished the following morning at 6 o'clock. The air temperature was between +15 and +18°C.

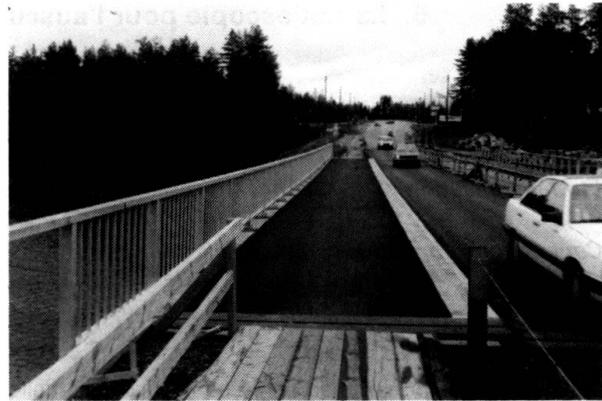
Fig. 4 The new sidewalk after the repairing work

The repairing work was made five years ago and the concrete structures are still in good condition. It is amazing that there are no cracks in the slender edge cantilever whatsoever.
