Zeitschrift: IABSE structures = Constructions AIPC = IVBH Bauwerke
Band: 12 (1988)
Heft: C-46: Repair and rehabilitation of bridges: case studies I

Artikel: Repairing work of the Käyräjoki Bridge (Finland)
Autor: Huura, Jorma / Falck, Kalevi
DOI: <https://doi.org/10.5169/seals-20923>

4. Repairing Work of the Käyräjoki Bridge (Finland)

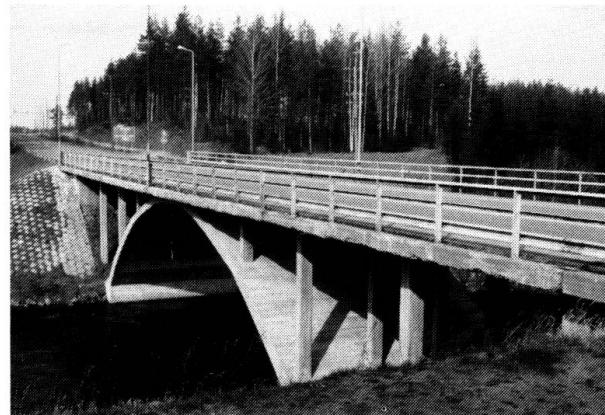
Fig. 1 The Käyräjoki bridge before repairing

The Käyräjoki bridge (Fig. 1) is located in a dell which causes that water is flowing on to the bridge more than otherwise. During wintertime the bridge is exposed to the salt-frost action. The bridge was built in 1963 when concrete was not air entrained. Consequently the concrete in the edge beams was scaling very badly twenty years after construction of the bridge.

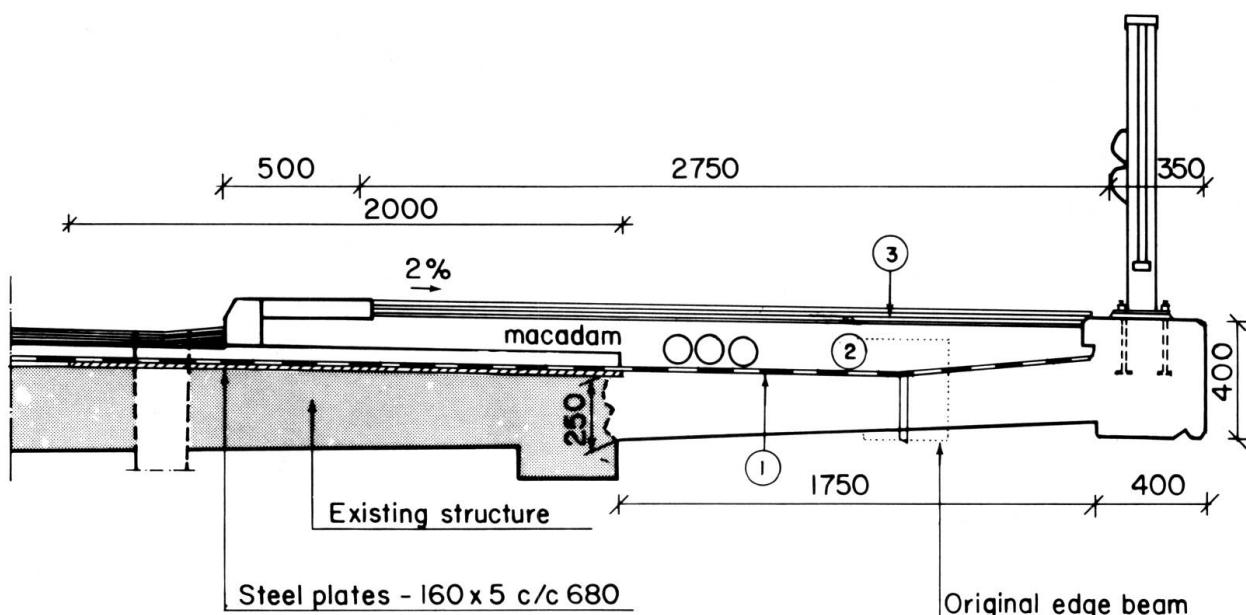
Fig. 2 The cross section of the cantilever edge with the glued steel plates

The edge of the existing structure was strengthened by two-meter-long steel plates which were glued by epoxy resin to the surface of the bridge deck (Fig. 2). The thickness of the joint between the plate and the concrete surface was 1 mm. Epoxy resin was injected into the joint. The shear strength requirement of the epoxy resin was 1.0 MN/m². The injection was done before removing the moulds and the scaffoldings. The work was based on the research done by Technical Research Centre of Finland. The corresponding method has been used afterwards successfully in various repairing works.

The protecting and surfacing layers of the repaired bridge deck were accomplished as follows (Fig. 2):

1. The waterproofing was made of rubberbitumen membrane, which was covered by ordinary bitumen sheets.
2. The levelling and drainage layer was made of macadam (without binder).
3. The wearing course was layed of asphaltic concrete.

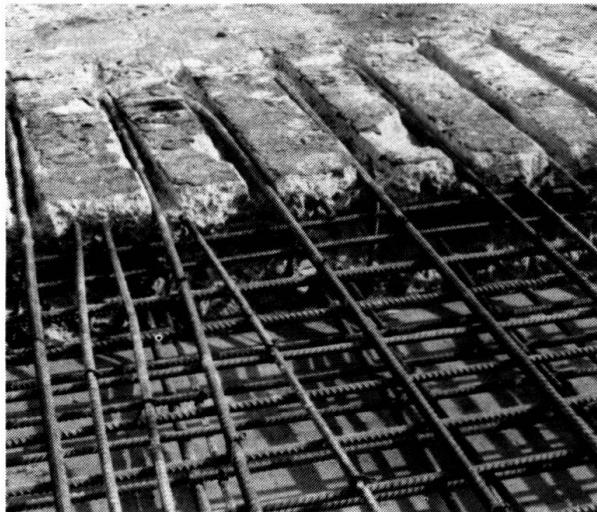
Fig. 3 The reinforcement of the cantilever

The reinforcement bars of the old structure were exposed about one meter and the new bars were anchored into the old concrete structure (Fig. 3). The quantity of the cement in concrete was 300 kg/m³ and the water-cement ratio was 0,50. The size of the aggregate was between 0 and 16 mm. Air entraining agent (aircontent 4,5–5,5 %), plasticizer and retarder (retardation 24 h) were used. The concreting work started at noon and the work was finished the following morning at 6 o'clock. The air temperature was between +15 and +18°C.

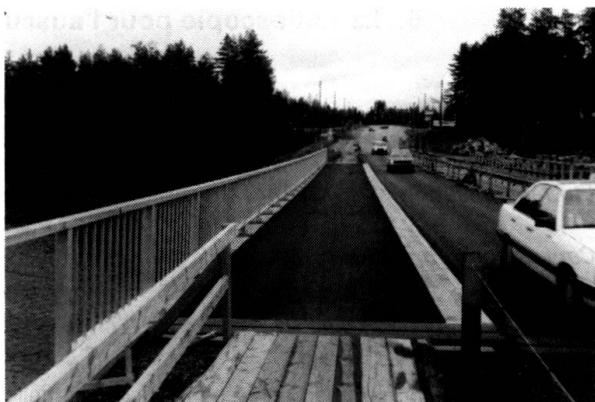
Fig. 4 The new sidewalk after the repairing work

The repairing work was made five years ago and the concrete structures are still in good condition. It is amazing that there are no cracks in the slender edge cantilever whatsoever.
