Zeitschrift: IABSE structures = Constructions AIPC = IVBH Bauwerke
Band: 12 (1988)
Heft: C-46: Repair and rehabilitation of bridges: case studies I

Artikel: Repairing work of the Käyräjoki Bridge (Finland)
Autor: Huura, Jorma / Falck, Kalevi
DOI: <https://doi.org/10.5169/seals-20923>

4. Repairing Work of the Käyräjoki Bridge (Finland)

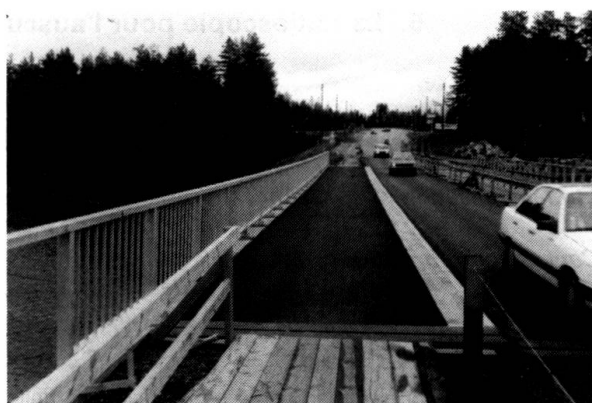
Fig. 4 The new sidewalk after the repairing work

The repairing work was made five years ago and the concrete structures are still in good condition. It is amazing that there are no cracks in the slender edge cantilever whatsoever.
