7. Off Ramp of Hanshin Expressway in Osaka (Japan)

Owner: Hanshin Expressway Public Corporation
Consultant: Prof. Dr. K. Horikawa
Contractor: Takara Giken Co. Ltd.
Work's duration (Field work): 4 months (2 weeks)
Repair date: 1985

Reshape of End Part of Plate Girder Bridge

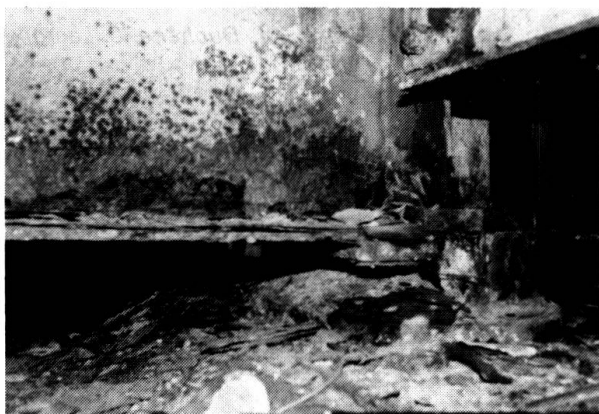
Corrosion is one type of damages in steel bridges in service and is apt to occur near expansion joints, bearing shoes and so on. In these parts, the thickness of members decreases by corrosion. In an extreme case, the fillet welds between web and lower flange are lost, as shown in Fig. 1. The cause of this example was considered to be the leakage of water with free lime because stalagmite was found on the lower surface of slab and water dropped even on a fine day.

Fig. 1 An example of corrosion

- 1) Cutting off the corroded part, then a new member with T section is connected using H.T. bolts.
- 2) Cutting off the corroded part, then a new member with T section is connected using welding at site.
- 3) Cutting off the corroded part, then only a new lower flange is connected using welding at site. As a result, the plate girder is reshaped from uniform section to non-uniform section.

These procedures have both merits and demerits. However, procedure 3) has merit for repair of bearing shoes, because the working space is secured after the reshape work, and the safety of structure is maintained during the repair.

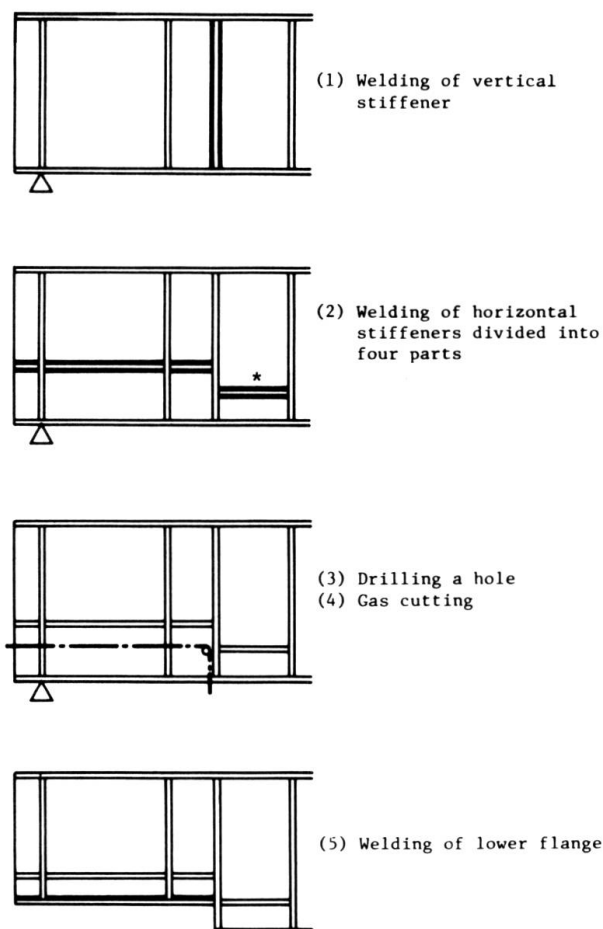
Fig. 2 Recommended procedures

From the above results, the procedures for the repair to be recommended are as shown in Fig. 2.

- 1) Firstly, welding of vertical stiffener
- 2) Secondly, welding of horizontal stiffeners
It is desirable that the stiffeners marked by * in Fig. 2 is welded on the same level as the lower flange fixed in stage 5) and welded to the next vertical stiffener.
- 3) Then drilling of a hole
- 4) And gas cutting
- 5) Finally, welding of lower flange

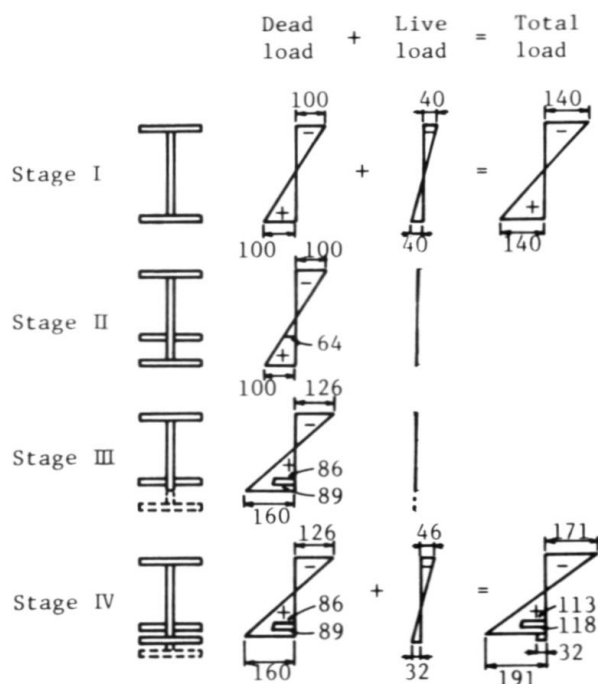
Assuming an existing girder with the same proportion as the model, the stresses on each stage are considered to be as shown in Fig. 3.

Stage I: Original section.
Assume the stresses due to the dead load and the live load as shown in the figure.

Stage II: Welding of stiffeners.
The live load is not considered, because there is no traffic. The stress due to the dead load does not change.

Stage III: Gas cutting.
The stress, that exists in the section to be cut off, is redistributed. Also, the force is shared by horizontal stiffeners. The stress after redistribution can be calculated from the following three conditions.

- 1) Difference of strains exists between stiffeners and web.
- 2) The integral of moment by the stresses equilibrates with the external moment.
- 3) The integral of the stresses is equal to zero.

Stage IV: Welding of lower flange.
The stress due to the dead load does not change. The entire section is effective to resist the live load.

Fig. 3 Schematic example of stress (MPa)

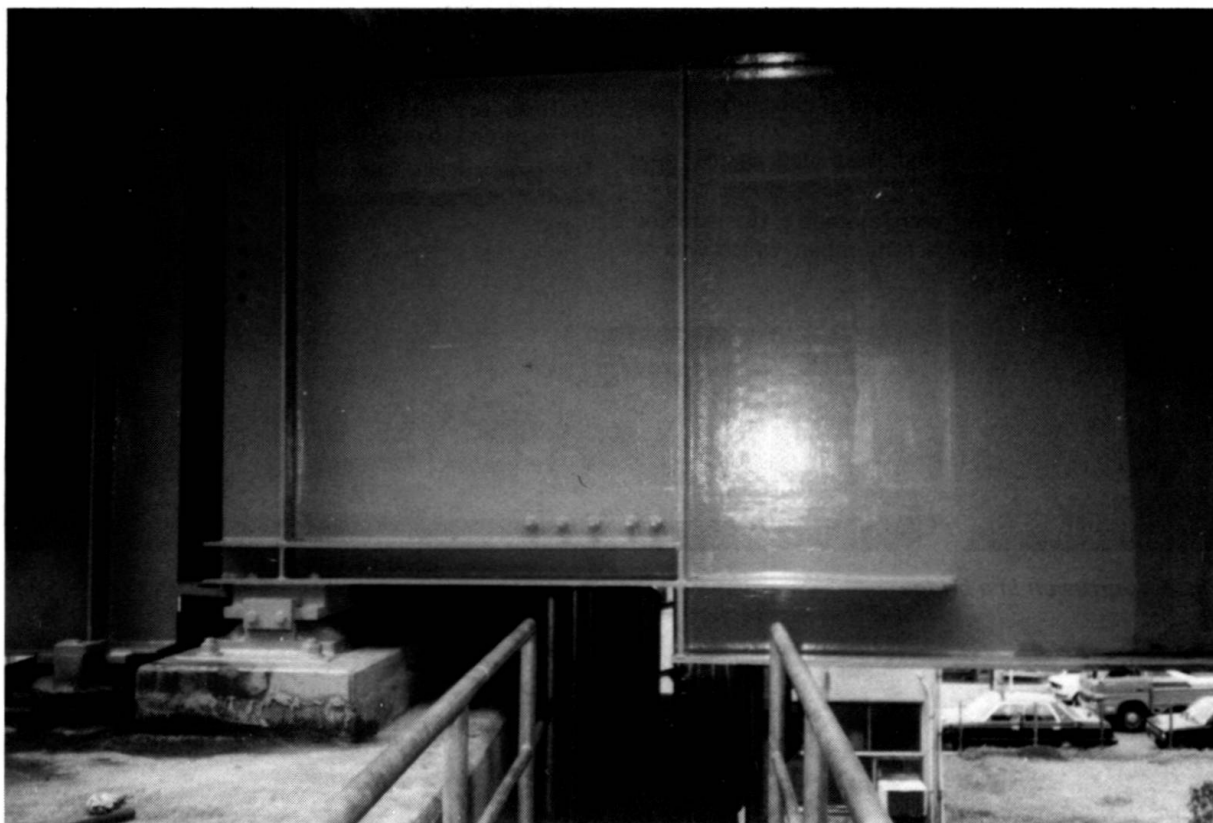
The existing bridge after the repair is shown in Fig. 4.

Fig. 4 Existing bridge after remedy
