**Artikel:** Off ramp of Hanshin expressway in Osaka (Japan)  
**Autor:** Horikawa, K. / Suzuki, H.  
**DOI:** <https://doi.org/10.5169/seals-20926>

## 7. Off Ramp of Hanshin Expressway in Osaka (Japan)

**Owner:** Hanshin Expressway Public Corporation  
**Consultant:** Prof. Dr. K. Horikawa  
**Contractor:** Takara Giken Co. Ltd.  
**Work's duration (Field work):** 4 months (2 weeks)  
**Repair date:** 1985

### Reshape of End Part of Plate Girder Bridge

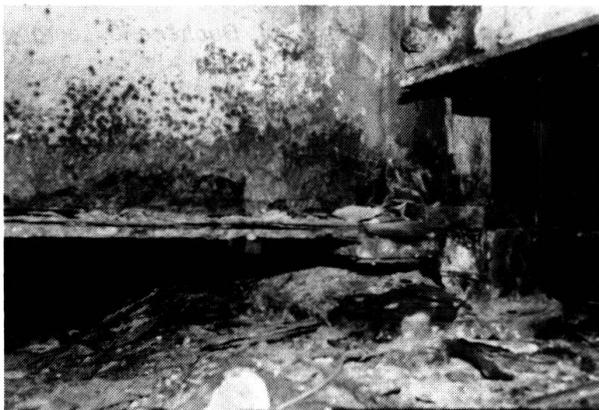
Corrosion is one type of damages in steel bridges in service and is apt to occur near expansion joints, bearing shoes and so on. In these parts, the thickness of members decreases by corrosion. In an extreme case, the fillet welds between web and lower flange are lost, as shown in Fig. 1. The cause of this example was considered to be the leakage of water with free lime because stalagmite was found on the lower surface of slab and water dropped even on a fine day.

Fig. 1 An example of corrosion

- 1) Cutting off the corroded part, then a new member with T section is connected using H. T. bolts.
- 2) Cutting off the corroded part, then a new member with T section is connected using welding at site.
- 3) Cutting off the corroded part, then only a new lower flange is connected using welding at site. As a result, the plate girder is reshaped from uniform section to non-uniform section.

These procedures have both merits and demerits. However, procedure 3) has merit for repair of bearing shoes, because the working space is secured after the reshape work, and the safety of structure is maintained during the repair.

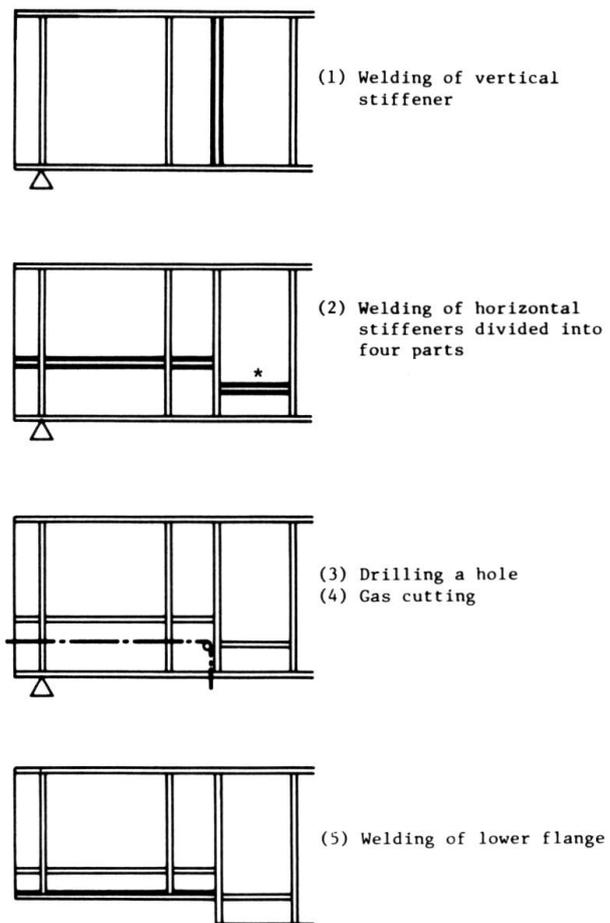
Fig. 2 Recommended procedures

From the above results, the procedures for the repair to be recommended are as shown in Fig. 2.

- 1) Firstly, welding of vertical stiffener
- 2) Secondly, welding of horizontal stiffeners  
It is desirable that the stiffeners marked by \* in Fig. 2 is welded on the same level as the lower flange fixed in stage 5) and welded to the next vertical stiffener.
- 3) Then drilling of a hole
- 4) And gas cutting
- 5) Finally, welding of lower flange

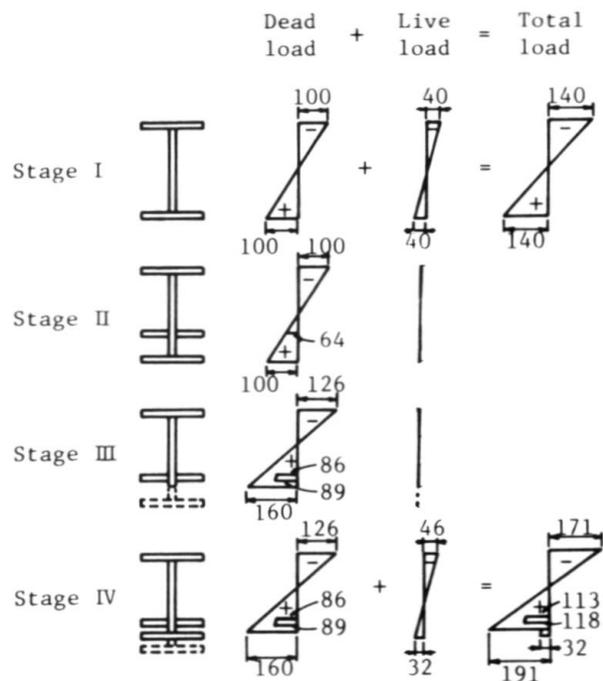
Assuming an existing girder with the same proportion as the model, the stresses on each stage are considered to be as shown in Fig. 3.

- Stage I: Original section.  
Assume the stresses due to the dead load and the live load as shown in the figure.
- Stage II: Welding of stiffeners.  
The live load is not considered, because there is no traffic. The stress due to the dead load does not change.

- Stage III: Gas cutting.  
The stress, that exists in the section to be cut off, is redistributed. Also, the force is shared by horizontal stiffeners. The stress after redistribution can be calculated from the following three conditions.

- 1) Difference of strains exists between stiffeners and web.
  - 2) The integral of moment by the stresses equilibrates with the external moment.
  - 3) The integral of the stresses is equal to zero.

- Stage IV: Welding of lower flange.  
The stress due to the dead load does not change. The entire section is effective to resist the live load.
- The existing bridge after the repair is shown in Fig. 4.

Fig. 3 Schematic example of stress (MPa)

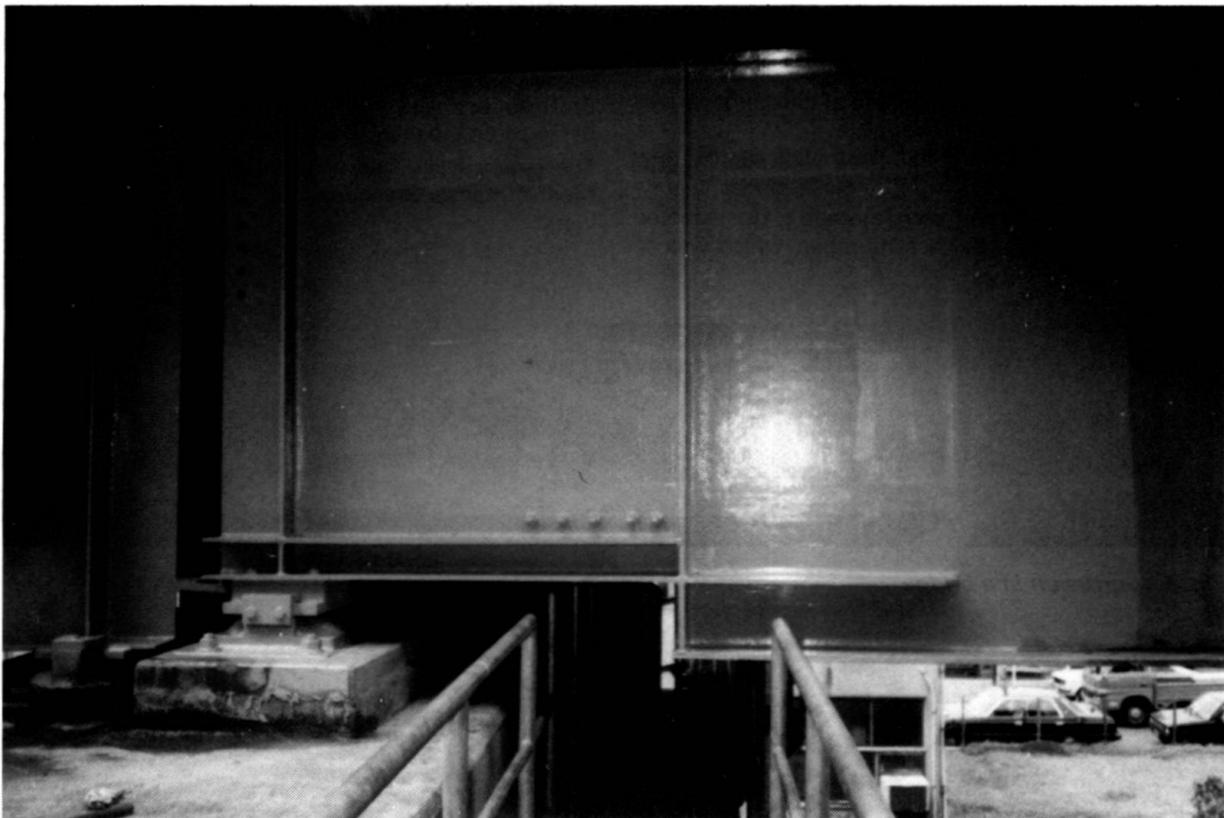
Fig. 4 Existing bridge after remedy
