## 7. Off Ramp of Hanshin Expressway in Osaka (Japan)

**Owner:** Hanshin Expressway Public Corporation  
**Consultant:** Prof. Dr. K. Horikawa  
**Contractor:** Takara Giken Co. Ltd.  
**Work's duration (Field work):** 4 months (2 weeks)  
**Repair date:** 1985

### Reshape of End Part of Plate Girder Bridge

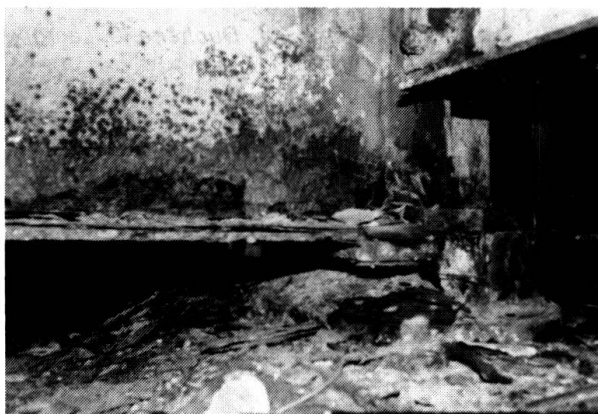
Corrosion is one type of damages in steel bridges in service and is apt to occur near expansion joints, bearing shoes and so on. In these parts, the thickness of members decreases by corrosion. In an extreme case, the fillet welds between web and lower flange are lost, as shown in Fig. 1. The cause of this example was considered to be the leakage of water with free lime because stalagmite was found on the lower surface of slab and water dropped even on a fine day.

Fig. 1 An example of corrosion

- 1) Cutting off the corroded part, then a new member with T section is connected using H.T. bolts.
- 2) Cutting off the corroded part, then a new member with T section is connected using welding at site.
- 3) Cutting off the corroded part, then only a new lower flange is connected using welding at site. As a result, the plate girder is reshaped from uniform section to non-uniform section.

These procedures have both merits and demerits. However, procedure 3) has merit for repair of bearing shoes, because the working space is secured after the reshape work, and the safety of structure is maintained during the repair.

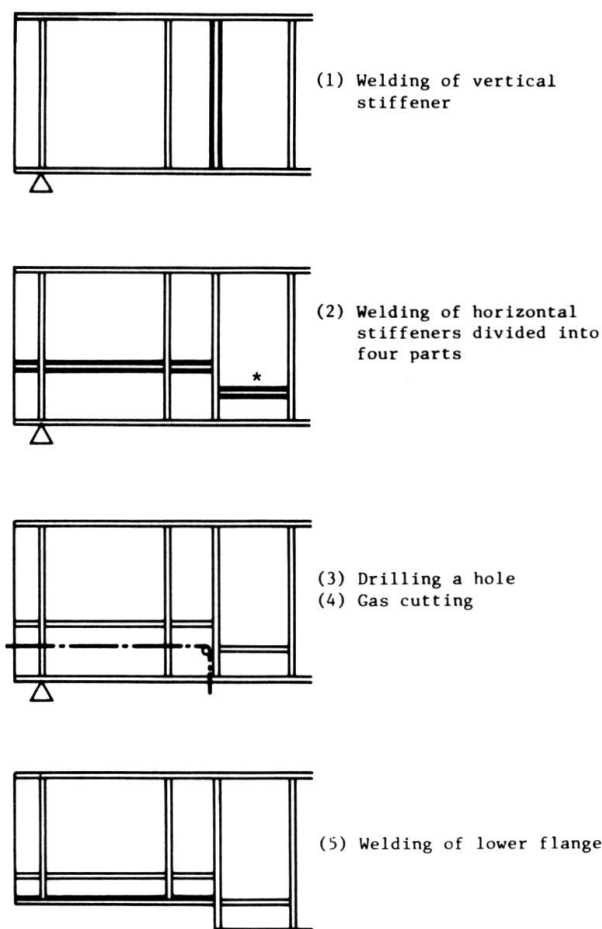
Fig. 2 Recommended procedures

From the above results, the procedures for the repair to be recommended are as shown in Fig. 2.

- 1) Firstly, welding of vertical stiffener
- 2) Secondly, welding of horizontal stiffeners
- It is desirable that the stiffeners marked by \* in Fig. 2 is welded on the same level as the lower flange fixed in stage 5) and welded to the next vertical stiffener.
- 3) Then drilling of a hole
- 4) And gas cutting
- 5) Finally, welding of lower flange

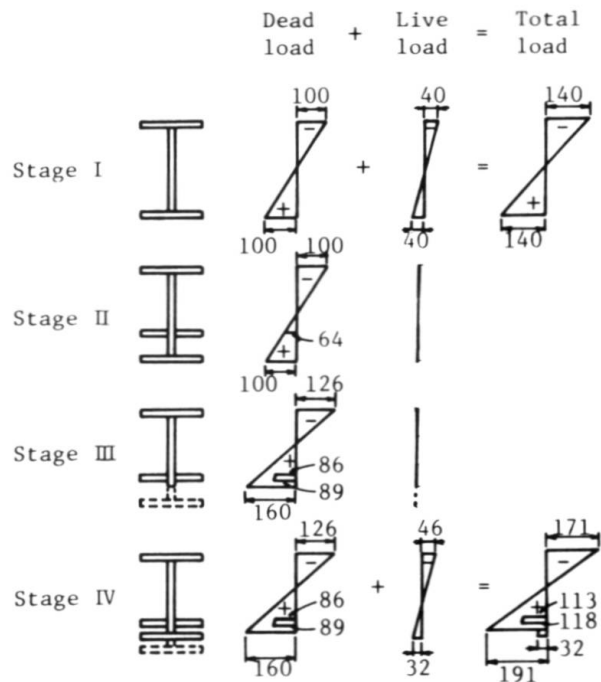
Assuming an existing girder with the same proportion as the model, the stresses on each stage are considered to be as shown in Fig. 3.

Stage I: Original section.  
Assume the stresses due to the dead load and the live load as shown in the figure.

Stage II: Welding of stiffeners.  
The live load is not considered, because there is no traffic. The stress due to the dead load does not change.

Stage III: Gas cutting.  
The stress, that exists in the section to be cut off, is redistributed. Also, the force is shared by horizontal stiffeners. The stress after redistribution can be calculated from the following three conditions.

- 1) Difference of strains exists between stiffeners and web.
- 2) The integral of moment by the stresses equilibrates with the external moment.
- 3) The integral of the stresses is equal to zero.

Stage IV: Welding of lower flange.  
The stress due to the dead load does not change. The entire section is effective to resist the live load.

Fig. 3 Schematic example of stress (MPa)

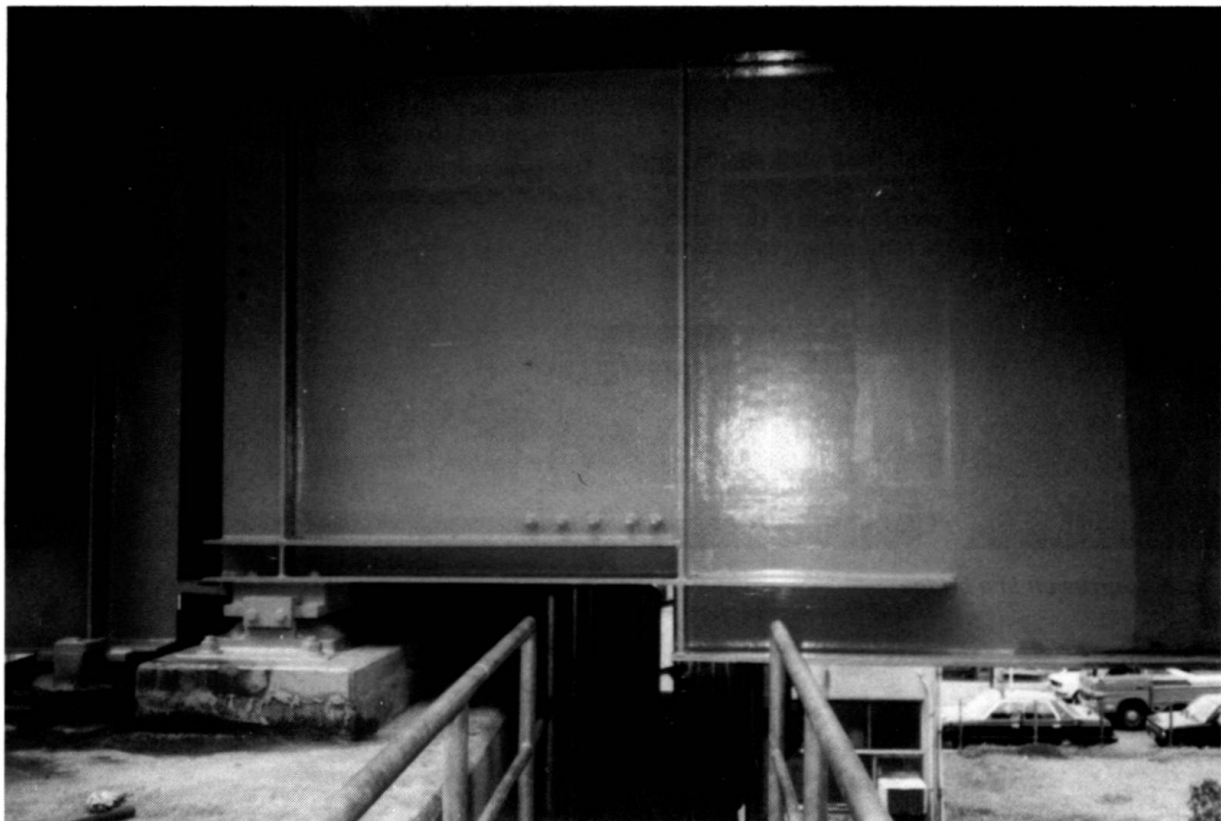
The existing bridge after the repair is shown in Fig. 4.

Fig. 4 Existing bridge after remedy
