## 7. Off Ramp of Hanshin Expressway in Osaka (Japan)

<b>Owner:</b>	<i>Hanshin Expressway Public Corporation</i>
<b>Consultant:</b>	<i>Prof. Dr. K. Horikawa</i>
<b>Contractor:</b>	<i>Takara Giken Co. Ltd.</i>
<b>Work's duration (Field work):</b>	<i>4 months (2 weeks)</i>
<b>Repair date:</b>	<i>1985</i>

### Reshape of End Part of Plate Girder Bridge

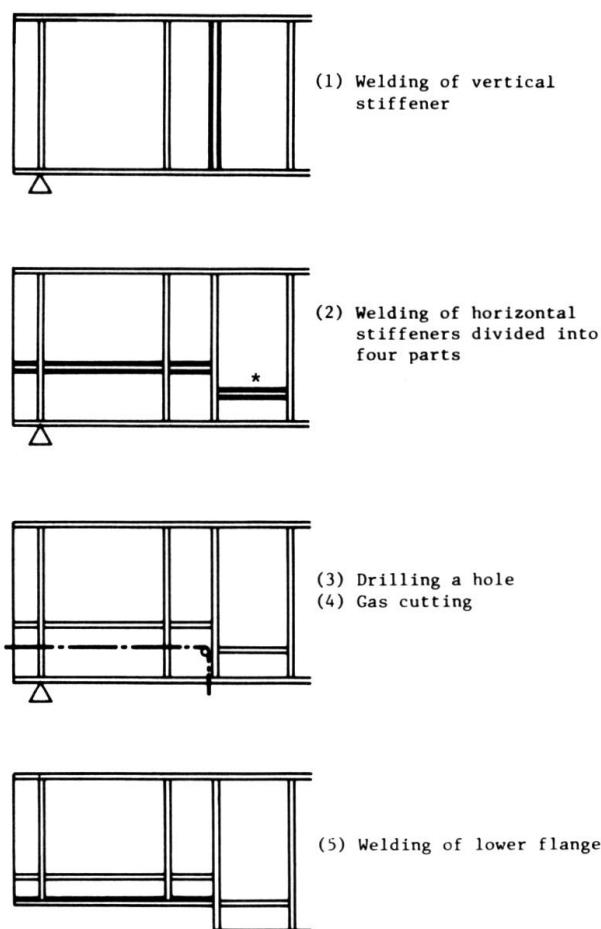
Fig. 2 Recommended procedures

From the above results, the procedures for the repair to be recommended are as shown in Fig. 2.

- 1) Firstly, welding of vertical stiffener
- 2) Secondly, welding of horizontal stiffeners  
It is desirable that the stiffeners marked by \* in Fig. 2 is welded on the same level as the lower flange fixed in stage 5) and welded to the next vertical stiffener.
- 3) Then drilling of a hole
- 4) And gas cutting
- 5) Finally, welding of lower flange

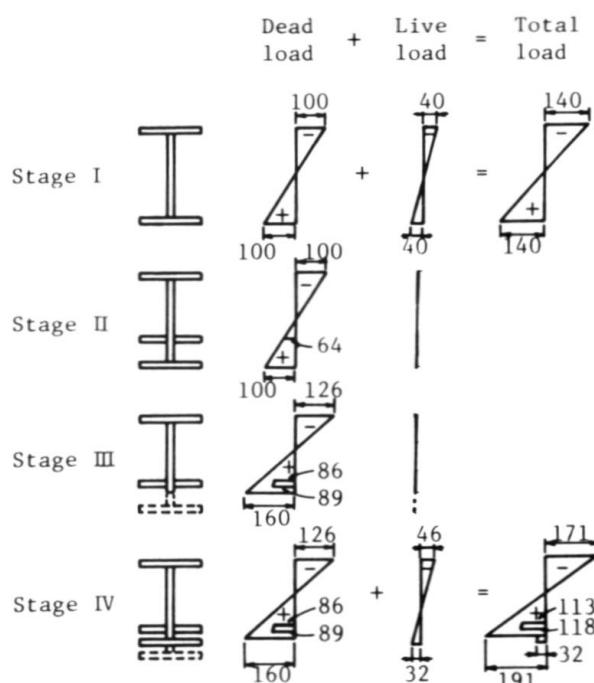
Assuming an existing girder with the same proportion as the model, the stresses on each stage are considered to be as shown in Fig. 3.

The stress, that exists in the section to be cut off, is redistributed. Also, the force is shared by horizontal stiffeners. The stress after redistribution can be calculated from the following three conditions.

Fig. 3 Schematic example of stress (MPa)

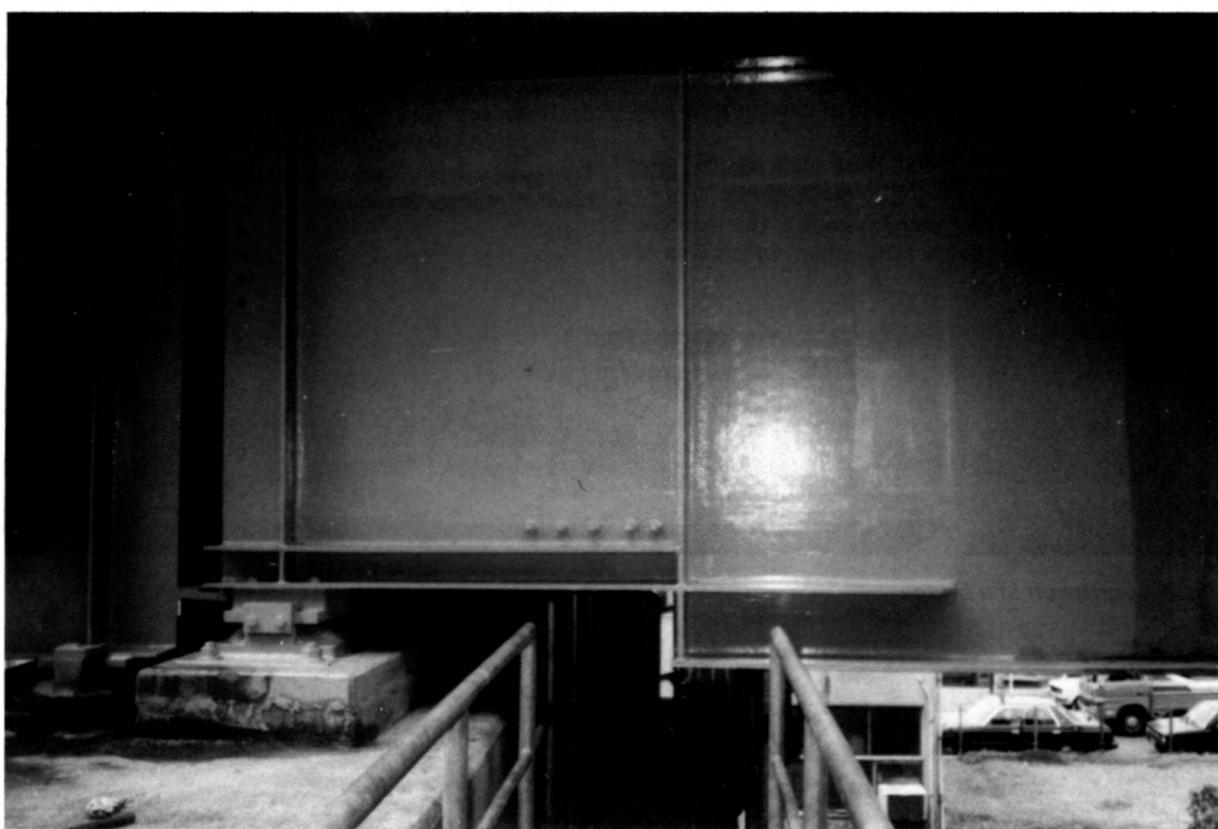
The existing bridge after the repair is shown in Fig. 4.

Fig. 4 Existing bridge after remedy
