8. Elevated Bridge in Hanshin Expressway in Osaka (Japan)

Owner: Hanshin Expressway Public Corporation
Consultant: Prof. Dr. K. Horikawa
Contractor: Takara Giken Co. Ltd.
Work's duration (Field work): 6 months (2 weeks)
Repair date: 1986

Replacement of Flange without Traffic Interruption

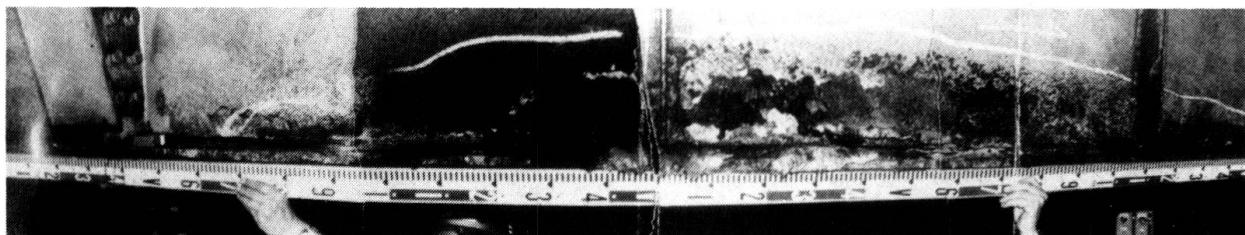
Heavy corrosion appeared at the lower flange plate, the lower end of web plate and one of the vertical stiffeners of a plate girder bridge (Fig. 1). It was caused by leakage of water through the timber plate used for a mold, which had been left in the concrete slab after completion. The location of the corroded area was the main girder near the span center of a 2-span continuous girder bridge for highway. The bridge was an elevated bridge in such a heavy traffic urban area (Fig. 2), that it was impossible to use any intermediate supports for the girder during repair and also impossible to suspend the traffic on the highway. Thus, the corroded area had to be repaired under loading and vibration.

Fig. 1 Corrosion in a bridge

Thinking of the heavy corrosion, method 3) was adopted in the repair using a by-pass member, which was to

carry the force that was carried by the part to be removed, during the repair. This repairing method is named «By-pass Method». Connections of the new part were of both welding and fastening with H.T. bolts; the lower flange was welded and the web was fastened with H.T. bolts.
