8. Elevated Bridge in Hanshin Expressway in Osaka (Japan)

Owner: Hanshin Expressway Public Corporation
Consultant: Prof. Dr. K. Horikawa
Contractor: Takara Giken Co. Ltd.
Work's duration (Field work): 6 months (2 weeks)
Repair date: 1986

Replacement of Flange without Traffic Interruption

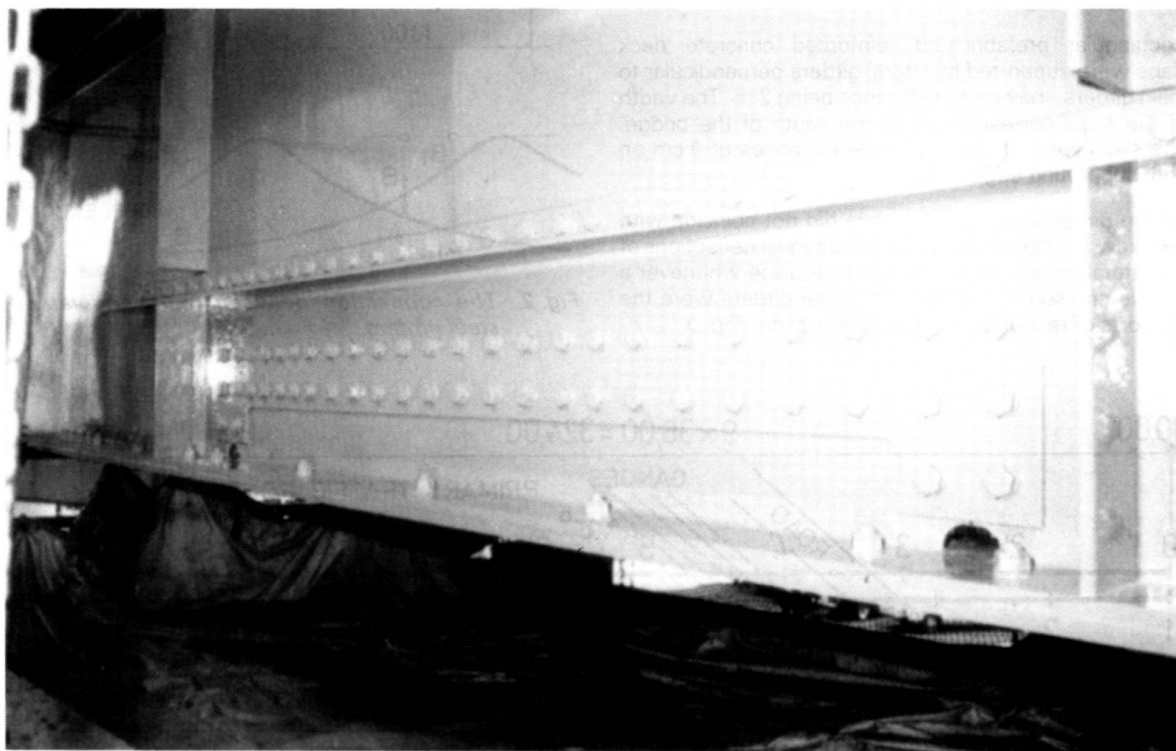
The repaired girder is shown in Fig. 3. The Technical Merit of Kansai Branch of JSCE was awarded for this work.

Fig. 3 Girder after remedy at site
