## 8. Elevated Bridge in Hanshin Expressway in Osaka (Japan)

**Owner:** Hanshin Expressway Public Corporation  
**Consultant:** Prof. Dr. K. Horikawa  
**Contractor:** Takara Giken Co. Ltd.  
**Work's duration (Field work):** 6 months (2 weeks)  
**Repair date:** 1986

### Replacement of Flange without Traffic Interruption

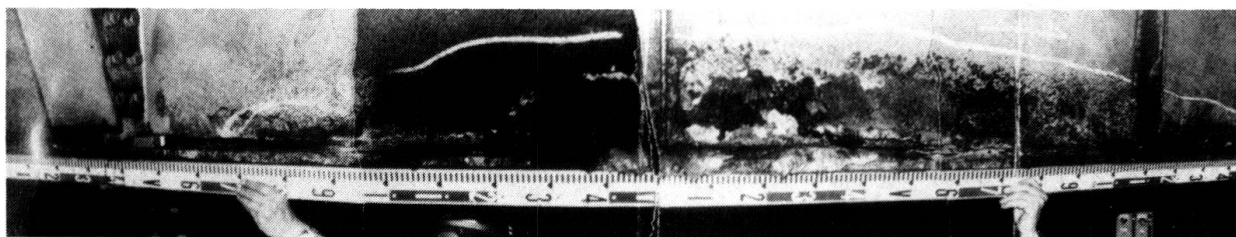
Heavy corrosion appeared at the lower flange plate, the lower end of web plate and one of the vertical stiffeners of a plate girder bridge (Fig. 1). It was caused by leakage of water through the timber plate used for a mold, which had been left in the concrete slab after completion. The location of the corroded area was the main girder near the span center of a 2-span continuous girder bridge for highway. The bridge was an elevated bridge in such a heavy traffic urban area (Fig. 2), that it was impossible to use any intermediate supports for the girder during repair and also impossible to suspend the traffic on the highway. Thus, the corroded area had to be repaired under loading and vibration.

Fig. 1 Corrosion in a bridge

Thinking of the heavy corrosion, method 3) was adopted in the repair using a by-pass member, which was to

carry the force that was carried by the part to be removed, during the repair. This repairing method is named «By-pass Method». Connections of the new part were of both welding and fastening with H.T. bolts; the lower flange was welded and the web was fastened with H.T. bolts.

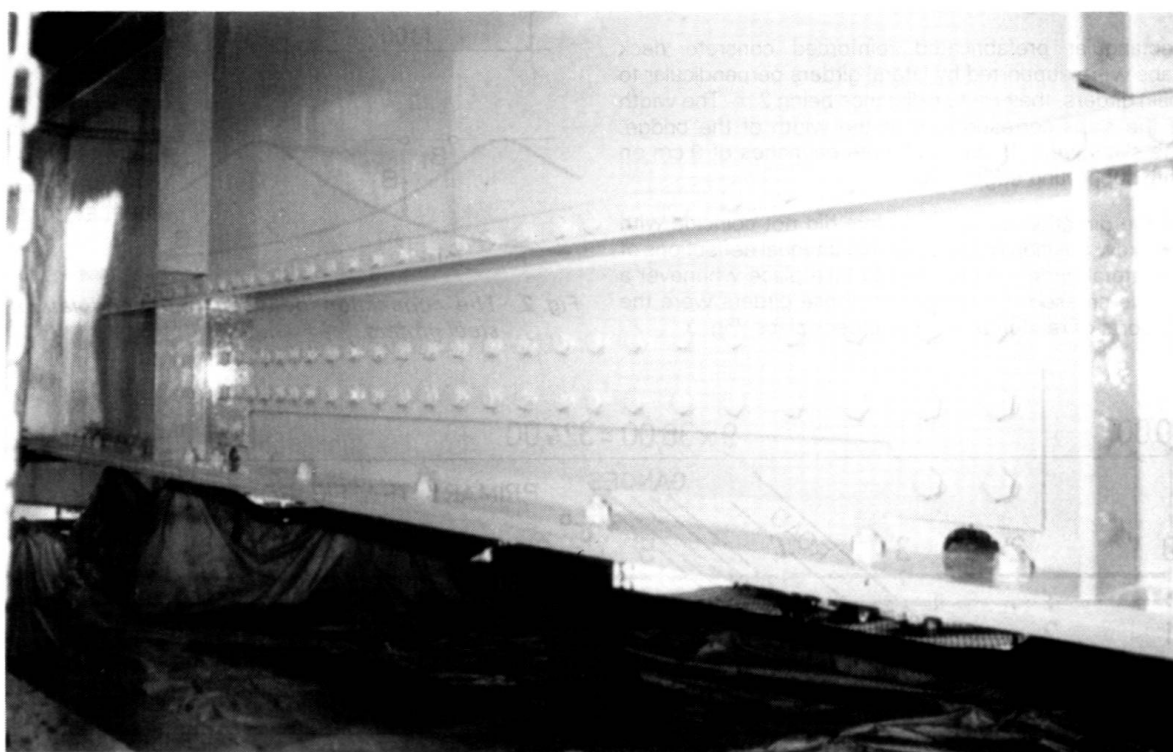
Fig. 3 Girder after remedy at site

The repaired girder is shown in Fig. 3. The Technical Merit of Kansai Branch of JSCE was awarded for this work.
