8. Elevated Bridge in Hanshin Expressway in Osaka (Japan)

Owner: Hanshin Expressway Public Corporation
Consultant: Prof. Dr. K. Horikawa
Contractor: Takara Giken Co. Ltd.
Work's duration (Field work): 6 months (2 weeks)
Repair date: 1986

Replacement of Flange without Traffic Interruption

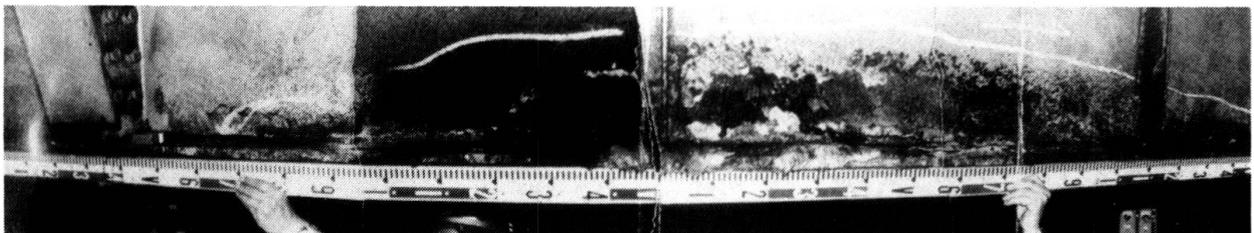
Heavy corrosion appeared at the lower flange plate, the lower end of web plate and one of the vertical stiffeners of a plate girder bridge (Fig. 1). It was caused by leakage of water through the timber plate used for a mold, which had been left in the concrete slab after completion. The location of the corroded area was the main girder near the span center of a 2-span continuous girder bridge for highway. The bridge was an elevated bridge in such a heavy traffic urban area (Fig. 2), that it was impossible to use any intermediate supports for the girder during repair and also impossible to suspend the traffic on the highway. Thus, the corroded area had to be repaired under loading and vibration.

Fig. 1 Corrosion in a bridge

Thinking of the heavy corrosion, method 3) was adopted in the repair using a by-pass member, which was to

carry the force that was carried by the part to be removed, during the repair. This repairing method is named «By-pass Method». Connections of the new part were of both welding and fastening with H. T. bolts; the lower flange was welded and the web was fastened with H. T. bolts.

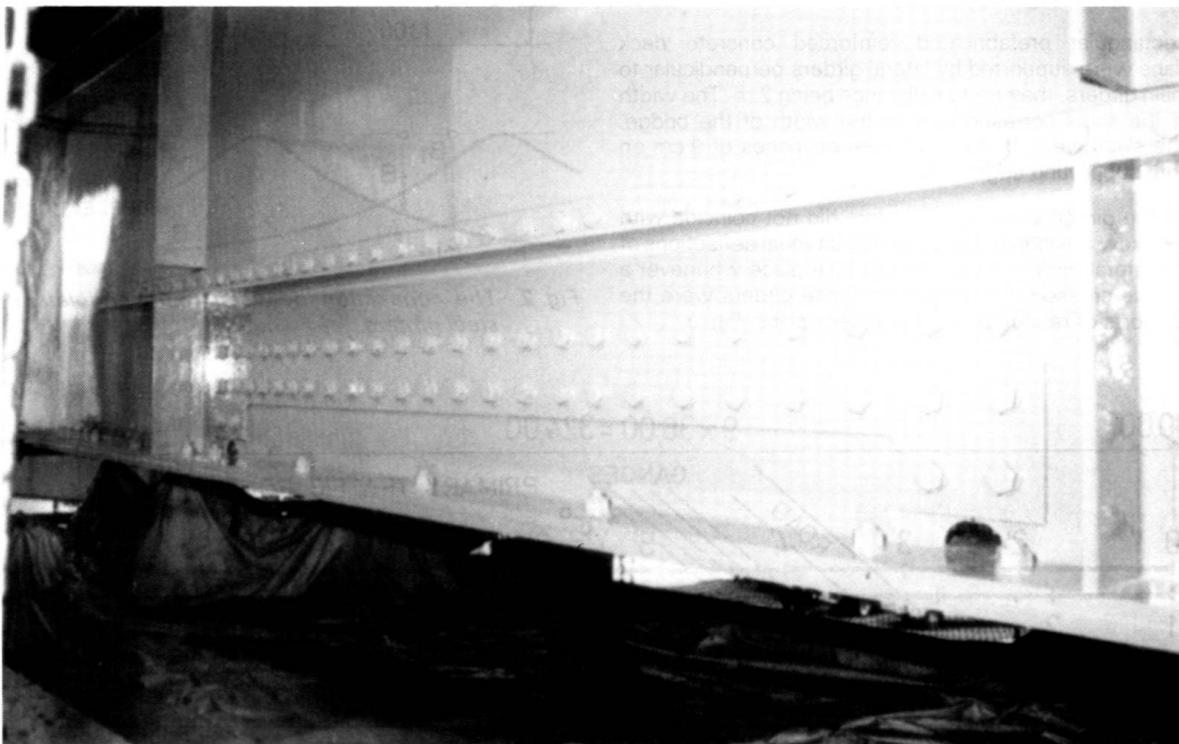
The repaired girder is shown in Fig. 3. The Technical Merit of Kansai Branch of JSCE was awarded for this work.

Fig. 3 Girder after remedy at site
