## 9. The Bridge in the Radnička Street in Belgrade (Yugoslavia)

**Owner:** *The City of Belgrade*  
**Designer:** *Construction: Directorate for Bridges, Belgrade*  
*Rehabilitation: University of Belgrade, Department of Civil Engineering*  
**Contractor:** *Construction and rehabilitation: Mostogradnja, Belgrade*  
**Date of construction:** 1968  
**Date of rehabilitation:** 1984

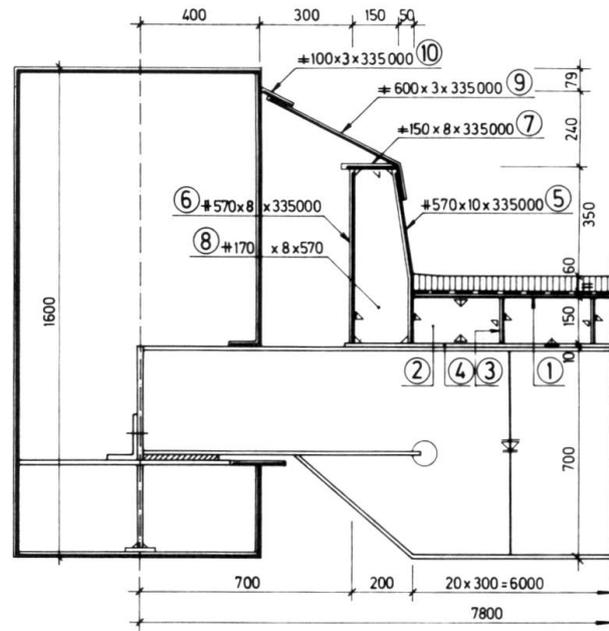
Fig. 4 The cross section of the bridge after rehabilitation

of the bridge so that the medium longitudinal seam was welded on the site. The connection of the orthotropic plate with the upper chord of the lateral girders was achieved by welding to the lower flange of the orthotropic plate, (Fig. 4).

Beside a correct engineering solution for the specific case, the application of the orthotropic steel plate achieved a decreased dead load of the structure which in the course of time proved very convenient for the increased live load.
