Artikel: The bridge in the Radnika Street in Belgrade (Yugoslavia)
Autor: Nenadi, G. / Pakvor, A. / Darijevi, Ž.
DOI: <https://doi.org/10.5169/seals-20928>

9. The Bridge in the Radnička Street in Belgrade (Yugoslavia)

Owner: The City of Belgrade
Designer: Construction: Directorate for Bridges, Belgrade
 Rehabilitation: University of Belgrade, Department of Civil Engineering
Contractor: Construction and rehabilitation: Mostogradnja, Belgrade
Date of construction: 1968
Date of rehabilitation: 1984

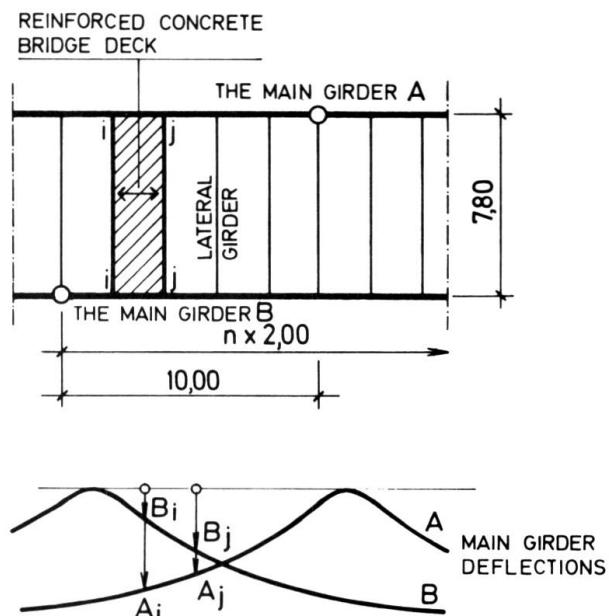
Fig. 2 The connection between main and lateral steel girders

The main box girder, lateral compound I beams, horizontal bracing and box columns are made of steel. The connection between the main and lateral steel girders is presented in Fig. 2.

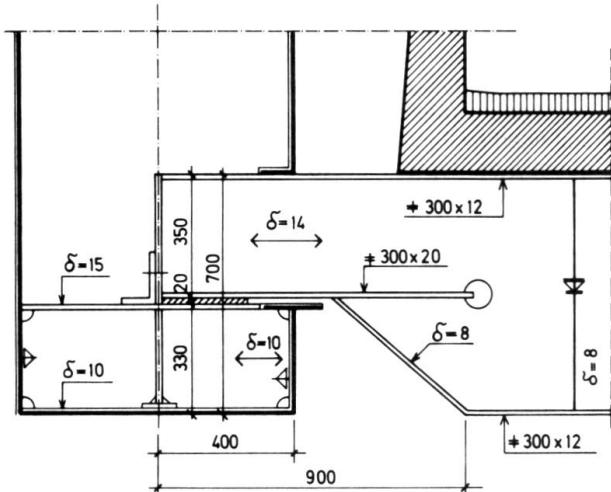
As the direction of lateral girders did not coincide with the skew position of the columns, unequal deflections of the lateral girders ends used to take place whenever a vehicle crossed the bridge and those girders were the supports of reinforced concrete deck slabs, Fig. 3.

The permitted movement of heavy vehicles by the right main girder only, still increased the unequal deflections of the lateral girders ends causing torsion and additional inconvenient stressing of reinforced concrete deck slabs.

Those slabs were connected to the upper chord of the lateral steel girders by pins anchored into the mass of concrete with four screws on both supporting edges. In the course of time, the connection was weakened and permanent damages of bridge decks above lateral girders took place. The lateral joints in asphaltic bridge deck, placed on each 2 m along the length of the bridge caused, beside uncomfortable drive, constant unforeseen dynamic impacts to the structure of the bridge. The repair of the bridge deck was practically impossible.

Fig. 3 Unequal deflections on lateral girders ends by which reinforced concrete deck slabs were supported
