9. The Bridge in the Radnička Street in Belgrade (Yugoslavia)

Owner: The City of Belgrade
Designer: Construction: Directorate for Bridges, Belgrade
 Rehabilitation: University of Belgrade, Department of Civil Engineering
Contractor: Construction and rehabilitation: Mostogradnja, Belgrade
Date of construction: 1968
Date of rehabilitation: 1984

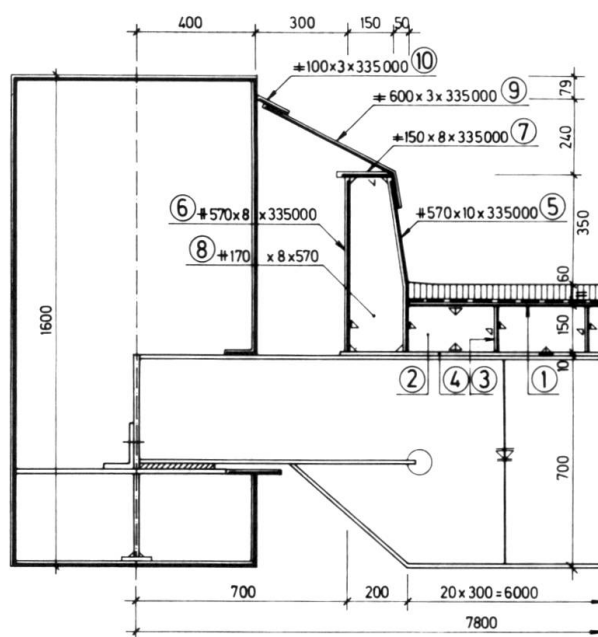
Fig. 4 The cross section of the bridge after rehabilitation

A relatively expensive but from the engineering point of view the most correct alternative solution was applied. The reinforced concrete bridge deck slabs were replaced by a orthotropic steel plate. However, due to the required minimum traffic brake and due to the existing connection between lateral and main girders, a modified orthotropic steel plate instead of the classical one was applied. Prefabricated, 10 m long assemblies of the orthotropic plate were delivered to the site and, in order to facilitate erection, their width was half the width

of the bridge so that the medium longitudinal seam was welded on the site. The connection of the orthotropic plate with the upper chord of the lateral girders was achieved by welding to the lower flange of the orthotropic plate, (Fig. 4).

Beside a correct engineering solution for the specific case, the application of the orthotropic steel plate achieved a decreased dead load of the structure which in the course of time proved very convenient for the increased live load.
