**Zeitschrift:** IABSE structures = Constructions AIPC = IVBH Bauwerke  
**Band:** 12 (1988)  
**Heft:** C-46: Repair and rehabilitation of bridges: case studies I

**Artikel:** Rehabilitation of Yamuna Bridge at Kairana (India)  
**Autor:** Manjure, P.Y. / Rohra, M.R.  
**DOI:** <https://doi.org/10.5169/seals-20929>

## 10. Rehabilitation of Yamuna Bridge at Kairana (India)

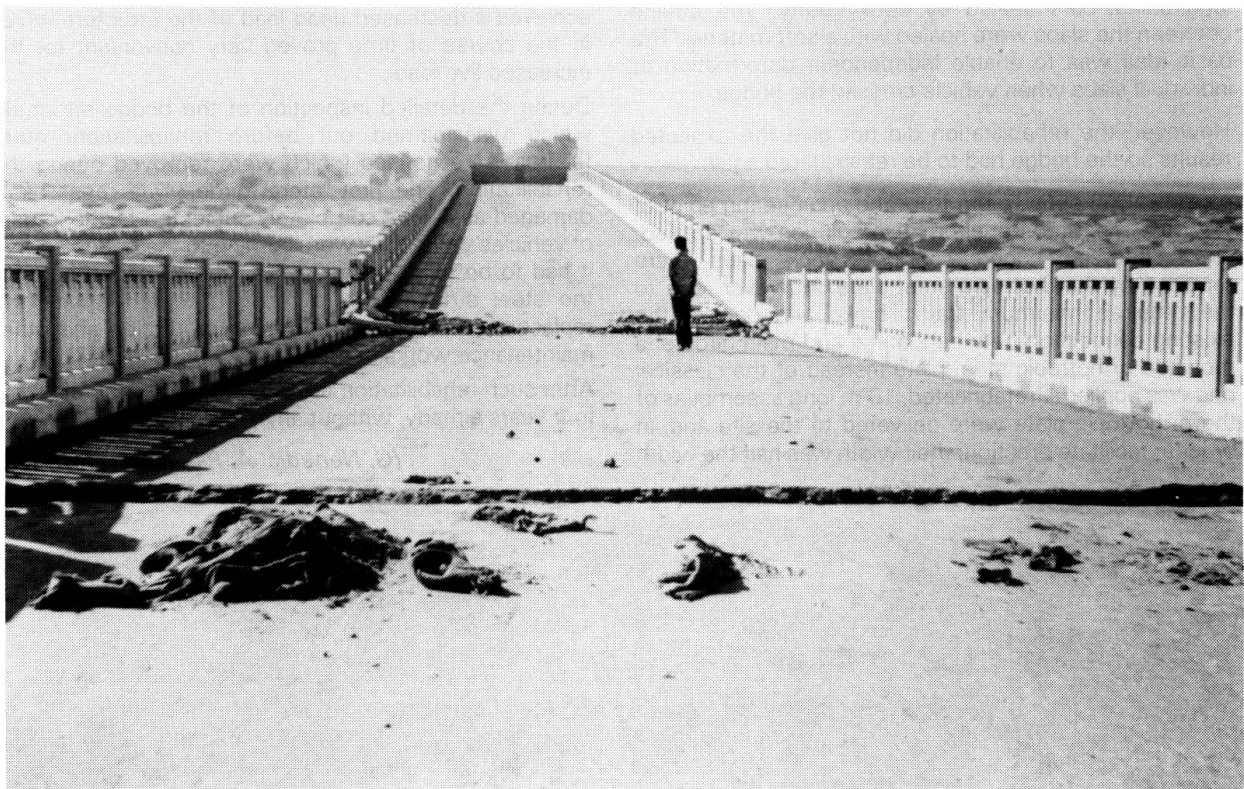
One well foundation (well No. 3) settled as well as tilted during the unprecedented floods in the year 1978. Water level rose above the design high flood level. The river had confined its course towards one bank of the bridge, causing excessive scour around well No. 3. Waterway

provided for the river was apparently excessive. Water flow was mainly confined in three spans out of total 10 spans. Moreover the water current was not at right angle to the bridge axis. This caused considerable scouring at one corner of the above well. It settled by 86 cms, and tilted by 1 in 42 in the longitudinal direction. Consequently, the top of Pier No. 3 supported on the affected well moved longitudinally by 86 cms. Single segmental roller bearings provided on Pier P3 toppled and box girder fell on collapsed bearings with an impact. Total settlement of box girder over pier was 1.34 metres, and at the lower most point of cantilever – 1.68 metres (see Fig. 1 and 2). The suspended spans supported on cantilever tips at either end of box girder also got tilted, one in downward and other one in upward direction. Rocker bearings provided at the other pier (No. 4) were not damaged or dislocated due to rotation of span. Some cracks developed in the webs of box girder as well as pier cap at the location of impact.

Fig. 1 Top view

It was decided to restore the bridge, as similar floods were not anticipated for a long period. Boulders in steel wire crates were dumped in the form of flexible garland around the affected well No. 3 to increase its stability and reduce the chances of further scour of bed. The pier was strengthened by concrete jacketing, so that it could withstand the loading in tilted position of well and pier.

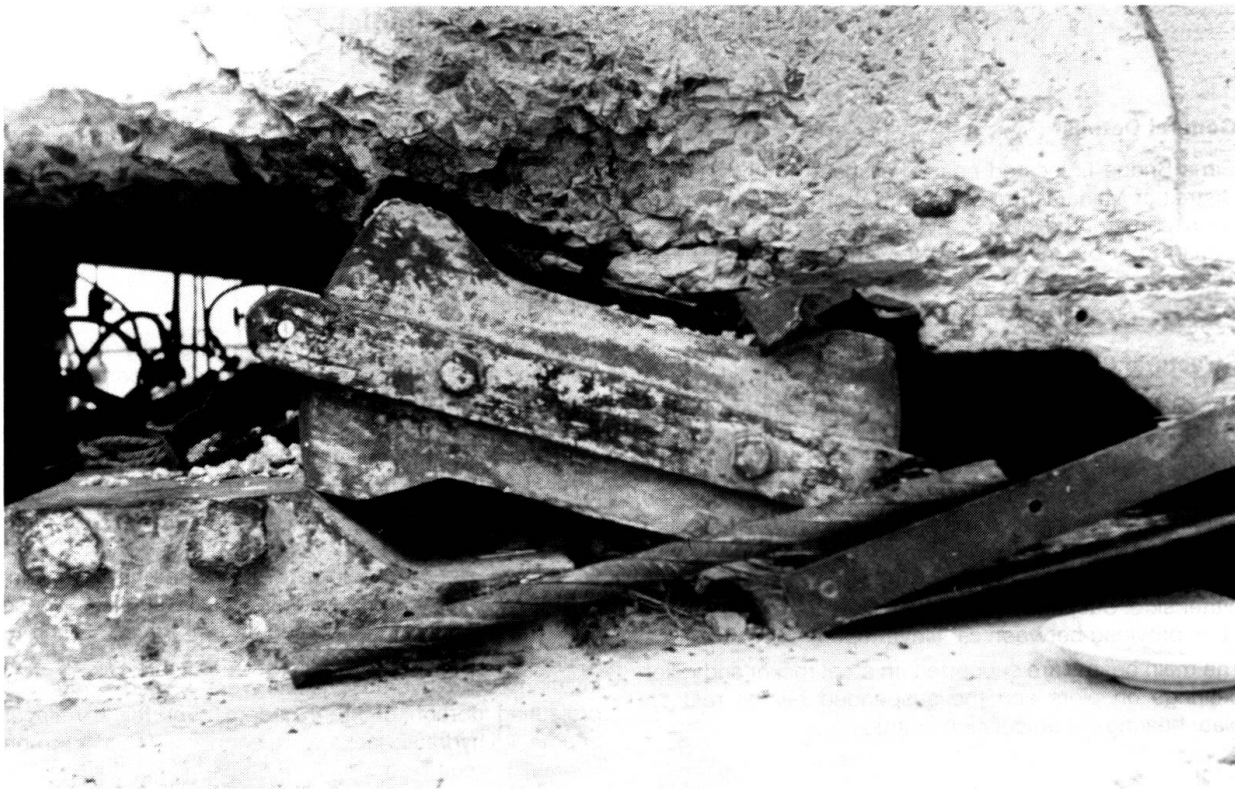
**Fig. 2** Position of segmental roller bearings

Tapered steel shims were used to cater for change in inclination of span over supports, during lifting operation. After bringing the span to the level position, the suspended spans were shifted longitudinally to their original position by use of Freyssinet flat jacks at the expansion joint positions.

ported, the new pier cap was concreted at the new higher level. Twin full roller bearings were provided for transfer of load of the span.

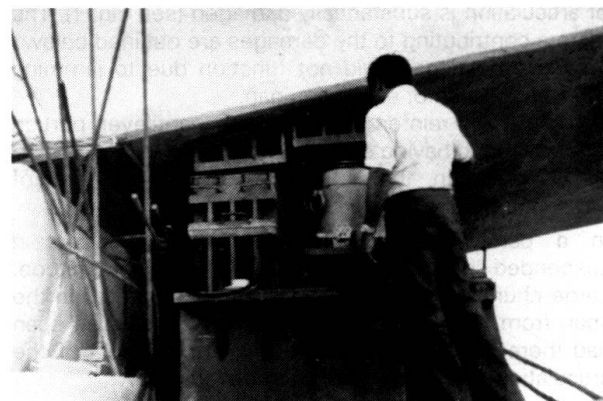
**Fig. 3** Lifting arrangement

The well cap was also strengthened. Six numbers steel supports were erected from the well cap for lifting of the box girder. Each box girder was provided with two lifting points, one on either side of the pier. The large diameter Hydraulic Jacks of 200 tonnes capacity with safety nut arrangement were used for lifting the weight of 800 tonnes. In addition to the jacks stand-by support points were provided. Steel packing was provided over these support points continuously during lifting operation.

Before commencement of lifting operation, all the cracks were injected with epoxy resins. The sloping suspended spans were properly held with the cantilever tips to prevent any undesirable movement during lifting operation. To achieve uniform reaction at all the lifting points, all the jacks were connected to a common hydraulic circuit. The soffit of box girder was sloping. Therefore, wedge shaped steel boxes were fixed to the soffit for getting level surface at lifting points. Lifting arrangement is shown in Fig. 3. Packing boxes of different heights were planned so as to have a minimum number of them in position at any given time.
