**Artikel:** Rehabilitation of Girna Bridge (India)  
**Autor:** Manjure, P.Y. / Rohra, M.R.  
**DOI:** <https://doi.org/10.5169/seals-20930>

## 11. Rehabilitation of Girna Bridge (India)

Girna Bridge is located near Chalisgaon town in Dhulia District of Maharashtra State on a State Highway. It has been constructed across river Girna by Public Works Department of Government of Maharashtra in the year 1965.

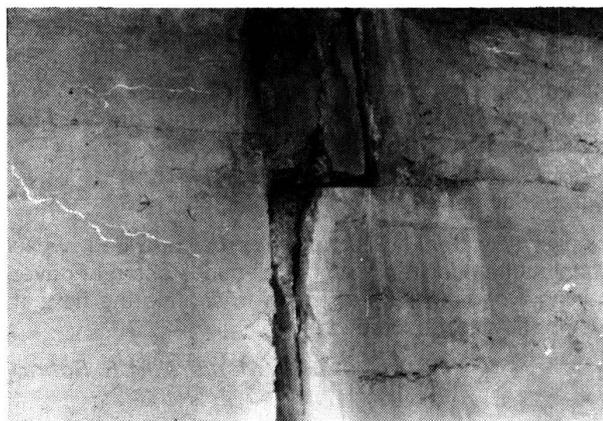
The distress mainly was in the superstructure. In the year 1980, it was observed that the concrete in the zone of articulation is substantially damaged (see Fig. 1). The factors contributing to the damages are outlined below:

- i) Plate bearings could not function due to jamming and absence of expansion gap.
- ii) The main reinforcement in the cantilever portion was found having excessive cover.
- iii) Concrete in the articulation zone was not of adequate quality.

In a particular span (No. 6), distress noticed in suspended span at articulation was of higher magnitude. Large chunks of concrete were found separated in the span from the cantilever tips and the suspended span had therefore settled by about 40 mm. In most of the articulation tips, wide cracks had developed.

Fig. 1 Distress at articulation

Replacement of steel plate bearings by Neoprene Bearings and repairs to damaged concrete portion at the articulation were considered essential. For this purpose, it was necessary to lift the suspended spans and re-concrete the cantilever tips. Lifting of suspended spans was required to be done from the deck level since height of the superstructure was about 15 metres from river bed (see Fig. 2).

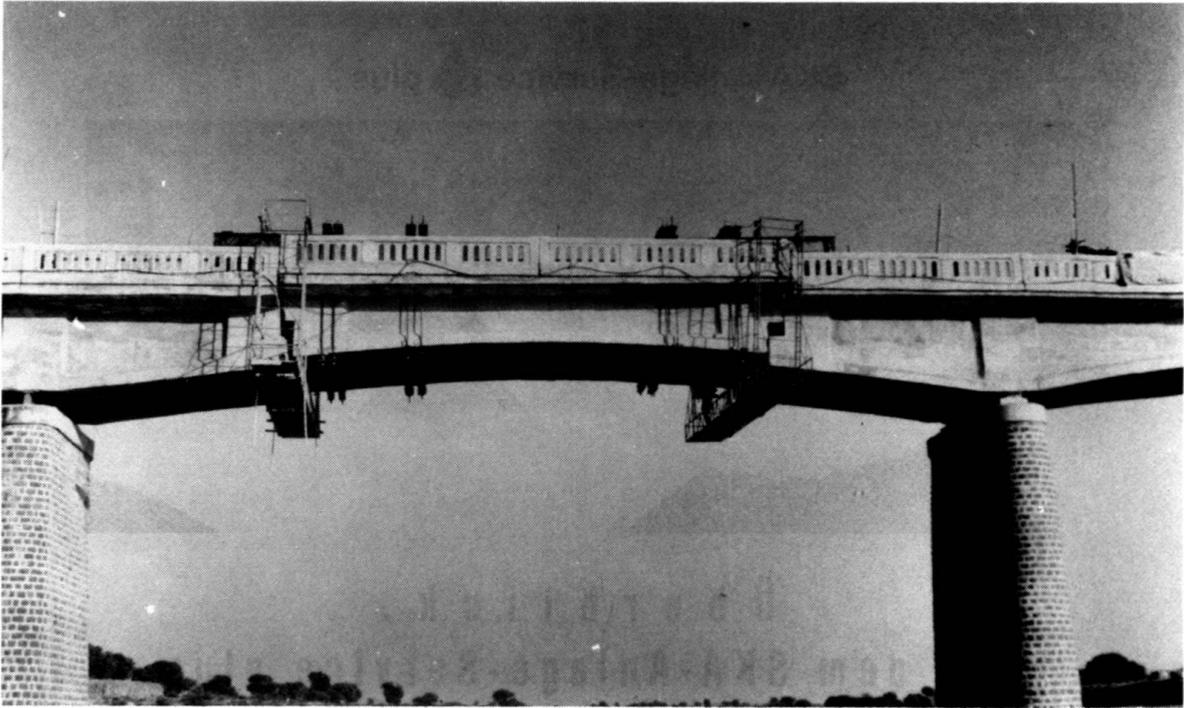
*Fig. 2 Lifting arrangement for suspended span*

Fabricated steel girders were placed in line with reinforced concrete beams over articulation portion. These steel girders were connected to reinforced concrete beams by means of Alloy steel suspenders at two locations. The hydraulic jacks were placed under the projecting portion of steel girders over the cantilever beams. All hydraulic jacks were connected to a common hydraulic circuit.

Lifting of the suspended span could be achieved by pressurizing the hydraulic circuit. It was possible to obtain almost uniform lifting, by controlling the valves on the circuitry. The span was raised by about 40 cms. Specially fabricated light weight platform was suspended from the deck for providing access to the articulation zone. Damaged concrete was removed by using pneumatic tools. Additional reinforcement was welded to the existing reinforcement (see Fig. 3) and re-concreting was done by using epoxy bond layer at the interface of old and new concrete. At this face, subsequently, epoxy was injected through the inlets provided at the time of concreting.

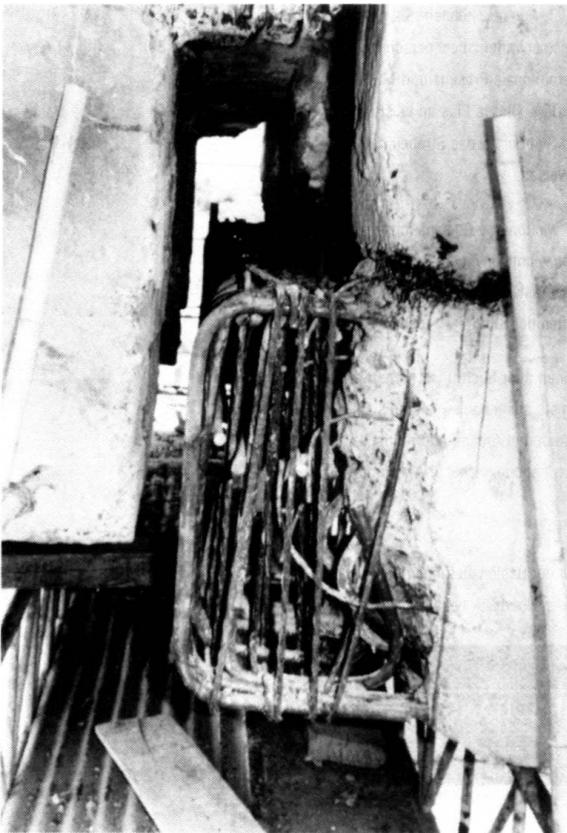
*Fig. 3 Cantilever tip is broken and additional reinforcement is provided*

In one span, external prestressing rods were provided to prevent separation of old concrete to new concrete besides other measures.
