11. Rehabilitation of Girna Bridge (India)

General Details

Girna Bridge is located near Chalisgaon town in Dhulia District of Maharashtra State on a State Highway. It has been constructed across river Girna by Public Works Department of Government of Maharashtra in the year 1965.

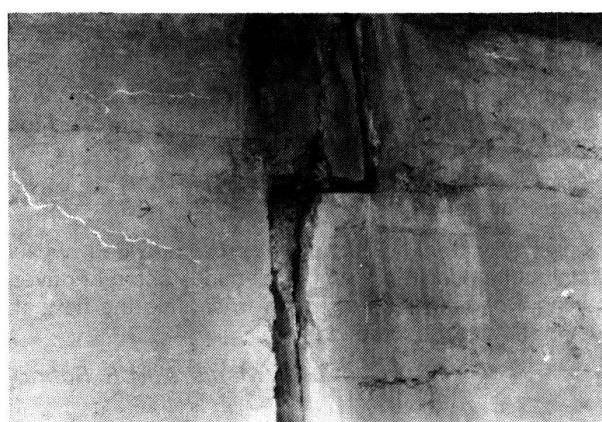
The distress mainly was in the superstructure. In the year 1980, it was observed that the concrete in the zone of articulation is substantially damaged (see Fig. 1). The factors contributing to the damages are outlined below:

- i) Plate bearings could not function due to jamming and absence of expansion gap.
- ii) The main reinforcement in the cantilever portion was found having excessive cover.
- iii) Concrete in the articulation zone was not of adequate quality.

In a particular span (No. 6), distress noticed in suspended span at articulation was of higher magnitude. Large chunks of concrete were found separated in the span from the cantilever tips and the suspended span had therefore settled by about 40 mm. In most of the articulation tips, wide cracks had developed.

Fig. 1 Distress at articulation

Replacement of steel plate bearings by Neoprene Bearings and repairs to damaged concrete portion at the articulation were considered essential. For this purpose, it was necessary to lift the suspended spans and re-concrete the cantilever tips. Lifting of suspended spans was required to be done from the deck level since height of the superstructure was about 15 metres from river bed (see Fig. 2).

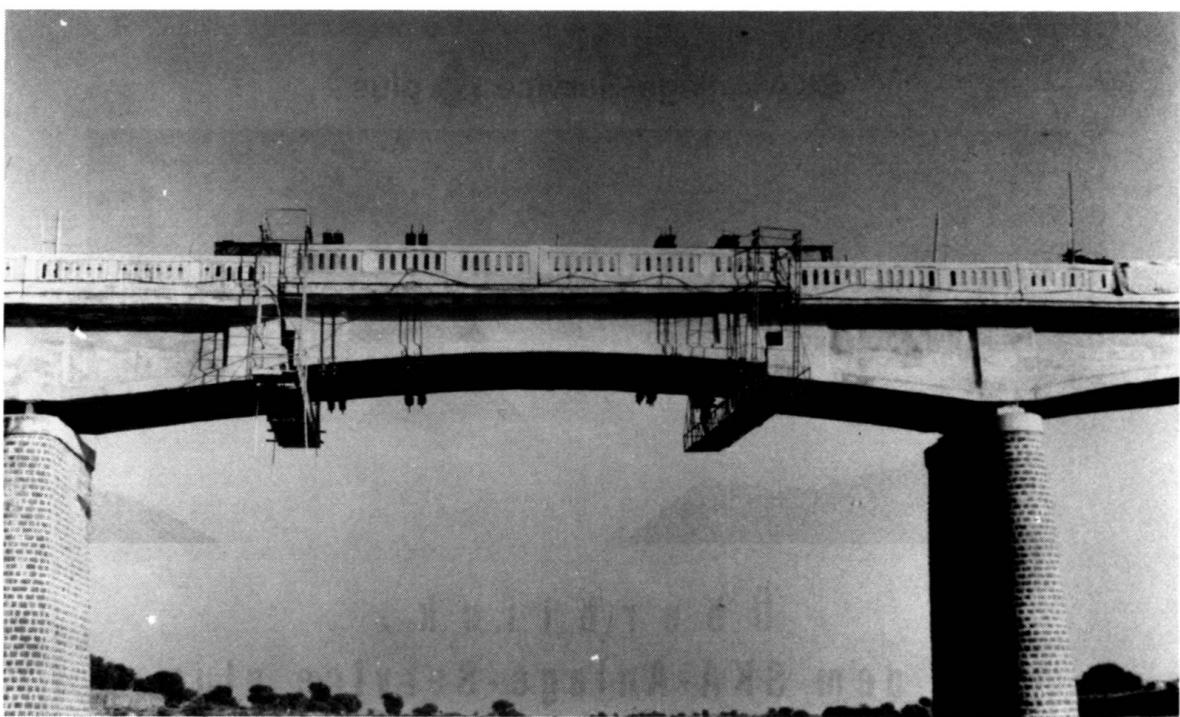
Fig. 2 Lifting arrangement for suspended span

Fabricated steel girders were placed in line with reinforced concrete beams over articulation portion. These steel girders were connected to reinforced concrete beams by means of Alloy steel suspenders at two locations. The hydraulic jacks were placed under the projecting portion of steel girders over the cantilever beams. All hydraulic jacks were connected to a common hydraulic circuit.

Lifting of the suspended span could be achieved by pressurizing the hydraulic circuit. It was possible to obtain almost uniform lifting, by controlling the valves on the circuitry. The span was raised by about 40 cms. Specially fabricated light weight platform was suspended from the deck for providing access to the articulation zone. Damaged concrete was removed by using pneumatic tools. Additional reinforcement was welded to the existing reinforcement (see Fig. 3) and re-concreting was done by using epoxy bond layer at the interface of old and new concrete. At this face, subsequently, epoxy was injected through the inlets provided at the time of concreting.

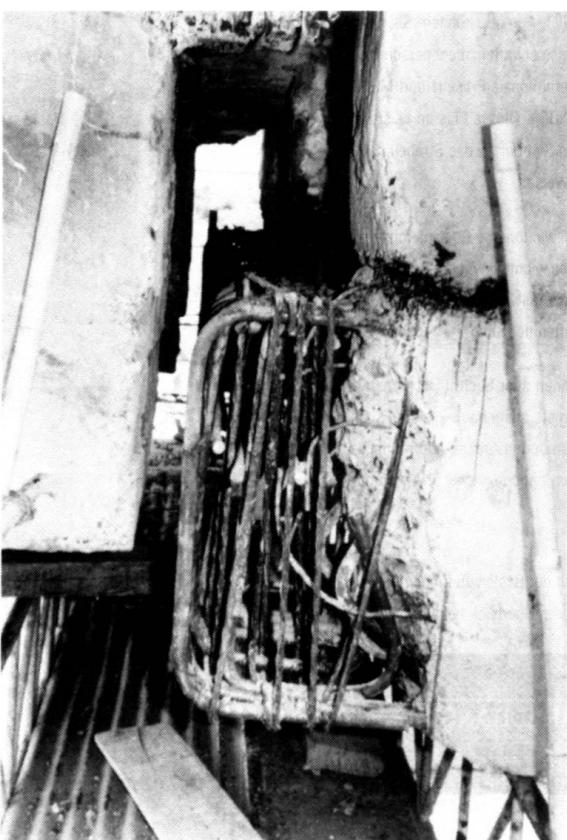
Fig. 3 Cantilever tip is broken and additional reinforcement is provided

In one span, external prestressing rods were provided to prevent separation of old concrete to new concrete besides other measures.

Neoprene Bearings were placed in position and the span was lowered onto these bearings after the new concrete has attained minimum strength for dead load reaction. The prestressing rods were grouted after 3 months or so, to enable monitoring at articulation during this period. These rods were restressed to make up slight loss of prestress and then grouting was carried out.
