Artikel: Rehabilitation of Girna Bridge (India)
Autor: Manjure, P.Y. / Rohra, M.R.
DOI: <https://doi.org/10.5169/seals-20930>

11. Rehabilitation of Girna Bridge (India)

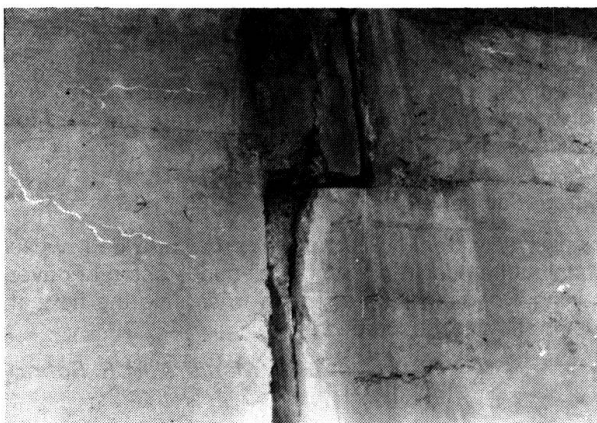
The distress mainly was in the superstructure. In the year 1980, it was observed that the concrete in the zone of articulation is substantially damaged (see Fig. 1). The factors contributing to the damages are outlined below:

- i) Plate bearings could not function due to jamming and absence of expansion gap.
- ii) The main reinforcement in the cantilever portion was found having excessive cover.
- iii) Concrete in the articulation zone was not of adequate quality.

In a particular span (No. 6), distress noticed in suspended span at articulation was of higher magnitude. Large chunks of concrete were found separated in the span from the cantilever tips and the suspended span had therefore settled by about 40 mm. In most of the articulation tips, wide cracks had developed.

Fig. 1 Distress at articulation

Replacement of steel plate bearings by Neoprene Bearings and repairs to damaged concrete portion at the articulation were considered essential. For this purpose, it was necessary to lift the suspended spans and re-concrete the cantilever tips. Lifting of suspended spans was required to be done from the deck level since height of the superstructure was about 15 metres from river bed (see Fig. 2).

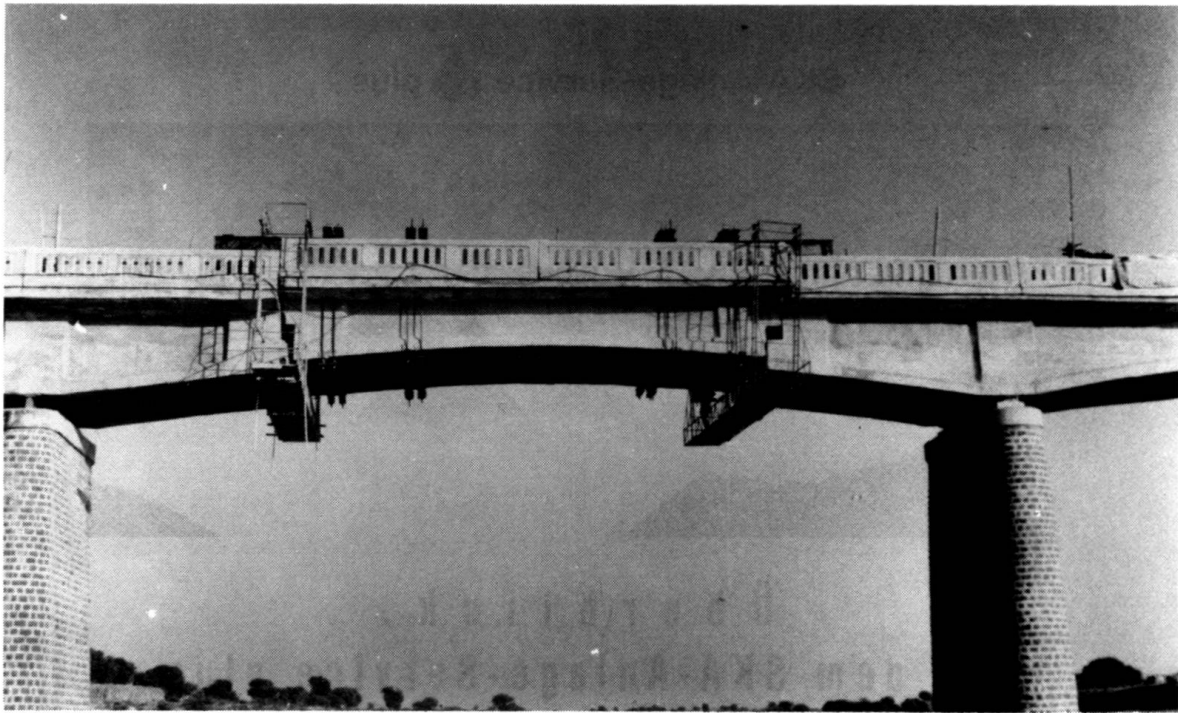
Fig. 2 Lifting arrangement for suspended span

Fabricated steel girders were placed in line with reinforced concrete beams over articulation portion. These steel girders were connected to reinforced concrete beams by means of Alloy steel suspenders at two locations. The hydraulic jacks were placed under the projecting portion of steel girders over the cantilever beams. All hydraulic jacks were connected to a common hydraulic circuit.

Lifting of the suspended span could be achieved by pressurizing the hydraulic circuit. It was possible to obtain almost uniform lifting, by controlling the valves on the circuitry. The span was raised by about 40 cms. Specially fabricated light weight platform was suspended from the deck for providing access to the articulation zone. Damaged concrete was removed by using pneumatic tools. Additional reinforcement was welded to the existing reinforcement (see Fig. 3) and re-concreting was done by using epoxy bond layer at the interface of old and new concrete. At this face, subsequently, epoxy was injected through the inlets provided at the time of concreting.

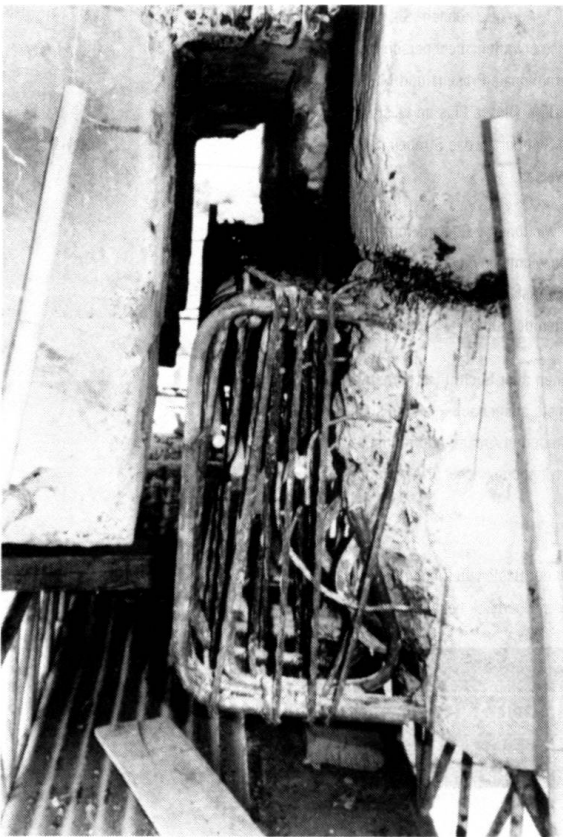
Fig. 3 Cantilever tip is broken and additional reinforcement is provided
