**Artikel:** Repair of scoured substructure (Japan)  
**Autor:** Morinaga, Norio  
**DOI:** <https://doi.org/10.5169/seals-20932>

## 2. Repair of Scoured Substructure (Japan)

## Case 1 Reinforcement with piles; Iwaide Bridge, Wakayama

## Case 2 Repair by reinforced concrete lining; Natori Bridge, Miyagi

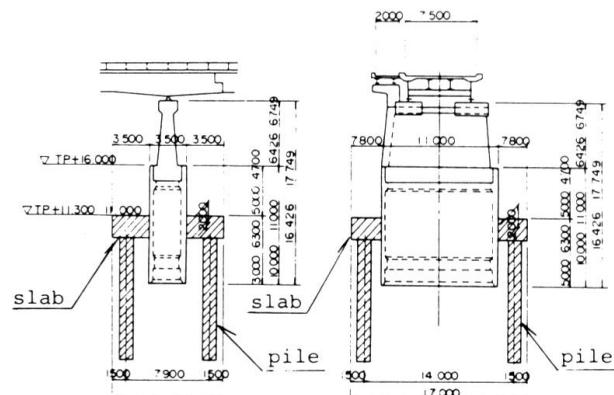
Fig. 2 Repair method (Iwaide Bridge)

The substructure has been scoured to a depth of 4 m average up to 6 m maximum from the effects of dredged riverbed and embankment located upstream. In the worst case, the depth of embedment was reduced to 5 m from the original 11 m. To prevent a further decrease, measures were taken in 1970 by temporarily placing protection blocks. Then in 1979 the caissons were checked again for its stability. To completely solve the problem, the substructure was reinforced by underpinning and constructing a new slab connected with the existing caisson. The repair job was performed on 7 heavily scoured substructures among a total number of 12.

For reinforcement of caisson with reduced depth of embedment, a cast in place pile method was chosen for underpinning, under consideration of geologic condition, clearance below girder during work an economy.

With the cast in place piles, four Benoto piles of 1.5 m diameter and 11.5 m length were placed at four sides of the caisson. The caisson and piles were connected by placing a 2 m thick slab on top to make a new footing (Fig. 2 and 3). To determine the dimension of slab and piles, the structure was analysed to resist working forces together with the existing bridge. The caisson and slab was connected by having the upper and lower steel reinforcements from the slab of 29 mm diameter and 3.5 m length embedded 30 cm deep with resin into the sides of the caisson.

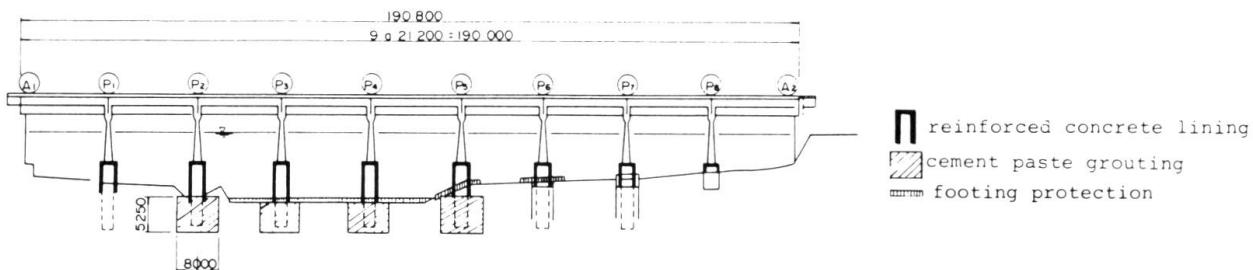
Fig. 4 Location of repair (Natori Bridge)

The Natori bridge, completed in 1932, has 190.8 m bridge length and 7.5 m road width (Fig. 4). The superstructure is a 9 span steel plate simple girder. The substructure consists of a rigid frame reinforced concrete pier and caisson.

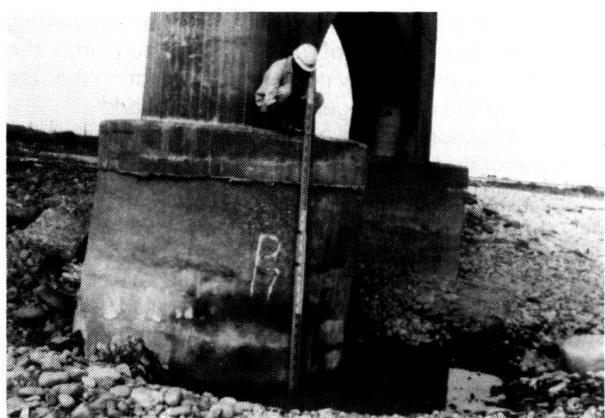
Fig. 6. Before repair (Natori Bridge)

- 1) Exposed steel reinforcements at top of the caisson.
- 2) Bridge pier endangered of toppling due to scouring at the caisson causing differential settlement and loss of strength in the surrounding foundation.
- 3) The connection between caisson and pier has been deteriorated from shear force.
- 4) Furthermore, due to its old design, its ability to resist today's load has been questioned.
