Artikel: Repair of scoured substructure (Japan)
Autor: Morinaga, Norio
DOI: <https://doi.org/10.5169/seals-20932>

2. Repair of Scoured Substructure (Japan)

Case 1 Reinforcement with piles; Iwaide Bridge, Wakayama

Case 2 Repair by reinforced concrete lining; Natori Bridge, Miyagi

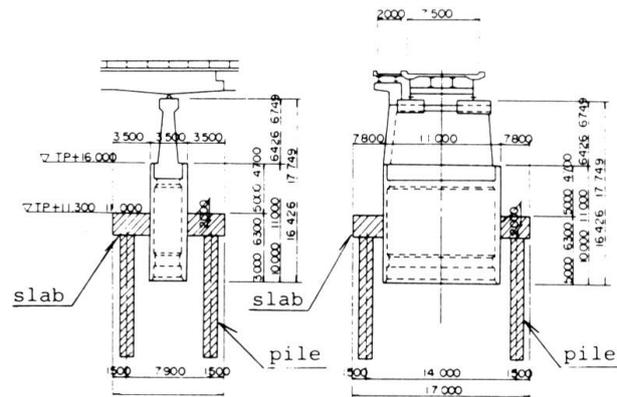
Fig. 2 Repair method (Iwaide Bridge)

The substructure has been scoured to a depth of 4 m average up to 6 m maximum from the effects of dredged riverbed and embankment located upstream. In the worst case, the depth of embedment was reduced to 5 m from the original 11 m. To prevent a further decrease, measures were taken in 1970 by temporarily placing protection blocks. Then in 1979 the caissons were checked again for its stability. To completely solve the problem, the substructure was reinforced by underpinning and constructing a new slab connected with the existing caisson. The repair job was performed on 7 heavily scoured substructures among a total number of 12.

For reinforcement of caisson with reduced depth of embedment, a cast in place pile method was chosen for underpinning, under consideration of geologic condition, clearance below girder during work an economy.

With the cast in place piles, four Benoto piles of 1.5 m diameter and 11.5 m length were placed at four sides of the caisson. The caisson and piles were connected by placing a 2 m thick slab on top to make a new footing (Fig. 2 and 3). To determine the dimension of slab and piles, the structure was analysed to resist working forces together with the existing bridge. The caisson and slab was connected by having the upper and lower steel reinforcements from the slab of 29 mm diameter and 3.5 m length embedded 30 cm deep with resin into the sides of the caisson.

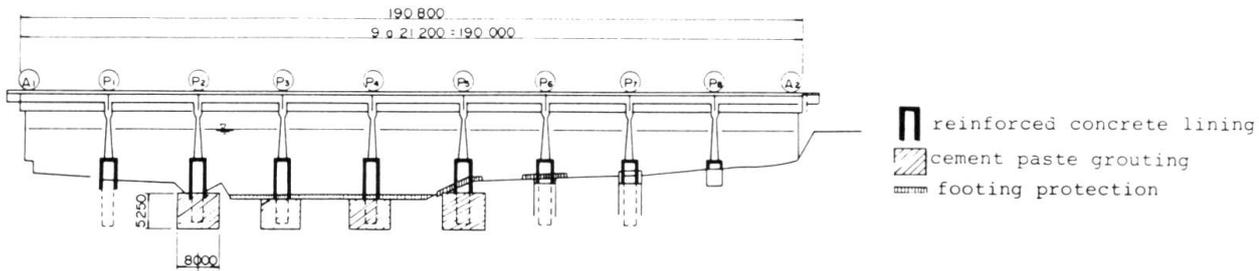
Fig. 4 Location of repair (Natori Bridge)

The Natori bridge, completed in 1932, has 190.8 m bridge length and 7.5 m road width (Fig. 4). The superstructure is a 9 span steel plate simple girder. The substructure consists of a rigid frame reinforced concrete pier and caisson.

The substructure on this bridge was repaired due to the following problems:

- 1) Exposed steel reinforcements at top of the caisson.
- 2) Bridge pier endangered of toppling due to scouring at the caisson causing differential settlement and loss of strength in the surrounding foundation.
- 3) The connection between caisson and pier has been deteriorated from shear force.
- 4) Furthermore, due to its old design, its ability to resist today's load has been questioned.
