Zeitschrift: IABSE structures = Constructions AIPC = IVBH Bauwerke
Band: 12 (1988)
Heft: C-47: Repair and rehabilitation of bridges: case studies II

Artikel: Repair of scoured substructure (Japan)
Autor: Morinaga, Norio
DOI: <https://doi.org/10.5169/seals-20932>

Case 2 Repair by reinforced concrete lining; Natori Bridge, Miyagi

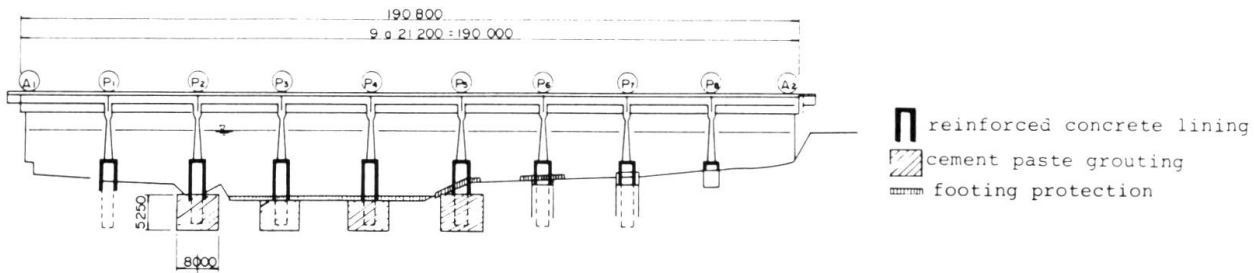
Fig. 4 Location of repair (Natori Bridge)

The Natori bridge, completed in 1932, has 190.8 m bridge length and 7.5 m road width (Fig. 4). The superstructure is a 9 span steel plate simple girder. The substructure consists of a rigid frame reinforced concrete pier and caisson.

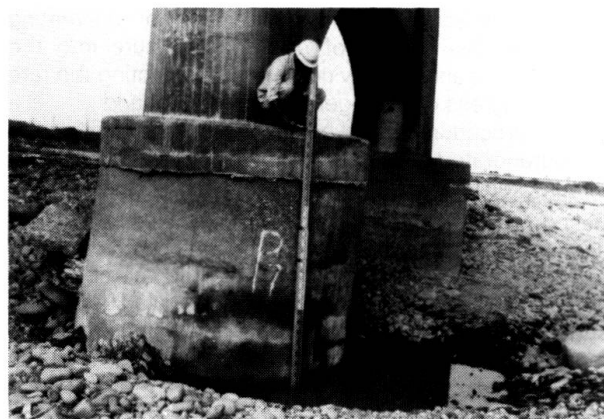
Fig. 6 Before repair (Natori Bridge)

The substructure on this bridge was repaired due to the following problems:

- 1) Exposed steel reinforcements at top of the caisson.
- 2) Bridge pier endangered of toppling due to scouring at the caisson causing differential settlement and loss of strength in the surrounding foundation.
- 3) The connection between caisson and pier has been deteriorated from shear force.
- 4) Furthermore, due to its old design, its ability to resist today's load has been questioned.
