**Artikel:** Repair of scoured substructure (Japan)  
**Autor:** Morinaga, Norio  
**DOI:** <https://doi.org/10.5169/seals-20932>

## Case 2 Repair by reinforced concrete lining; Natori Bridge, Miyagi

**Owner:** Ministry of Construction  
**Contractor:** Endo Construction  
**Work's duration:** phase 1: 5 months,  
phase 2: 2 years and 1 month  
**Date of repair:** phase 1: 1974 – 1975  
phase 2: 1981 – 1983

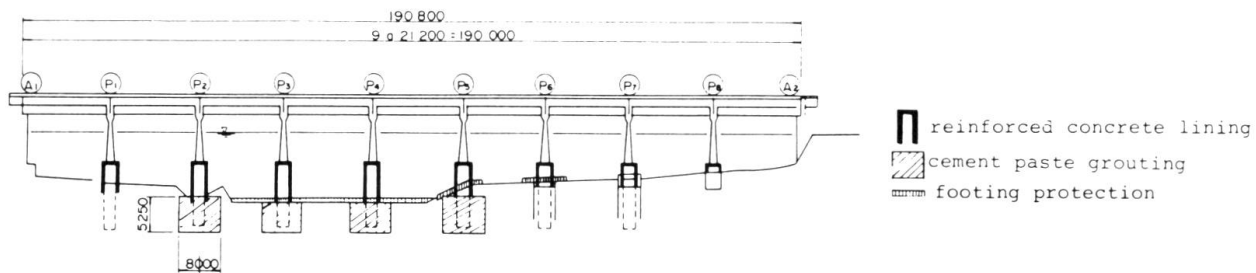
Fig. 4 Location of repair (Natori Bridge)

The Natori bridge, completed in 1932, has 190.8 m bridge length and 7.5 m road width (Fig. 4). The superstructure is a 9 span steel plate simple girder. The substructure consists of a rigid frame reinforced concrete pier and caisson.

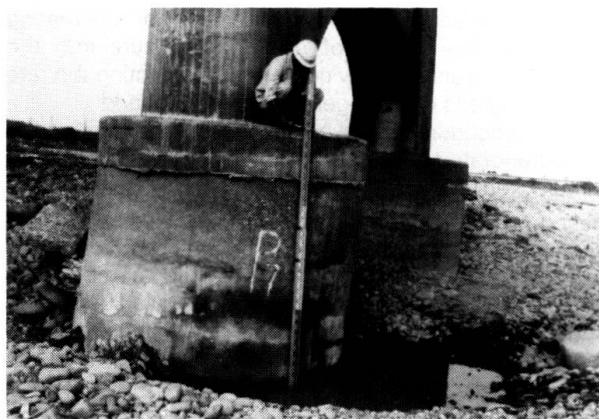
Fig. 6 Before repair (Natori Bridge)

- 1) Exposed steel reinforcements at top of the caisson.
- 2) Bridge pier endangered of toppling due to scouring at the caisson causing differential settlement and loss of strength in the surrounding foundation.
- 3) The connection between caisson and pier has been deteriorated from shear force.
- 4) Furthermore, due to its old design, its ability to resist today's load has been questioned.
