### 3. Rehabilitation of Prestressed Concrete Bridge Deteriorated by Salt (Japan)

#### Case 1 Nadachi Bridge, Niigata

## Case 2 Oyataroh Bridge, Miyazaki

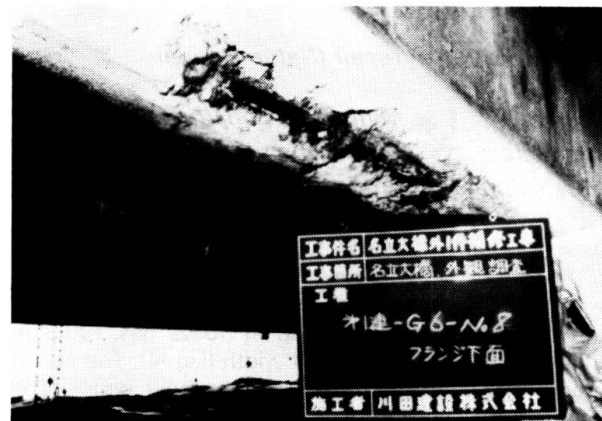
According to inspection test carried out in 1982, cracks and stripping were discovered mainly along the longitudinal reinforcements of the main girder lower flange. Corrosion seepage from these cracks and stripping were noticed at many places. These are the typical characteristics of damages on most concrete structures in the area affected by blown salt.

Fig. 1 Deterioration of flange (Nadachi Bridge)

In the actual rehabilitation procedure, the cracked concrete portions, portions with corrosion seepage and stripped portions (these areas have lost their strength and were acting only as loads on defected girders) were removed, then salt and debris stuck to the surface of steel members and concrete were removed by sand-blasting. In addition, a modified epoxy resin paint was applied to the surface of steel reinforcements and cables, then the concrete that was lost was restored.

Epoxy resins were used for rehabilitating the concrete. Porous concrete surfaces and uneven portions were corrected by epoxy resin mortar mixed with sand; to make a good surface for paints. Epoxy resin prepacked concrete method was adopted for continuous or large sections that had fallen off. In this case formwork was attached and filled with dry aggregate and then epoxy resin grout was applied.

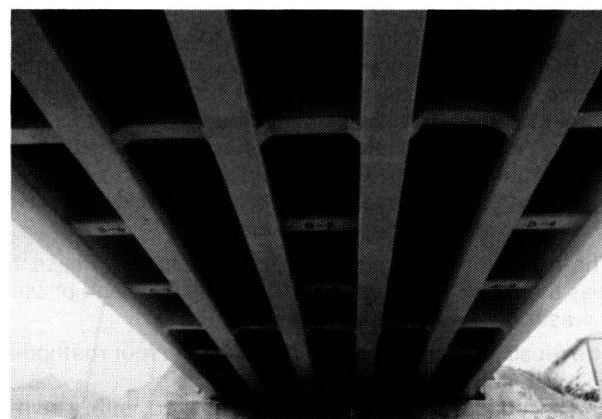
Fig. 2 After repair (Nadachi Bridge)

Upon completion of the rehabilitation of sections performed as stated above, an anti-corrosive paint was applied to prevent corrosive materials from penetrating.

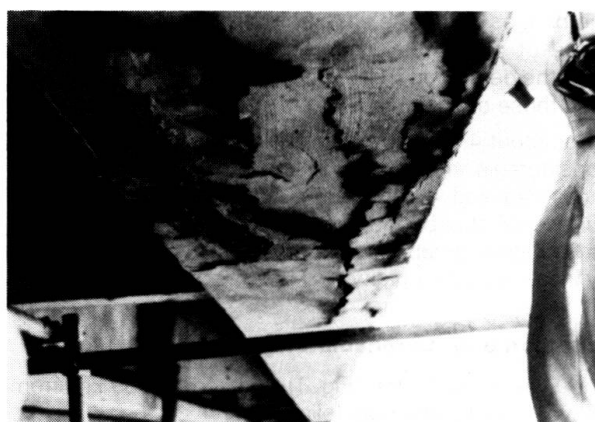
The inspection carried out in 1985 revealed damages typical of salt deterioration such as cracked concrete along the transverse reinforcement at the lower flange of main girders, concrete stripping and rust. Furthermore, inspection by breaking the concrete revealed that in some cases 2 cables were broken among the 12 cables that are used.

Fig. 3 Crack at lower flange (Oyataroh Bridge)

The same repair method was applied as for Nadachi bridge. Cracked or stripped concrete areas were removed, sandblasted, resin paint applied on steel and concrete restored to its original dimension with epoxy resin mortar by the prepacked concrete method. To repair broken cables, reinforcement methods by adding external cables were studied. Considering the present traffic and other conditions of this bridge, it was decided that the present strength is sufficient and that further reinforcement will not be needed.

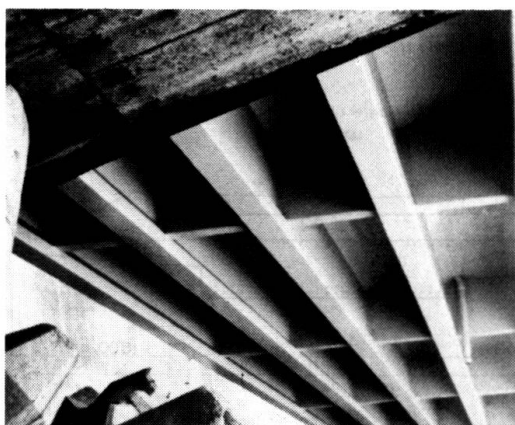
Fig. 4 After repair (Oyataroh Bridge)

The anti-corrosive paint applied is as follows: the first coat is epoxy resin primer; second, third and fourth coat is polybutadien resin paint; finish coat is polyurethane resin.
