Artikel: Rehabilitation of prestressed concrete bridge deteriorated by salt (Japan)

3. Rehabilitation of Prestressed Concrete Bridge Deteriorated by Salt (Japan)

Case 1 Nadachi Bridge, Niigata

Case 2 Oyataroh Bridge, Miyazaki

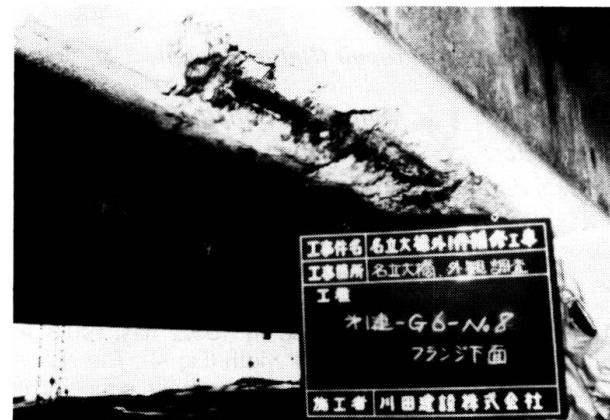
According to inspection test carried out in 1982, cracks and stripping were discovered mainly along the longitudinal reinforcements of the main girder lower flange. Corrosion seepage from these cracks and stripping were noticed at many places. These are the typical characteristics of damages on most concrete structures in the area affected by blown salt.

Fig. 1 Deterioration of flange (Nadachi Bridge)

In the actual rehabilitation procedure, the cracked concrete portions, portions with corrosion seepage and stripped portions (these areas have lost their strength and were acting only as loads on defected girders) were removed, then salt and debris stuck to the surface of steel members and concrete were removed by sandblasting. In addition, a modified epoxy resin paint was applied to the surface of steel reinforcements and cables, then the concrete that was lost was restored.

Epoxy resins were used for rehabilitating the concrete. Porous concrete surfaces and uneven portions were corrected by epoxy resin mortar mixed with sand; to make a good surface for paints. Epoxy resin prepakced concrete method was adopted for continuous or large sections that had fallen off. In this case formwork was attached and filled with dry aggregate and then epoxy resin grout was applied.

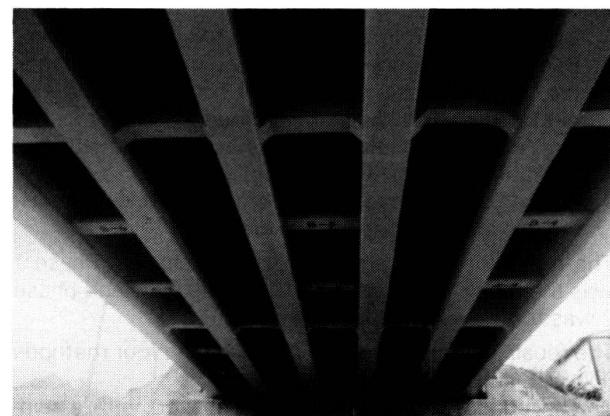
Fig. 2 After repair (Nadachi Bridge)

Upon completion of the rehabilitation of sections performed as stated above, an anti-corrosive paint was applied to prevent corrosive materials from penetrating.

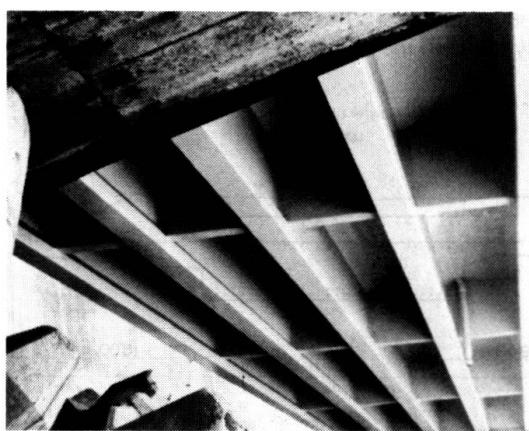
Fig. 4 After repair (Oyataroh Bridge)

The same repair method was applied as for Nadachi bridge. Cracked or stripped concrete areas were removed, sandblasted, resin paint applied on steel and concrete restored to its original dimension with epoxy resin mortar by the prepacked concrete method. To repair broken cables, reinforcement methods by adding external cables were studied. Considering the present traffic and other conditions of this bridge, it was decided that the present strength is sufficient and that further reinforcement will not be needed.

The anti-corrosive paint applied is as follows: the first coat is epoxy resin primer; second, third and fourth coat is polybutadien resin paint; finish coat is polyurethane resin.
