Rehabilitation of prestressed concrete bridge deteriorated by salt (Japan)

3. Rehabilitation of Prestressed Concrete Bridge Deteriorated by Salt (Japan)

Case 1 Nadachi Bridge, Niigata

Case 2 Oyataroh Bridge, Miyazaki

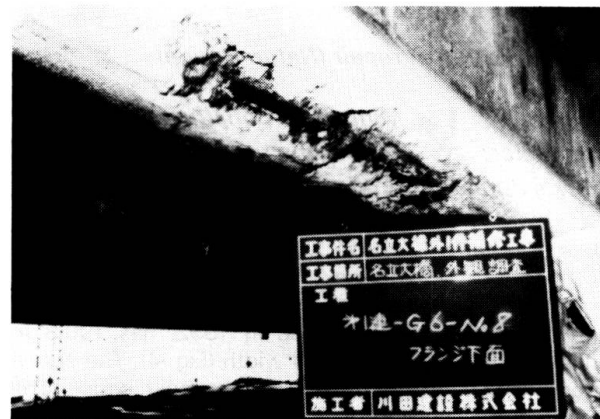
According to inspection test carried out in 1982, cracks and stripping were discovered mainly along the longitudinal reinforcements of the main girder lower flange. Corrosion seepage from these cracks and stripping were noticed at many places. These are the typical characteristics of damages on most concrete structures in the area affected by blown salt.

Fig. 1 Deterioration of flange (Nadachi Bridge)

In the actual rehabilitation procedure, the cracked concrete portions, portions with corrosion seepage and stripped portions (these areas have lost their strength and were acting only as loads on defected girders) were removed, then salt and debris stuck to the surface of steel members and concrete were removed by sand-blasting. In addition, a modified epoxy resin paint was applied to the surface of steel reinforcements and cables, then the concrete that was lost was restored.

Epoxy resins were used for rehabilitating the concrete. Porous concrete surfaces and uneven portions were corrected by epoxy resin mortar mixed with sand; to make a good surface for paints. Epoxy resin prepacked concrete method was adopted for continuous or large sections that had fallen off. In this case formwork was attached and filled with dry aggregate and then epoxy resin grout was applied.

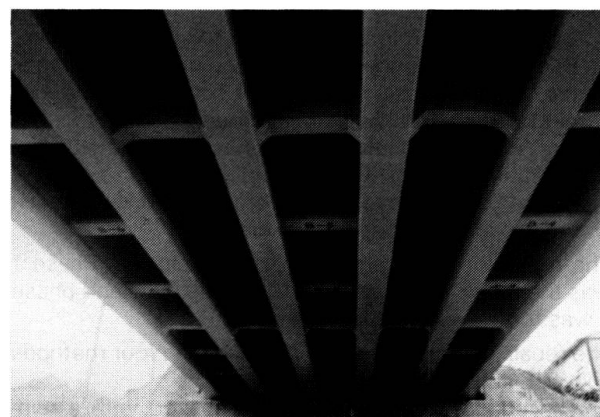
Fig. 2 After repair (Nadachi Bridge)

Upon completion of the rehabilitation of sections performed as stated above, an anti-corrosive paint was applied to prevent corrosive materials from penetrating.

In applying anti-corrosive paints to these concrete structures having the normal surfaces not treated with paint, there were many unknown points, and it was thought to be important to conduct a research on the suitable kinds of anti-corrosive paints. Thus, four kinds of paints shown in Table 1 were applied to the rehabilitated bridge. Generally, for a structure into which salt has already penetrated, the salinity will vary depending on the location of the portion to be painted, so that the effect of painted material varies by the location. Thus the effect at different places cannot be compared on the same basis. Therefore, concrete slabs painted with four different kinds of paints and unpainted concrete slabs were exposed below this bridge (Fig. 1 and 2).

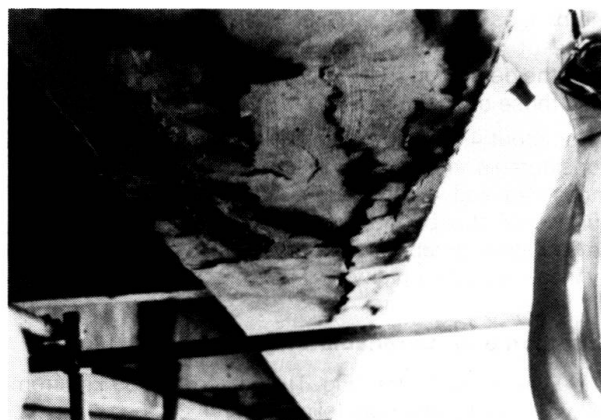
The inspection carried out in 1985 revealed damages typical of salt deterioration such as cracked concrete along the transverse reinforcement at the lower flange of main girders, concrete stripping and rust. Furthermore, inspection by breaking the concrete revealed that in some cases 2 cables were broken among the 12 cables that are used.

Fig. 3 Crack at lower flange (Oyataroh Bridge)

The same repair method was applied as for Nadachi bridge. Cracked or stripped concrete areas were removed, sandblasted, resin paint applied on steel and concrete restored to its original dimension with epoxy resin mortar by the prepacked concrete method. To repair broken cables, reinforcement methods by adding external cables were studied. Considering the present traffic and other conditions of this bridge, it was decided that the present strength is sufficient and that further reinforcement will not be needed.

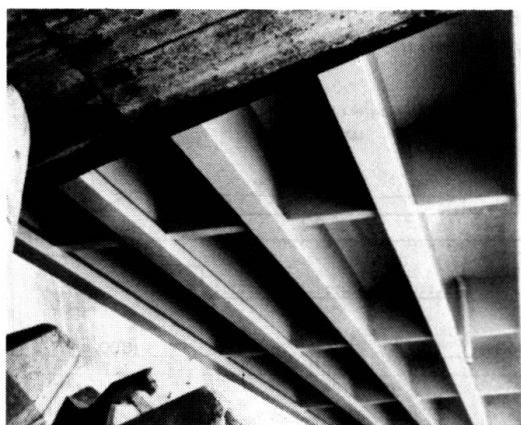
Fig. 4 After repair (Oyataroh Bridge)

The anti-corrosive paint applied is as follows: the first coat is epoxy resin primer; second, third and fourth coat is polybutadien resin paint; finish coat is polyurethane resin.
